SERVICE BULLETINS

Number	Subject
AG. 1.A.	Filling a new Automatic Gearbox
AG. 5	Front and Rear Service
AG. 6	Rear Pump and Services (any)
AG. 7	Summing Points
AG. 8	Removal and replacement of the Automatic Gearbox
AG. 9	Tools. Front BAND SETTING Gauge
AG. 10.	Automatic gearbox front Servo Adjusting Gauge.
AG. 11.	" " Leaks
AG. 12.	" " DISTRICTS
AG. 13.	Loosening of Torus Cover Set Screws. Oil Leaks
AG. 14.	1000 mile service.
AG. 15	Torus Cover Gasket - W/1117
AG. 16	Dipstick Volume modification
AG. 17	Pressure Valve from pump Oil Seal - S2 Care
AG. 18.	Front band setting tool. UR. 3144
AG. 19	Vented Bell Housing Bottom Cover
AG. 19	Addendum. Vented Bell Housing Bottom Cover

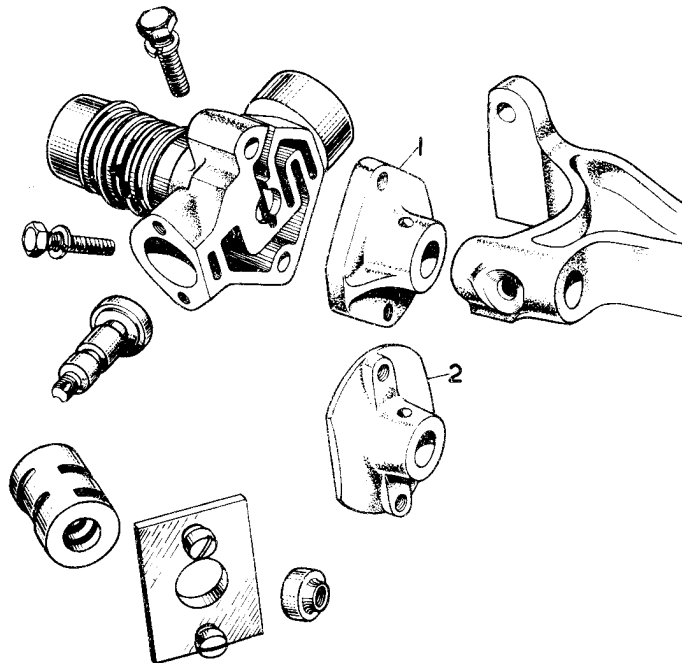
EXPLODED VIEW OF GOVERNOR ASSEMBLY.

The governor driving flange in Automatic Gearboxes bearing the Serial Numbers C1 to C384 is in aluminium and has been superseded by a steel flange.

- 1. Aluminium Flange.
- 2. Steel Flange.

If it is necessary to service either the governor or the rear pump in these boxes, the complete governor and pump assembly should be changed for one containing a steel flange. It is not practicable to fit a steel flange to an existing shaft without the use of special equipment.

Retailers are asked to keep a stock of the latest assembly, Part Number UG.1426, and to return any displaced assemblies as quickly as possible to the London Service Station for re-working.

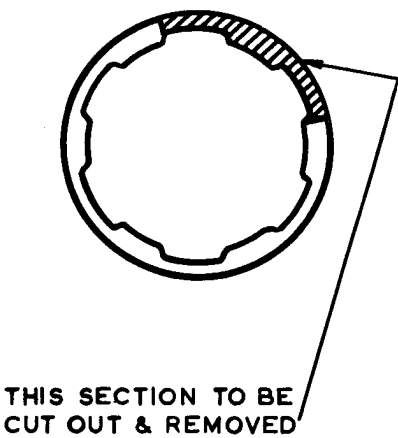
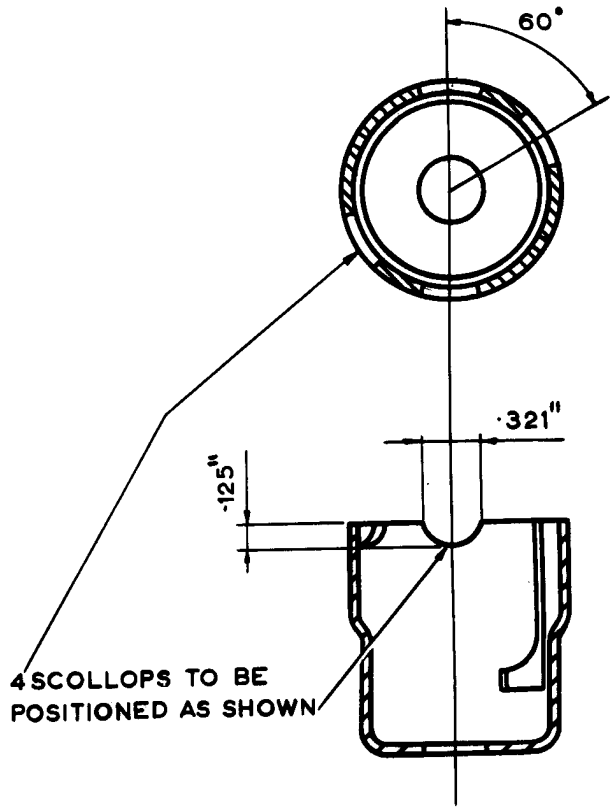
After prolonged running at high speed it may be possible for air pressure inside the gearbox to rise sufficiently to force oil through the normally satisfactory front pump oil seal.

This possibility is overcome by modifying the automatic gearbox oil breather and level indicator so that the pressure is relieved sufficiently to prevent oil leakage.

Take the oil breather and level indicator from the gearbox and carefully remove the retaining device securing the retaining cap to the indicator rod. The retaining device may be either a cee clip, spring clip, or split pin. This will allow the retaining cap, the copper mesh crimp and the serrated washer to be removed from the indicator rod. Cut the serrated washer and file the retaining cap as illustrated. Thoroughly clean and remove all metal particles, re-assemble the components and replace the assembly in the gearbox.

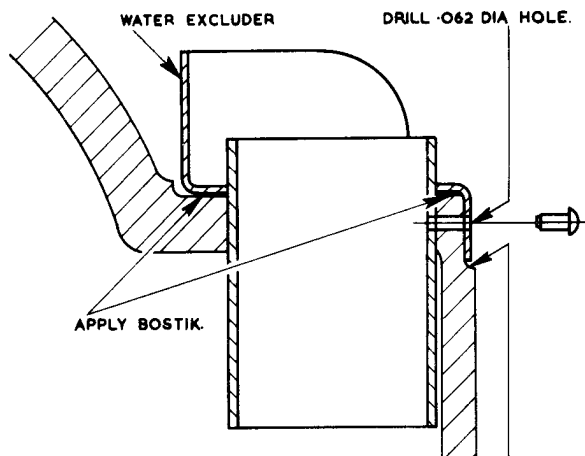
Fig.1.

The following modification should be carried out to prevent water entering the gearbox by way of the dipstick aperture, only when the gearbox has already been removed for some other reason and is to be refitted into the chassis. All replacement gearboxes will incorporate this modification.

File a horizontal flat approx. 0.4" deep on the outside of the dipstick housing sufficiently deep to receive the right angled drilled location lip of the water excluder (see Fig. 1).

FILE HORIZONTAL FLAT .400 DEEP
TO RECEIVE EXCLUDER LIP.

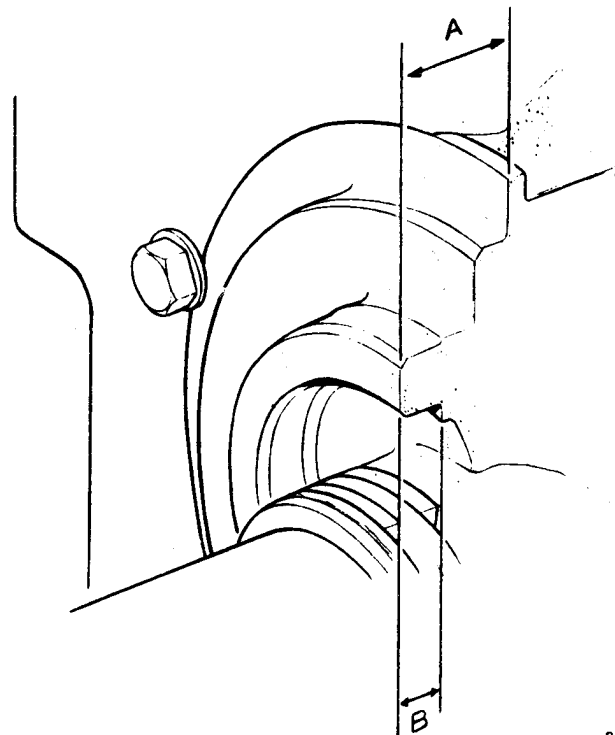
Fig.1. Pump Cover Checking Dimensions.

Difficulties have arisen concerning the fitting of the oil seal between the front pump cover and the torus cover. The following is a brief outline of the stages of modification in order of their introduction :

Using a depth gauge or vernier callipers, measure dimensions 'A' and 'B' given in Figure 1. Subtract dimension 'B' from dimension 'A'. A result which lies between 0.355 in. and 0.400 in. indicates that the cover is not of the modified type and that a washer must be fitted; a result between 0.415 in. and 0.450 in. indicates a modified pump, requiring no action.

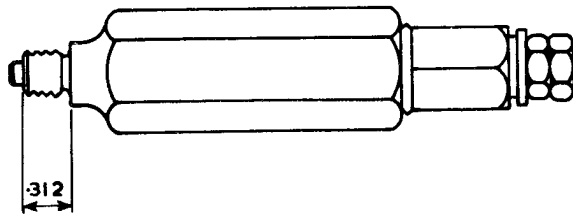
Tool No. 27647/G.1002.

It has been found that due to a combination of manufacturing tolerances, that it is possible when using the front servo adjusting gauge for the end of the threaded portion to touch the servo piston, and so make accurate adjustment impossible.

As a guarantee against this happening, Retailers are asked to check that the threaded portion of these gauges (Part No. 27647/G.1002) conform to the dimension .312 as shown in the illustration below, and if not to modify by machining to suit.

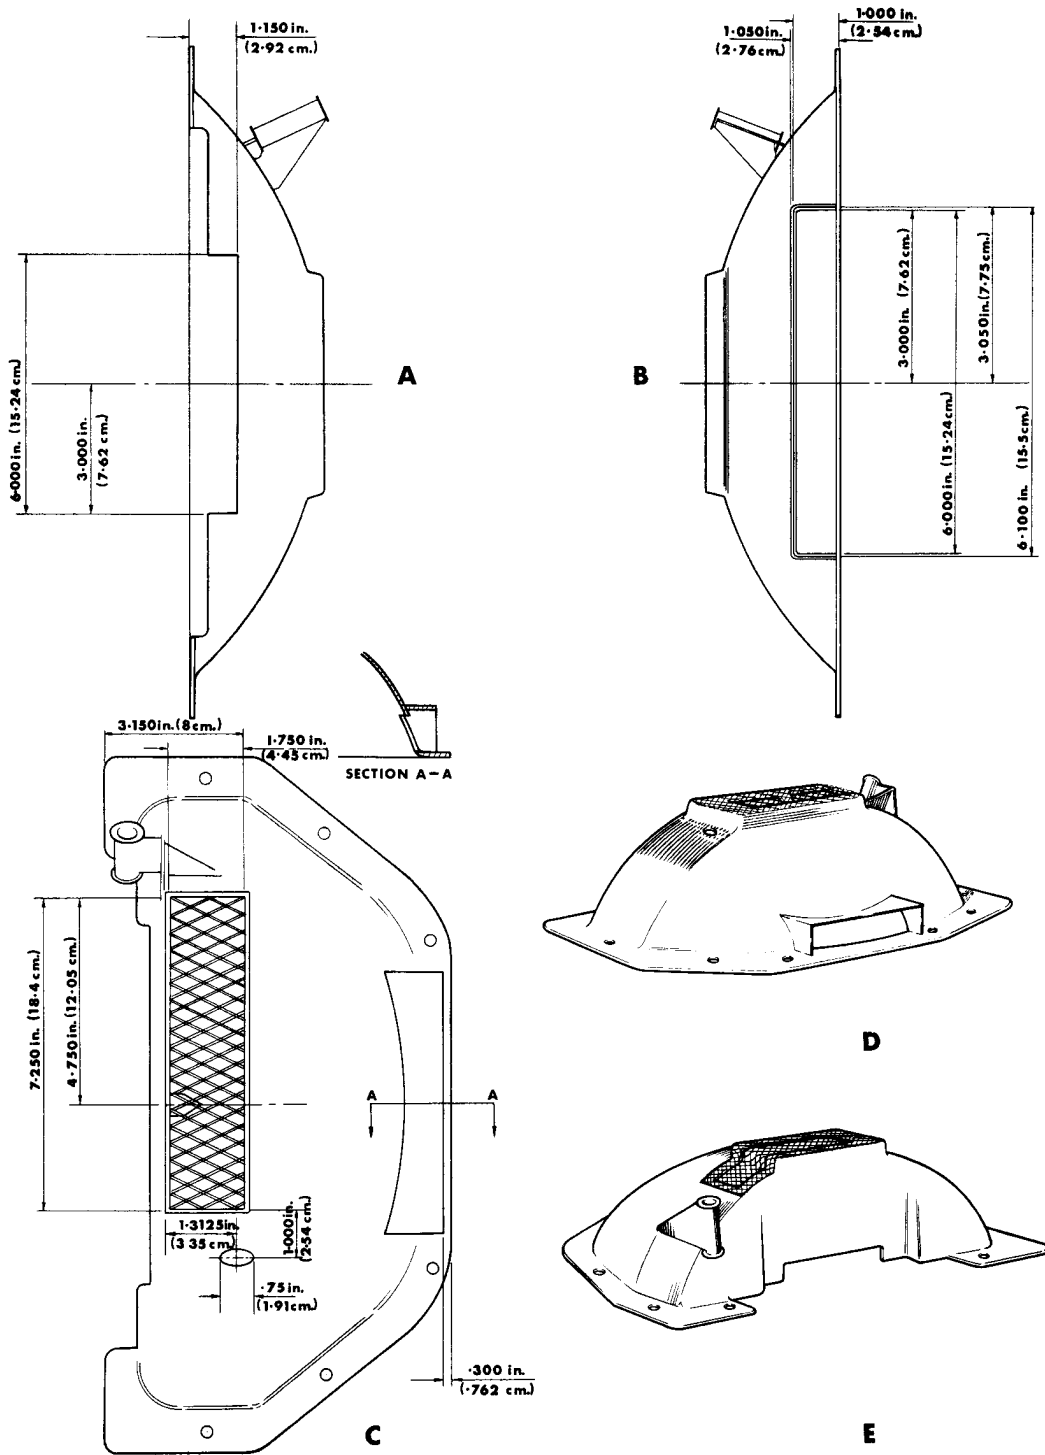
Fig. 1 Modifications to bell housing bottom cover

A number of recent complaints of slipping gearchanges and loss of drive in cars used frequently in congested town conditions have been attributed to overheated gearbox oil. It is known that the enormous number of gearchanges coming one after the other in conditions where there is negligible flow of cool air past the gearbox and bell housing, will maintain the gearbox oil at a very high temperature. The oil eventually oxidises, and thus reduces the coefficient of friction between the steel plates and the faced plates in the clutch packs. This causes slip, which heats the oil more and continues the vicious circle until the facing material of the clutch plates is attacked and disintegrates. Total loss of drive will follow. In service, this process of deterioration can first be recognised by slip at the 2-3 change, gradually extending to all the 'up' changes.

The bell housing bottom covers of all cars operating in and around London should be modified on a Category 2 basis. Retailers should obtain modified bell housing bottom covers from Rolls-Royce Service Depot, Hythe Road, Willesden. It should be noted that there is only a limited quantity of these covers available and there may be a few weeks delay in modifying stocks.

7. When the modifications are complete, paint the bell housing bottom cover assembly with a zinc based paint such as 'Rust-Annode'

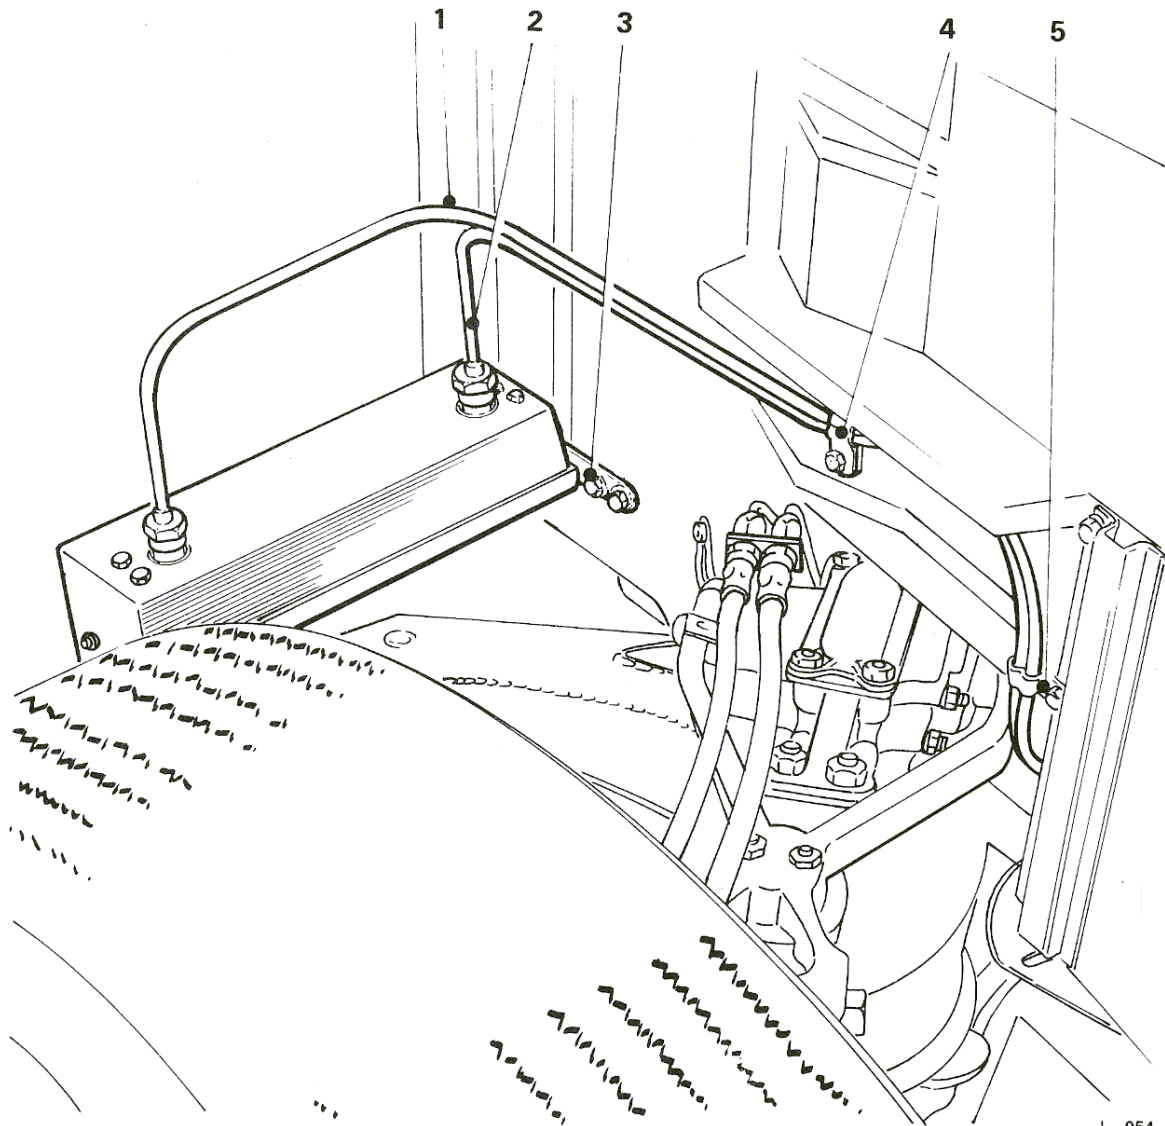
Figure 1 Oil cooler in position behind left-hand "snowpack"

A number of recent complaints of slipping gearchanges in cars used frequently in city conditions have been attributed to overheated gearbox oil. The overheated oil causes slip between the clutch plates on drive take-up resulting in harsh and jerky gear changes.
