**CHASSIS FRAME**

CATEGORY 3A MODIFICATION.

WELDED FRAME STIFFENERS.

FUEL TANK MOUNTING STRAP INTERMEDIATE BRACKET.

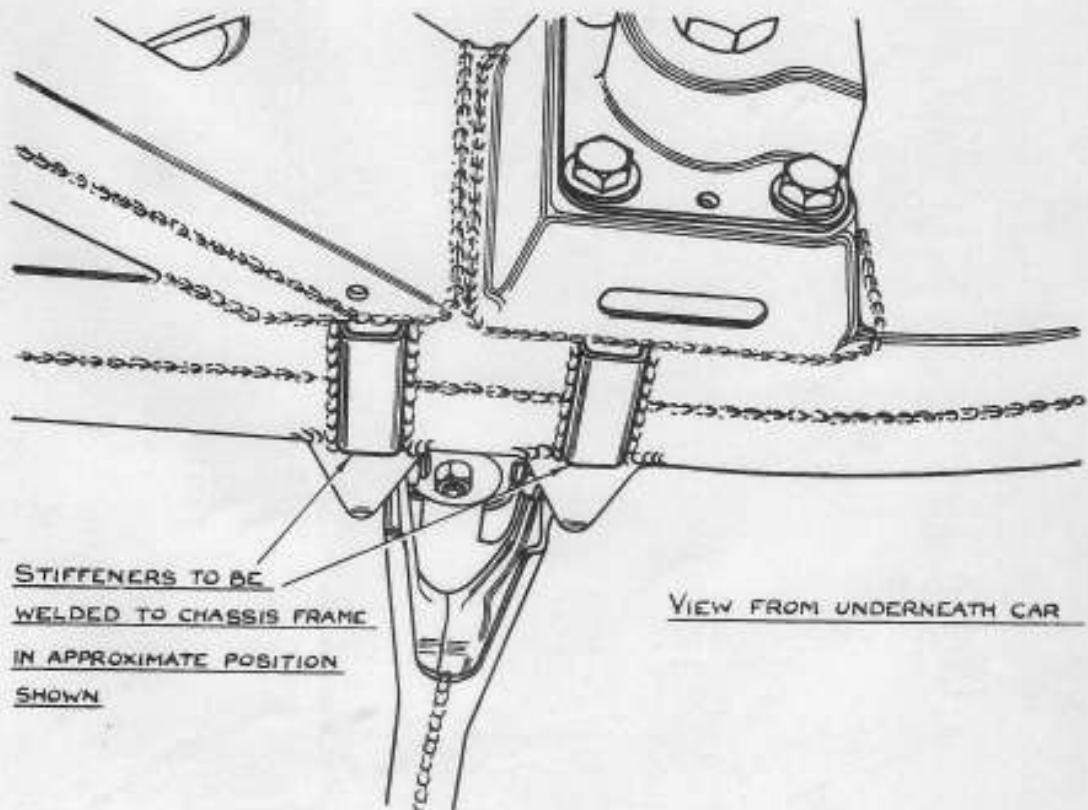
On certain cars it may be found that when raising the car with the car jack provided, the jacking spigot "springs" relative to the frame, and it may even be possible in extreme cases for this to damage the frame.

In the unlikely event of damage to the frame, which will be evident in the form of a split in the welding along the underside of the frame, the frame is to be welded electrically. It is neither desirable nor practicable for these components to be gas welded.

To prevent any "springing" at the jacking point and to overcome any possibility of damage to the frame, stiffening pieces are to be electrically welded to the underside of the frame adjacent to the jacking points as illustrated.

<u>Part No.</u>	<u>No.Off.</u>
Chassis Frame Stiffener	UR.3305.	4.

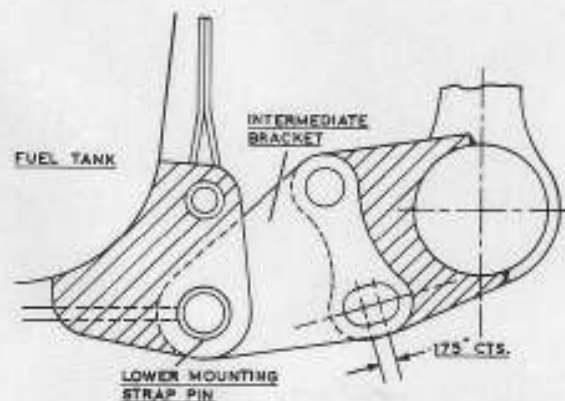
MODIFICATION TO THE FUEL TANK MOUNTING STRAP  
INTERMEDIATE BRACKET.

It may be necessary on certain cars to lower the rear of the fuel tank so that the wiring loom fitted to the undersurface of the boot floor cannot be chafed between the top of the fuel tank and the undersurface of the boot floor.

Raise the rear right hand road wheel and remove it to inspect whether sufficient clearance exists between the upper surface of the fuel tank and the undersurface of the boot floor. If the wiring loom shows signs of being chafed it must be replaced, or if the clearance is inadequate, the four rear mounting intermediate brackets are to be modified.

Support the fuel tank in such a manner that it cannot be damaged by its own weight and so that the load is removed from the mounting straps. Disconnect the mounting straps by removing the two lower-most strap pins, one each side, and withdrawing the lower straps from the strap pins by removing the two adjusting nuts. Remove the intermediate bracket securing nuts and bolts and elongate the lower bolt holes as indicated.

Replace the brackets and strap pins leaving the intermediate bracket fixing bolts loose until the fuel tank mounting shoes have been positioned to allow the tank to assume the correct clearance from the undersurface of the boot floor. Inspect to ensure that the fuel tank does not foul elsewhere. It will be necessary to relieve the fuel tank support to facilitate this operation, but leaving it close in position for safety.
