CATEGORY 2.

ENGINE REAR MOUNTING AND REAR EXTENSION BRACKET.

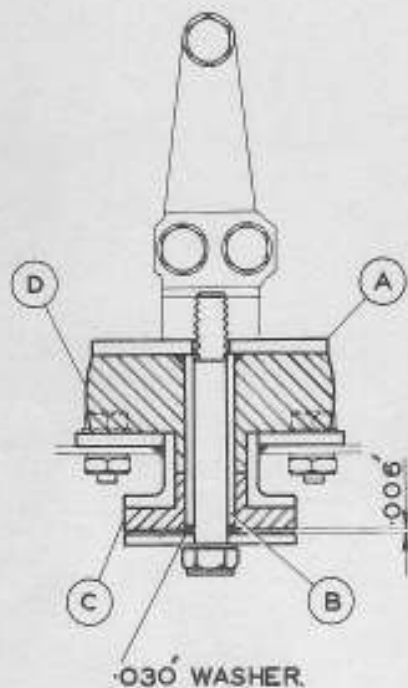
Engine Rear Mounting.

On certain vehicles it has been found that when the engine rear mounting bolt is fully tightened, the upper washer of the rear mounting distorts slightly to conical form, so that it seats only over an area close around the bolt hole in the undersurface of the bracket. This permits relative movement between the upper washer and the bracket, which may eventually cause fatigue failure of the engine mounting bolt at that point.

- A. Rear Mounting Upper Washer.
- B. Distance Tube (Welded to upper washer).
- C. Rebound Rubber.
- D. Upper Mounting Rubber.

This is overcome by machining a counterbore in the undersurface of the rear extension bracket .750" in diameter and .005" - .010" deep, so that should the upper washer distort, the effective seating will not be confined close to the bolt hole, but to the diameter of the counterbore.

The rear engine mounting is also to be checked to ensure that the lower rebound rubber is not held tight but has .006" vertical clearance, when the assembly is tightened in position with the engine load on. If there is insufficient clearance a .030" thick steel washer is to be placed between the lower steel washer of the assembly, and the distance tube, taking care to ensure that the washer seats directly on the base of the distance tube, and does not foul the inside of the hole in the rebound rubber. Alternatively the distance tube can be lengthened .030" by welding and machining to a length of 2.045".

The modification to the rear extension bracket and to the assembly of upper washer and distance tube are as illustrated.
