DANFOSS SOLENOID VALVE

AIR CONDITIONING (REFRIGERATION) SYSTEM

CATEGORY 3AINTAKE WHISTLE - UNDERWING A.C.U.

AIR CONDITIONING CONTROLS

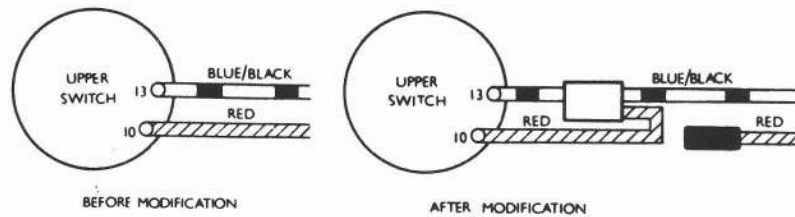
When the intake grilles in the front wings were changed from rubber mouldings to plated wire gauze, air flow in the upper system was increased, as intended, but in some cases gave rise to an obtrusive whistling noise whenever the upper flap was fully open.

The whistle is not evident until the flap passes the two thirds open position and as there is no appreciable difference in air flow between the two thirds open and the fully open positions, the whistle can be avoided simply by eliminating the fully open position, as described below.

**Fig. 1 Modification of the wiring of the 'Upper' (Ventilation) Switch.**

Remove the red wire from terminal 10 of the switch and tape it back.

Remove the blue/black wire from terminal 13 of the switch and cut the wire approximately one inch from the Lucar socket. Fit connector nipples (UD.2141) to the two cut ends and plug them both into a double connector (UD.1806). Fit a three inch length of red 14/.012 wire to the same connector and fit a Lucar socket (UD.6072) and sleeve (UD.6119) to the free end of the wire.

Reconnect the blue/black wire to terminal 13 of the switch and connect the new red wire to terminal 10.

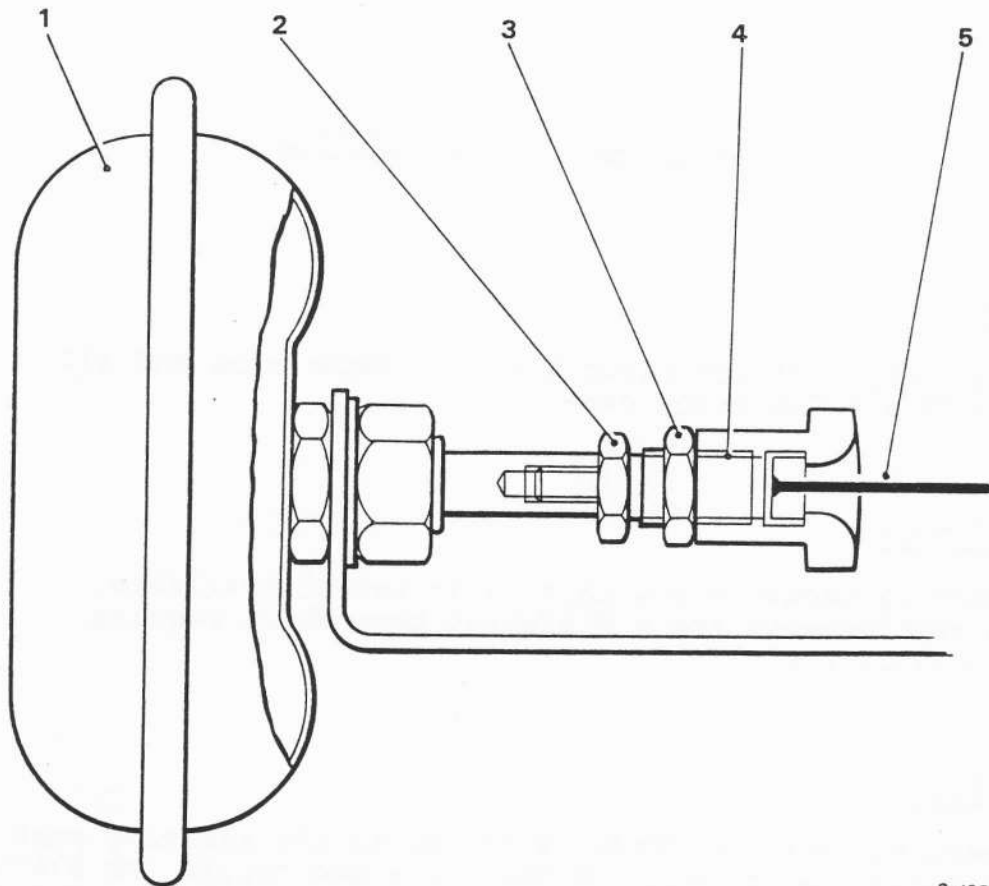
The existing vacuum valve unit is no longer available. Future replacements are a different type which require additional parts.

Figure 1 - Vacuum valve assembly

A screwed adapter (RH 9098) is fitted to the existing push rod on the vacuum valve unit. A new cable and nipple (RH 9100) is fitted, this being attached by means of a retainer (RH 9099) and retaining lock-nut (RE 22430). These are screwed and locked to the adapter (refer, Fig. 1).
