CAMSHAFTS - S2 ENGINES

BRITISH FULL-FLOW OIL FILTERS - S2. ENGINES

BREATHER BAFFLE

FITTING THE OIL PRESSURE TRANSMITTER

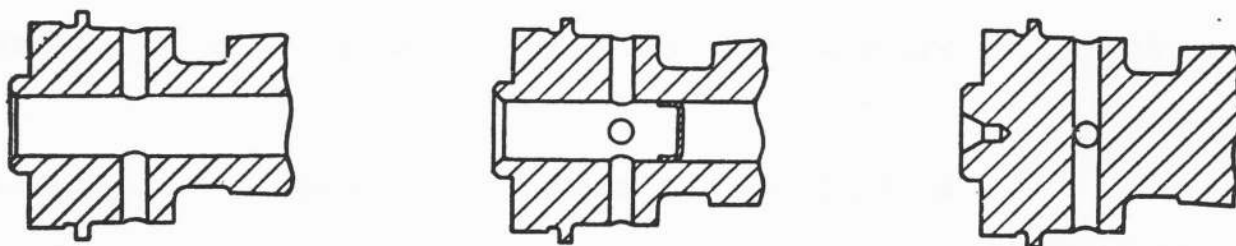
Fig. 1. Three types of camshaft fitted to V8 engines.

Three different methods of feeding oil to the camshaft bearings are employed on early production V 8 engines; these differences involve slight modifications to the camshaft and crankcase. The three stages of camshaft design are shown in Figure 1.

Camshafts fitted to engines employing stage one method of lubrication cannot be fitted to engines employing the second or third method.

Camshafts fitted to engines employing stage two or three method of lubrication, cannot be fitted to engines with stage one method.

Stages two and three are basically the same and camshafts fitted to engines employing either of these methods of lubrication are interchangeable; the only difference between stages two and three is a modification to the camshaft.

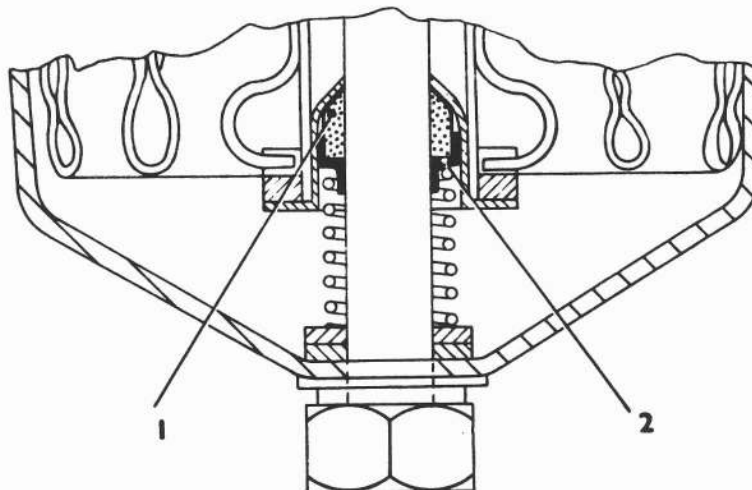
Fig.1. Scrap view of oil filter showing position of washers

It has been established that after servicing, some oil filters have been re-assembled without the cork sealing washer and/or the metal cup washer, which should have been fitted beneath the filter element.

Failure to fit these washers, allows unfiltered oil to pass up the central tube of the filter and this can result in serious damage to the engine bearings.

1. Cork sealing washer
2. Cup washer

When servicing an oil filter, it is essential that particular care is taken to ensure that the cork washer is in a serviceable condition and is fitted, together with the cup washer, in the correct position as shown in Figure 1.

Cork sealing washer	Part No. CD.255
Cup washer	" " CD.256

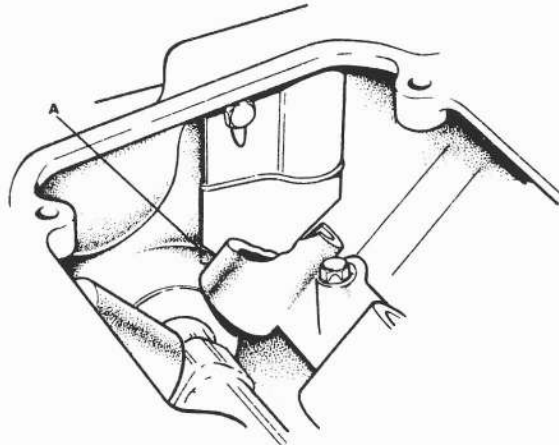
Fig.1. Modified Baffle shown in position.
'A' Area of Metal to be Removed

In isolated cases, loss of oil down the crankcase breather pipe on S2 cars may occur.

This is caused by the camshaft flinging oil through any gap which may exist between the breather baffle and the wall of the crankcase

Remove the baffle plate and relieve the bottom edge to ensure that it clears the boss, formed by the camshaft bearing (see 'A' in Fig 1). Fit the baffle plate in position, and if necessary bend it to ensure that it fits flush against the wall of the crankcase.

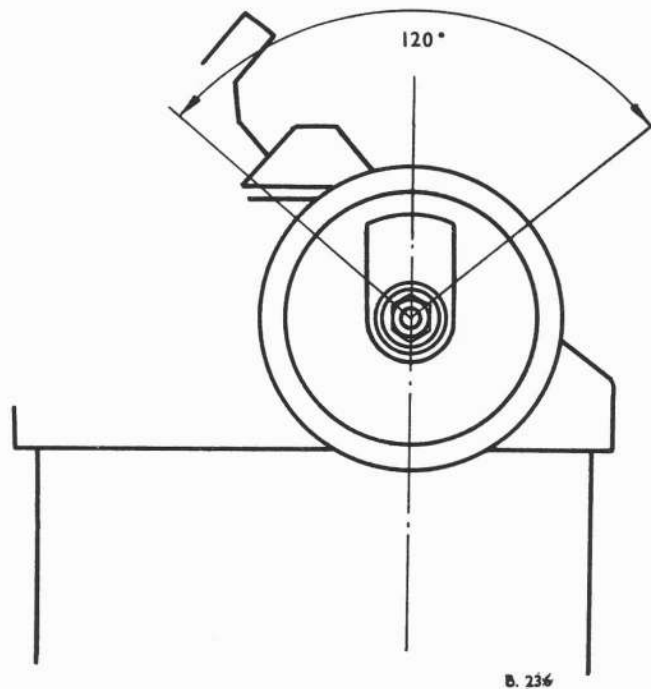
Fig.1. Position of the Oil Pressure Transmitter.

To obtain an accurate oil pressure reading on S2 engines it is essential that the oil pressure transmitter is correctly assembled to the oil filter head.

The transmitter should be fitted so that the raised portion of the cover is to the top of the filter and within 60° of either side of the vertical datum. (See Fig.1).

The correct position of the transmitter can be obtained by fitting additional copper washers to the threaded union.

The part number of the copper washer is UD.8017

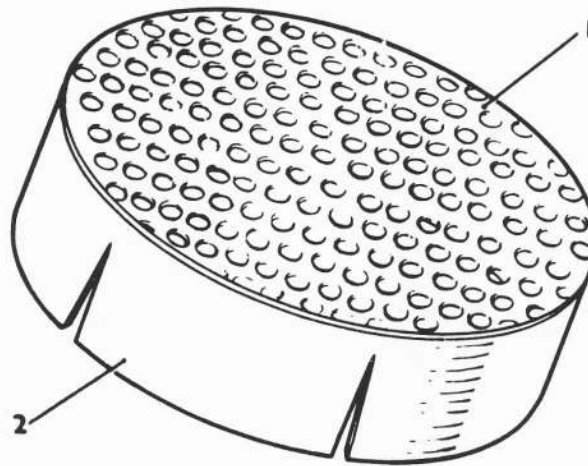
Fig.1. Sketch of filter for fitting over the carburetter choke housing.

If, for any reason the air silencer hosing is removed from the carburetter choke housing, it is essential that the choke should be masked with tape immediately, in order to prevent any possibility of foreign matter entering the engine induction system. For the same reason, if the carburetter 'T' piece and carburetters are removed, the induction manifold should also be masked.

Should it be necessary to operate the engine with the air cleaner disconnected, a gauze filter, similar to that shown in Figure 1, should be made and placed over the carburetter choke before running the engine. The sides of the tubing should be cut so that the tubing can be bent to grip the choke housing.

1. Gauze 2. $4\frac{1}{8}$ in. internal diameter tubing.
