CREWED JOTTINGS

Issue 22

December 2008 REPORT

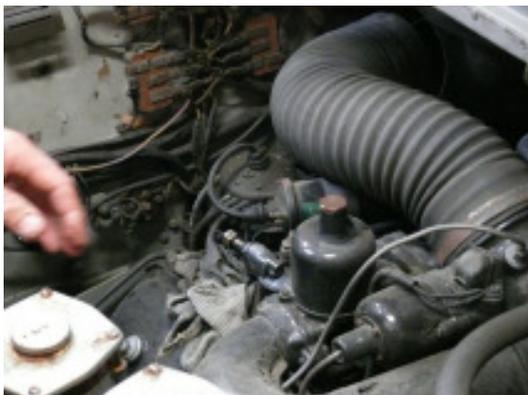
Gauze Strainer

The solution was fortunately quite simple. After a few checks it was found that an appreciable amount of 'gunk' had accumulated around the gauze filter strainer that led into the float chamber of the right carburettor which restricted the flow of fuel into it. We also checked the main fuel filter (adjacent to the fuel tank), and both filter gauzes in the fuel pump (according to the workshop manual, these should be cleaned every 10,000 miles) and after balancing the carbs and adjusting the mixture, the old girl was back to her former self again.

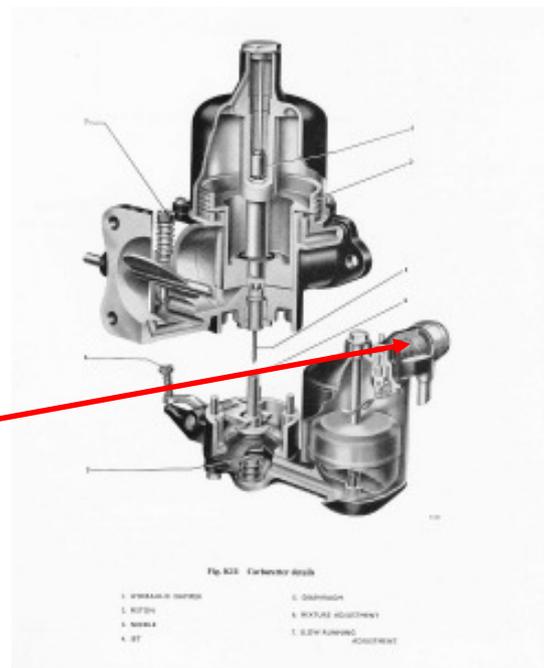
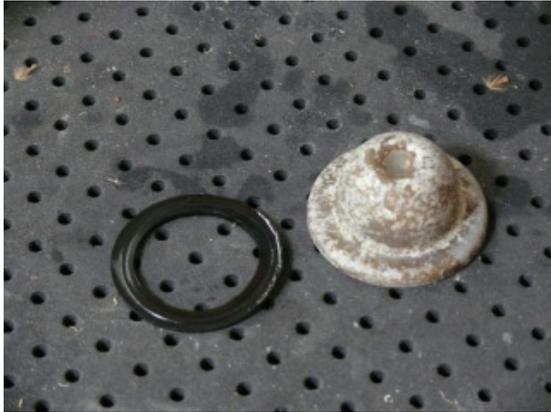
Removing The Gauze Strainer

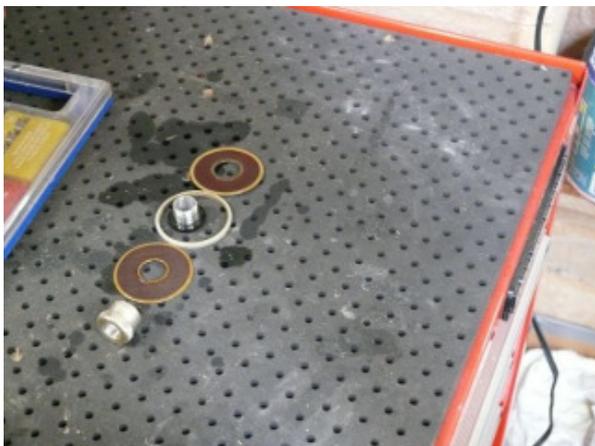
Removing The Main Fuel Filter Adjacent To The Fuel Tank For Cleaning. The Fuel Lines Were Also Cleaned.

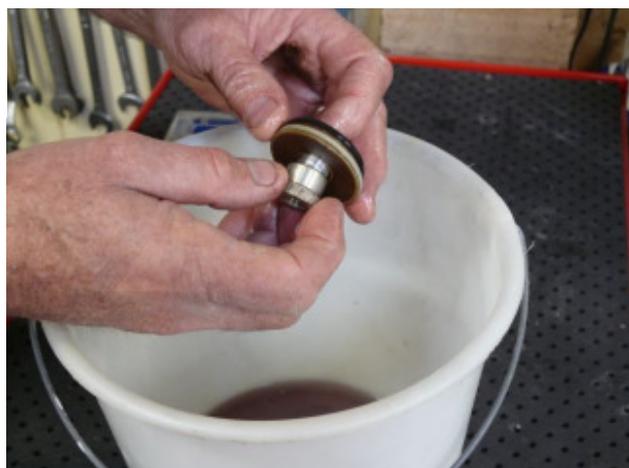
Getting Everything Clean Did The Trick In The End.

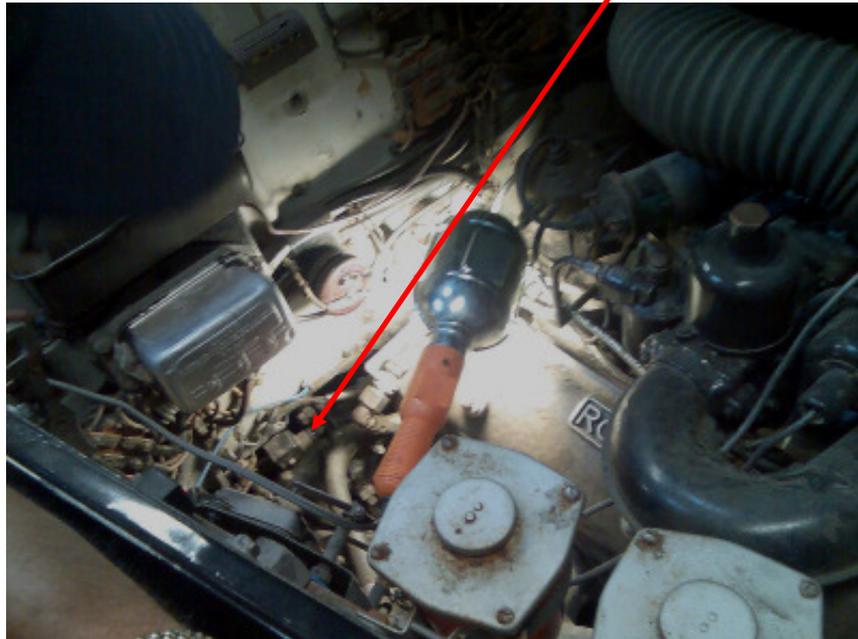
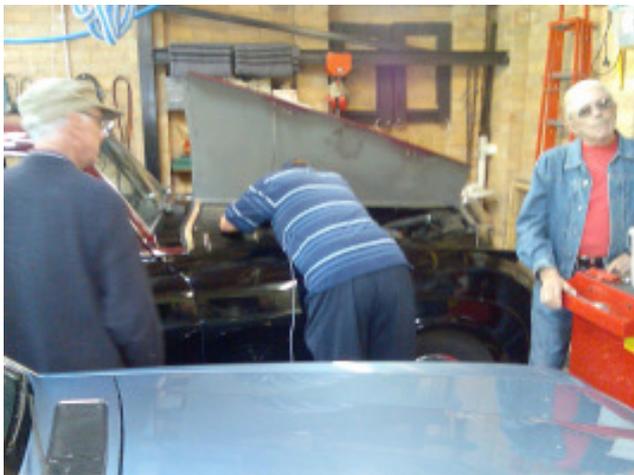
Another problem was that the reversing lights weren't operating and as both lights weren't illuminating, the first place to check was the fuse box. No blown fuses, so we checked the reversing light switch which is attached to the base of the steering column. There are two separate switches located near the steering box. One is for the reverse lamp, the other for neutral. They are operated by the same flap on the gear selector rod.

The problem here was that the switch was worn down and it wasn't reaching the terminal to close the circuit. There is some room for adjustment but in this case, the small rod was not going to reach the contact. Short of replacing the unit (and they're not cheap), we decided to use a 'home remedy.'

As the old saying goes, 'Necessity is the mother of invention', and an excellent medium that closed the gap was (believe it or not), a plastic tyre valve cap which was Superglued over the small shaft.

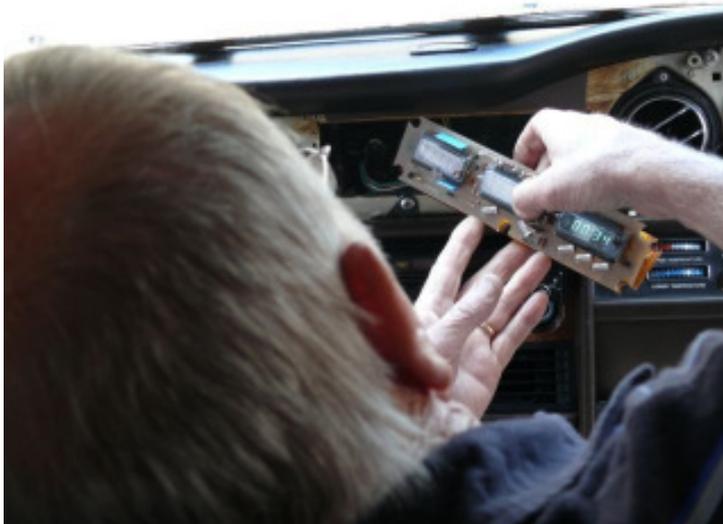
Readers may recall a couple of issues back that my clock and outside temperature gauge were not working. This seems to be a bit of a common problem with Spirits and Spurs (Only some. Turbos and the later SZ Bentleys have analogue clocks and temp gauges) and one of our group had the same problem. Actually, mine still had some issues as well; there seems to be a hairline crack behind the circuit that causes it to cease operating intermittently. Terry H. got them both up and running again by simply soldering every solder point on view.

Terry H. Tests The Clock/Temp Gauge Assembly

Mine works in the main but further investigation will need to be made as it sometimes requires a bit of a tap to get the outside temp gauge working properly; it's of no huge importance but we'll get it right eventually and you will be informed of the culprit in due course. Richard Treacy advised, "Don't forget to lacquer the newly-soldered tracks and components with electrical PCB insulation spray!" Thanks Richard.

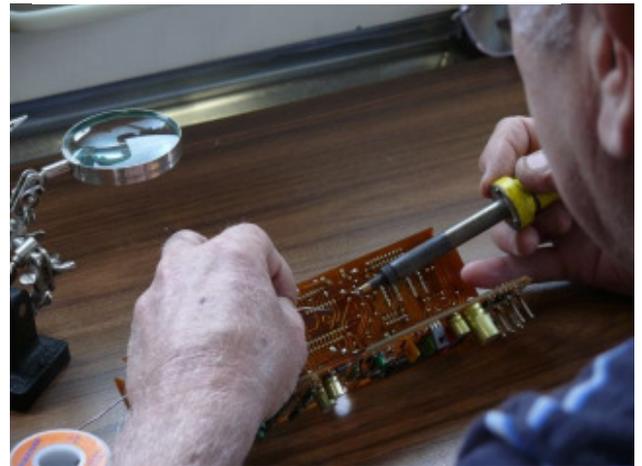
More Soldering

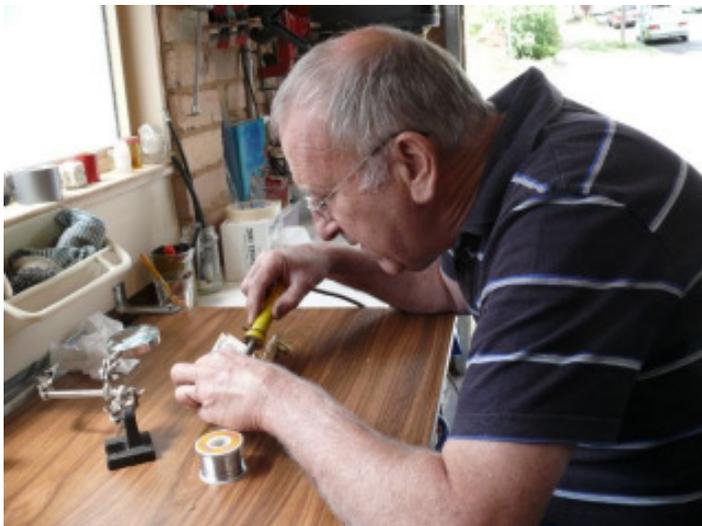
And More Still

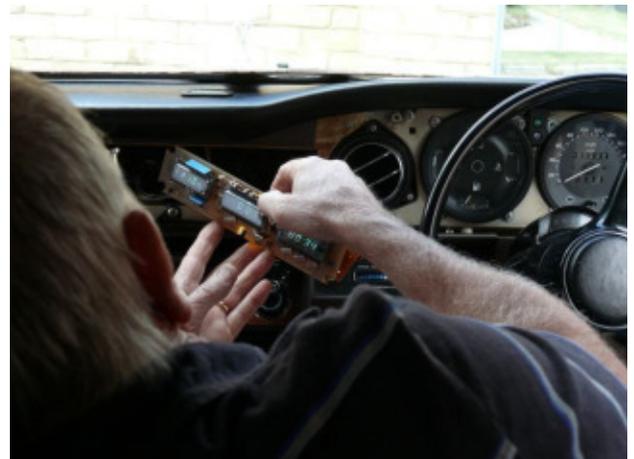
Working So Far, But We'll Keep A Eye On It.

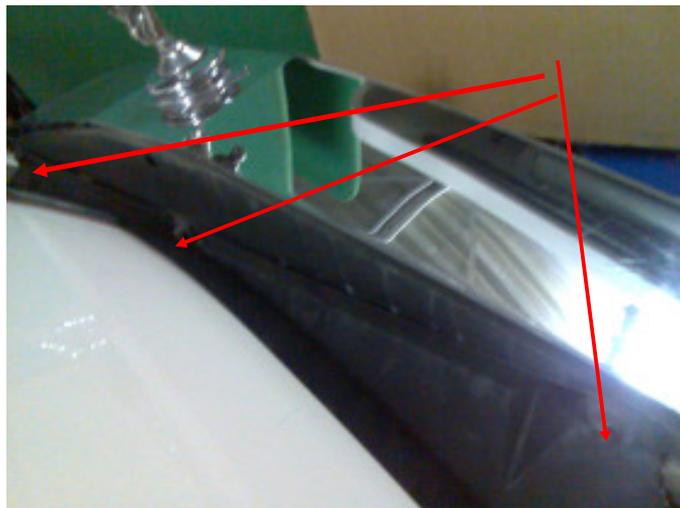
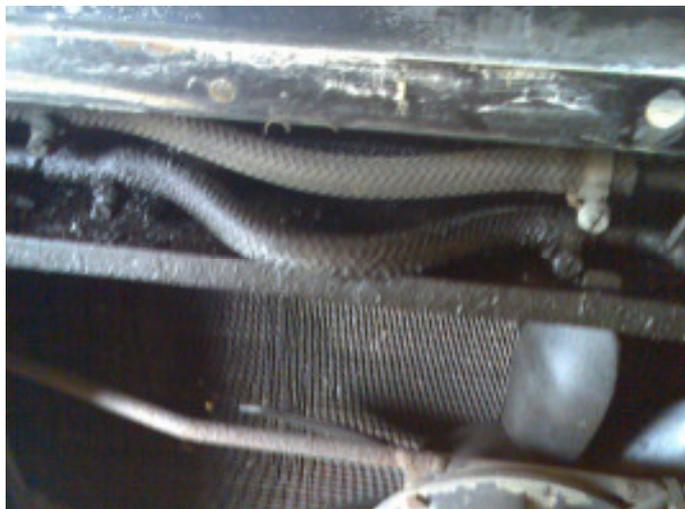
There are a couple of hoses hidden in front of the top of the radiator behind the grille. These braided hoses are for the power steering and presumably are positioned there to keep all of the workings cool. To get to them is relatively simple and you will need to remove the grille.

The photo on the right shows arrows pointing to the Allen screws (*Allen screws are possibly RR only, but are definitely not on Bs - but a good retrofit. They have 1/2" long 1/4UNF - 7/16"AF heads (R-R) UA102/Z (Bentley) UE7532Z. Thanks Again Richard*) which secure the grille in place.

The Hoses As Referred To

The hoses themselves appeared to be in reasonable condition and as we hadn't any new ones to replace them with, it was decided to rectify the cause, which was that the clamps had come loose. The lads gave the hoses a quick cleanup and tightened the clamps, but with the understanding that the Owner will replace the braided hoses at the earliest opportunity just to be certain.
