TEE-ONE TOPICS

Number 85

SOMETHING TO TRY WHEN YOU HAVE A SPARE MOMENT

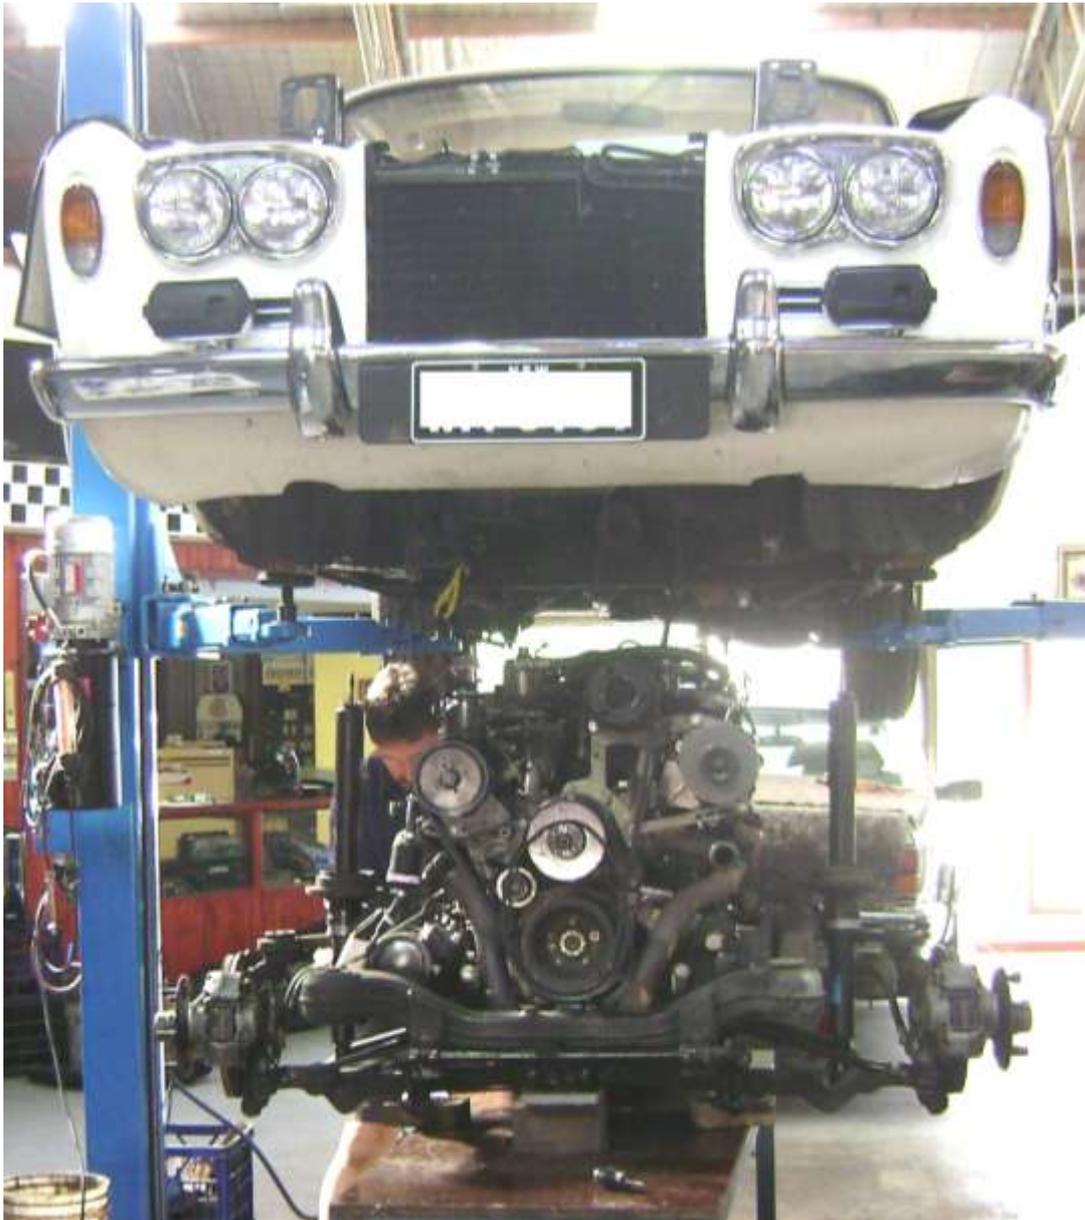
Well you will also need a patient friend with a side lift hoist, some more friends to help with the separation and a courageous heart to tackle the job of removing the engine on a Shadow. What you are looking at is the entire front end assembly of the sub frame, the complete

suspension, all the steering, the transmission and the entire engine. This is actually the original Factory approach using a different hoist and quite a bit more gear. If you are curious look it up in the Technical library. Most engine removals involve separation of the engine from the transmission and lifting the power unit straight out of the chassis. This is possible with the Shadow but extremely awkward given the surrounding clutter and unlike former models it has a very important structural bit across the front of the car that is welded very firmly and exactly in place!

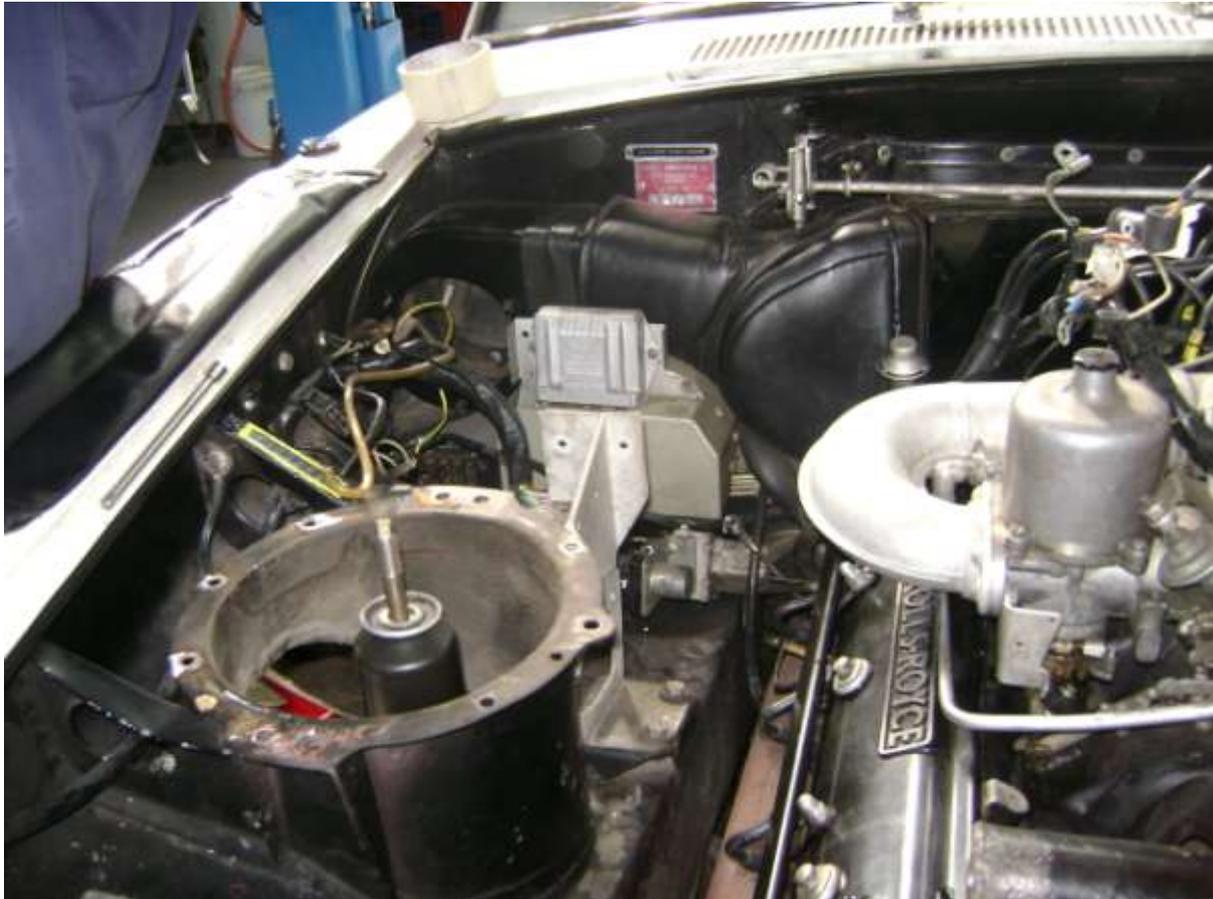
Having removed the bonnet and drained everything in sight including the hydraulic reservoir, the sump and the transmission, the coolant (including the block plugs under the exhaust manifold, if they are blocked try a long sharp screwdriver to drill through the muck and if that doesn't work get ready to have coolant over you, the floor, the hoist and several of your helpers.) You can leave the exhaust manifolds on but most of the exhaust system forward of the 'B' pillar should come off. The radiator can stay in but the fan and belts need to come off. Actually we took the radiator out to avoid possible damage and give a bit more room to manoeuvre.

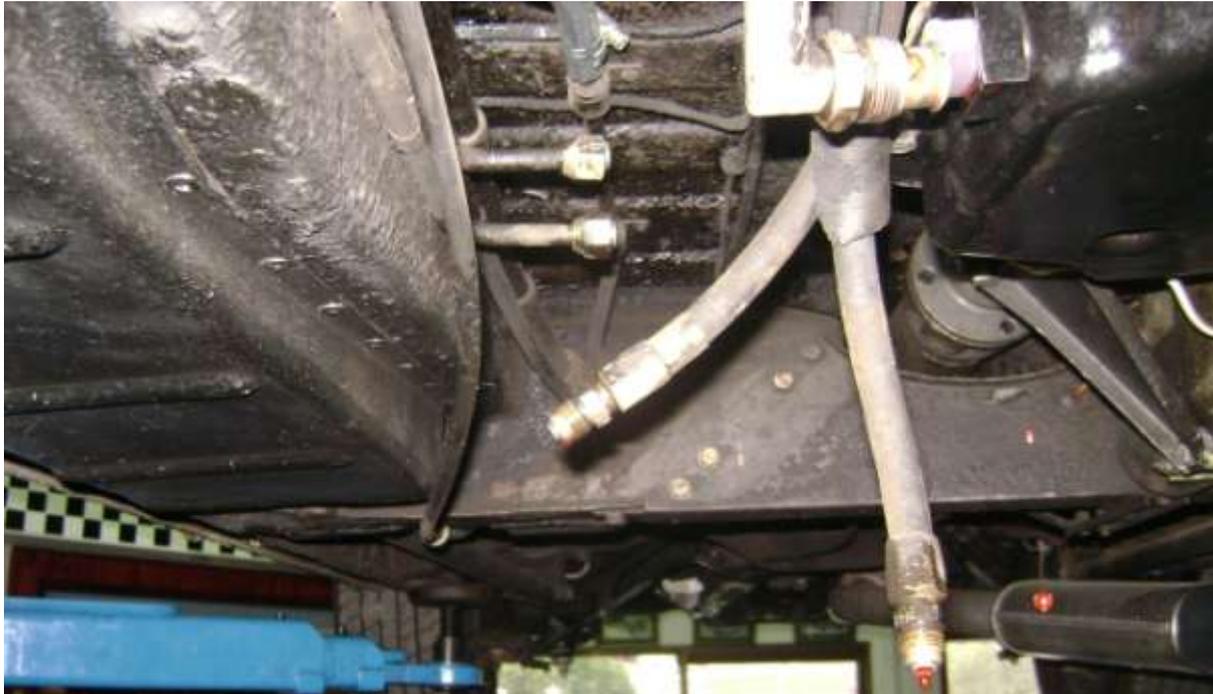
These two flexible lines send and receive transmission fluid via steel pipes seen to their left close to the car floor, to the lower end of the radiator where a separate core is fitted for cooling. The output flange at the rear of the transmission can be seen unbolted. It is not necessary to remove the propeller shaft. The cover for the legendary rat trap is at left.

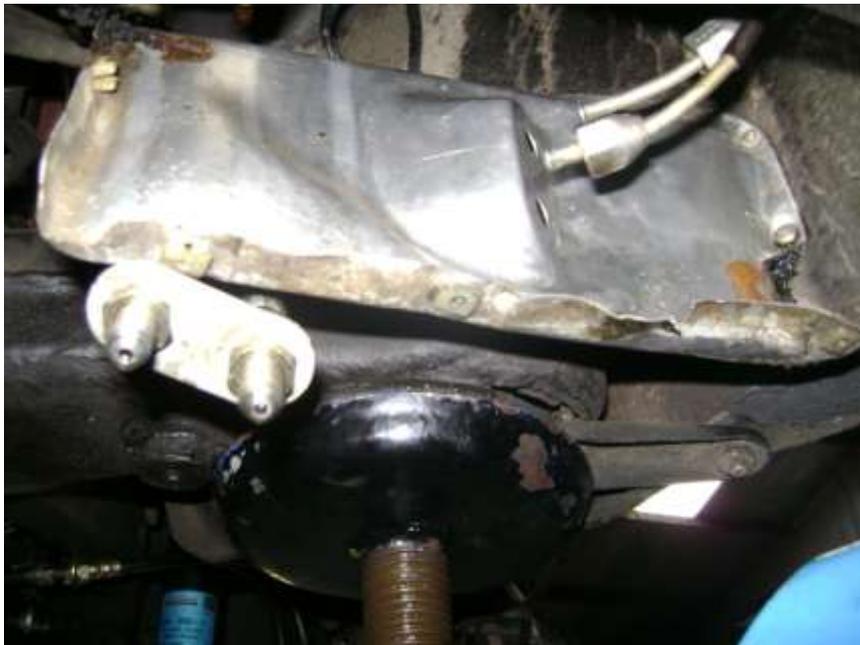
The aluminium plate at the left is the front closure for the rattrap. The pipe ends at left are the two flexible lines between the body and the sub frame. Until early in the Spirit run which is basically the same it was thought provision should be made for movement between the two. Later Sprits have simple rigid pipe connections. These lines carry hydraulic fluid from the brake distribution lines to the

myriad of pipes that infest the car. Each represents a separate system.

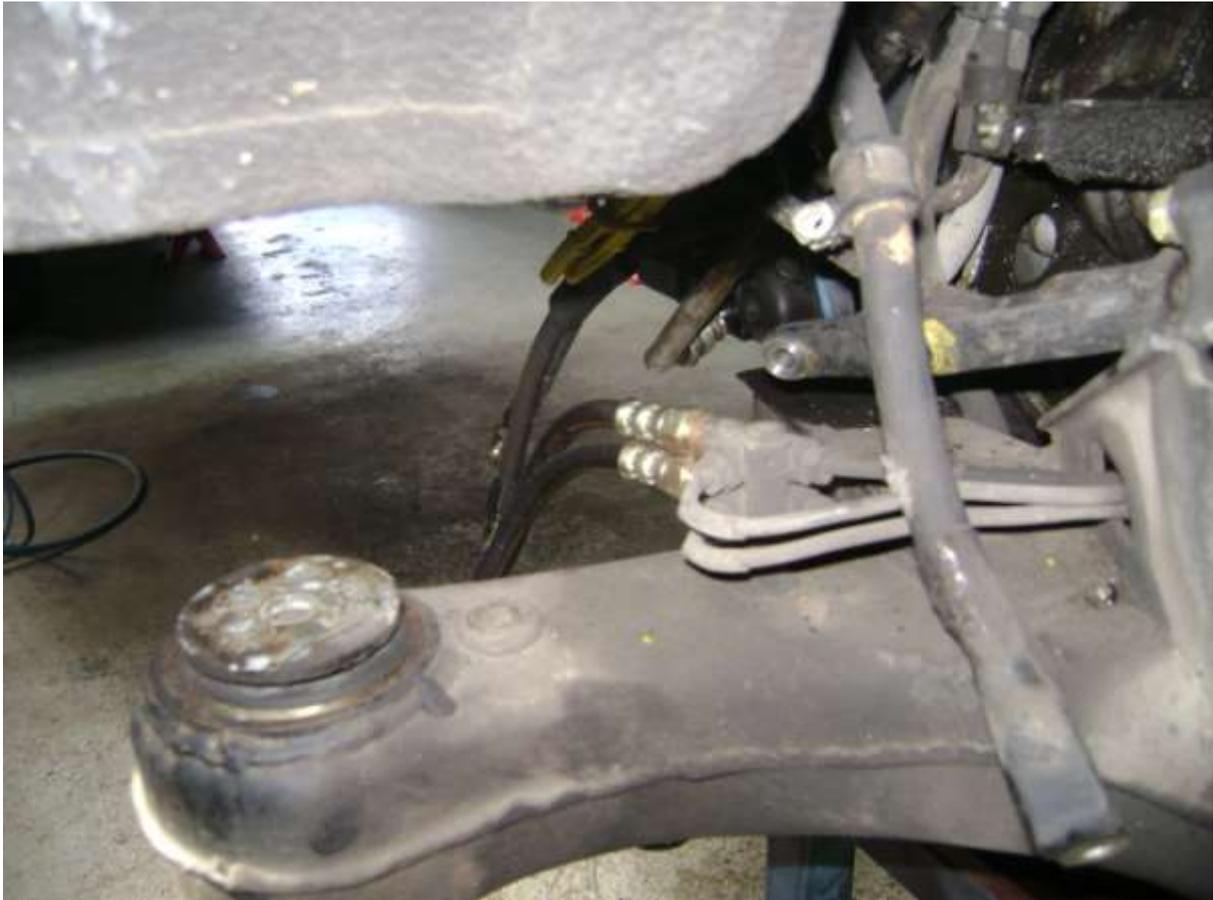
The connecting hoses seen on the previous page can be seen dangling from the junction blocks mounted on the rear of the sub frame. One of the four mounts of the frame to the body of the car is seen at left. The heavy cable draped over the frame brings all power to the car from the rear mounted battery and connects directly to the main starter terminal.

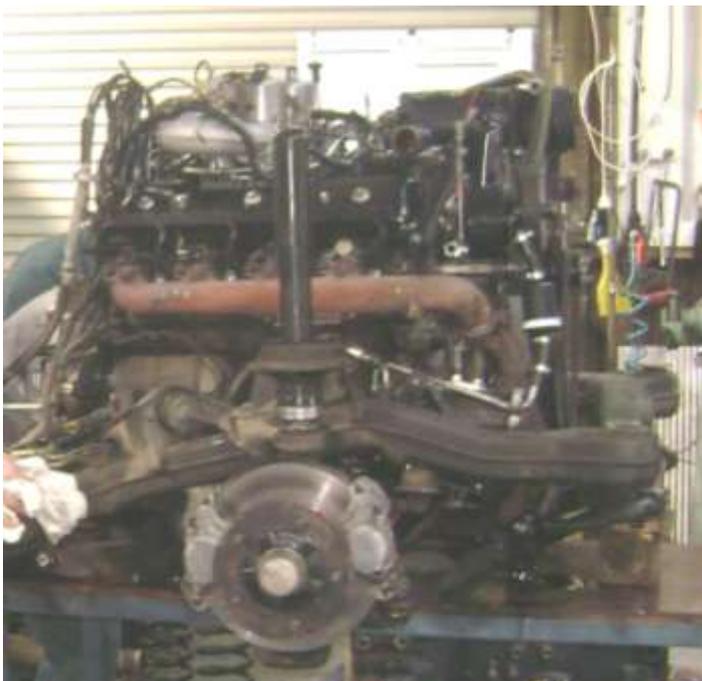
The complete mess has been left sitting on a very stout steel table and the body lifted away. The front mounting points for the sub-frame can also be seen as well as the anti-roll bar mounted beneath.

Incidentally the concertina cylinder immediately on the right hand end of the exhaust manifold is a transmission filter. I have fitted these to a myriad of cars to filter the returning oil for the power steering that comes back from the cooling matrix sitting on top of the radiator core. The main feature of these little units, readily available at any transmission place, is the incorporation of a magnet which

pulls all the bits of steel nasties that circulate in the steering circuit.

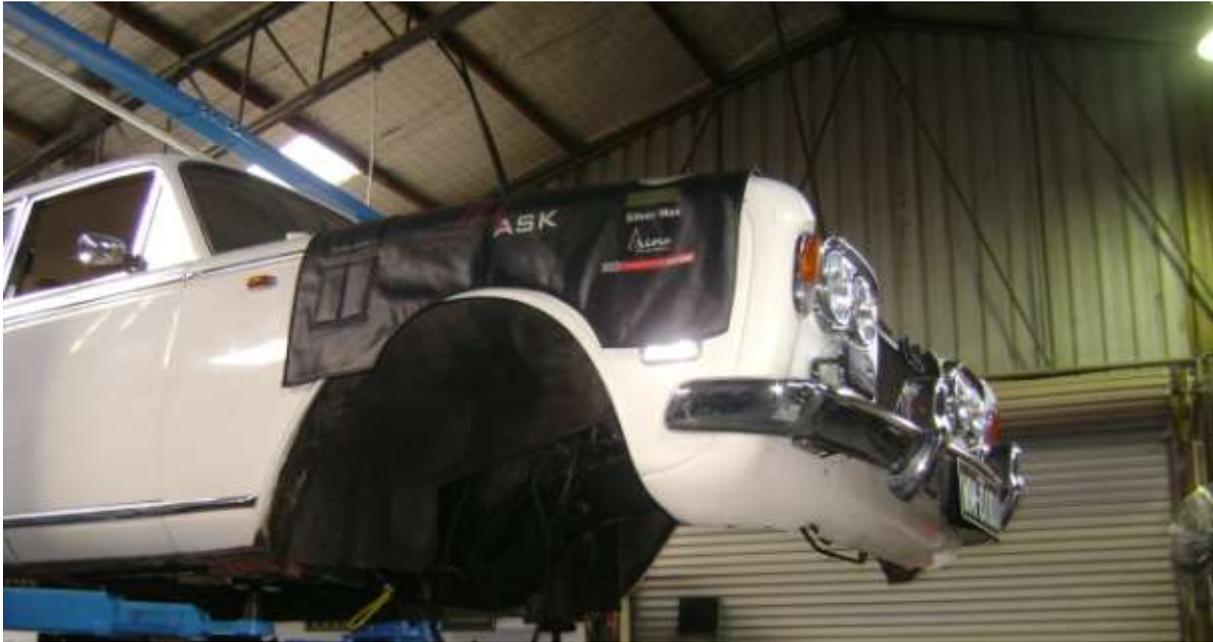
Surely this is a testimony to structural engineering. Even with the engine and transmission in place the lifting points are the same – there is no sagging!

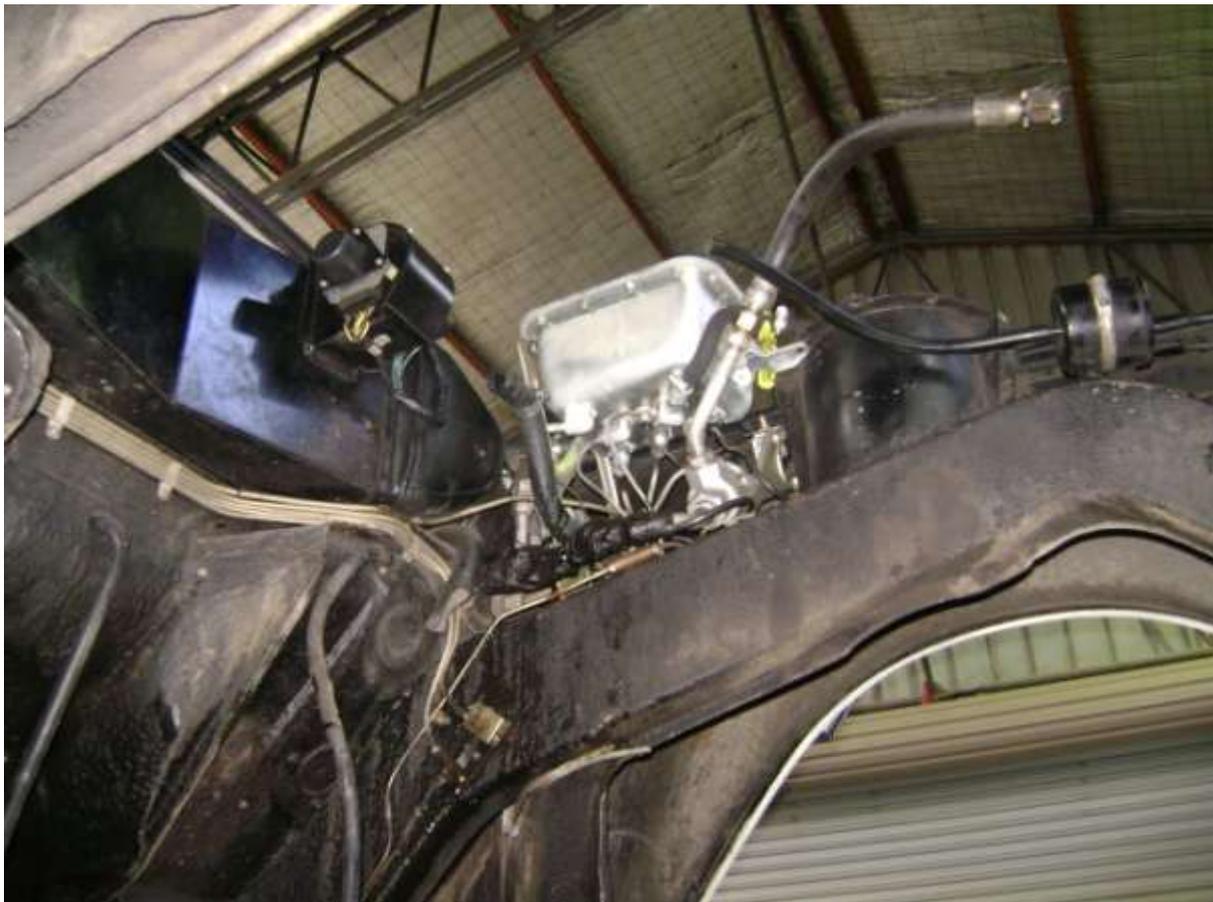
It is here that the owner if he has been properly briefed holds his breath. If the car has had a ‘front ender’, bum repairers do not or don’t care to pick up kinked side members which

buckle under impact. This car is obviously pristine. The other clue to automotive hari-kari is the spring towers themselves, one of which can be seen here. In a repaired car that has been done badly these are clearly not vertical due to distortion, something that is difficult to spot when the car the car is assembled. Again these were perfect. The owner is now breathing.

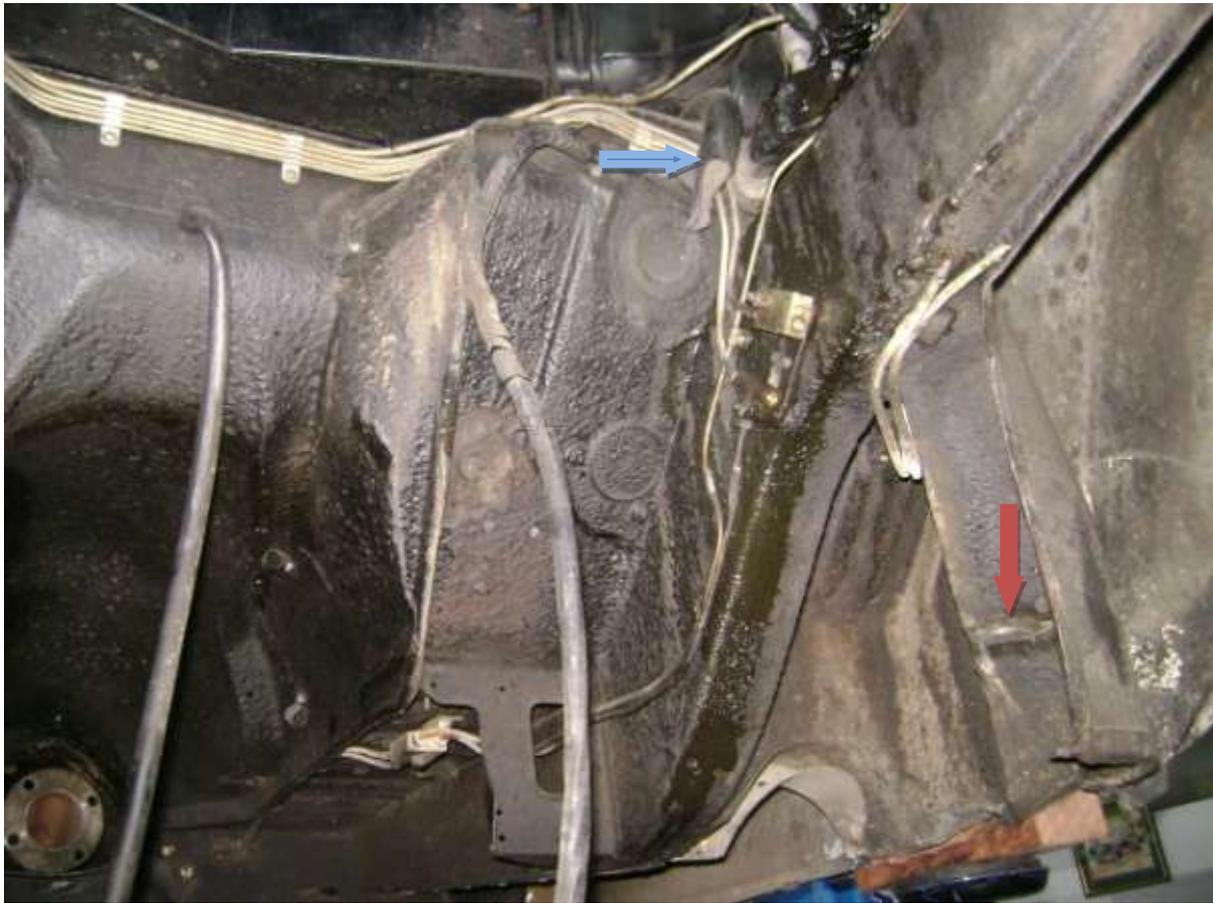
This is a good time to tart up the parts you can never really get to. The left rear sub frame mounting point (arrowed red) can be seen together with provision in the toe board for left hand drive cars as well as the rat trap mount which also changes side across the Atlantic. The blue arrow points to an often obscenely described rubber pendulous, moulding. There are two of these which drain the heater box, the top of which is open to the weather. The end of

them (this one has been 'clipped') is shaped to allow fluid out and keep dust etc out. They perish and fail to do their job. Now is the time to replace them.

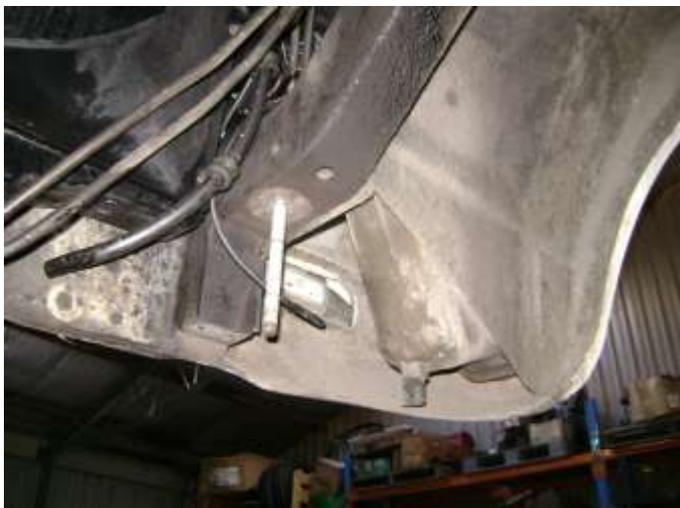
At left is the right front mount for the sub frame still with its bolt hanging through. The angled pipes are on their way to the bottom of the radiator core with the transmission fluid and the angled box tucked in behind the mudguard is the bottom end of the air cleaner! The bit hanging off the latter's bottom is a water drain should you do some river fording.

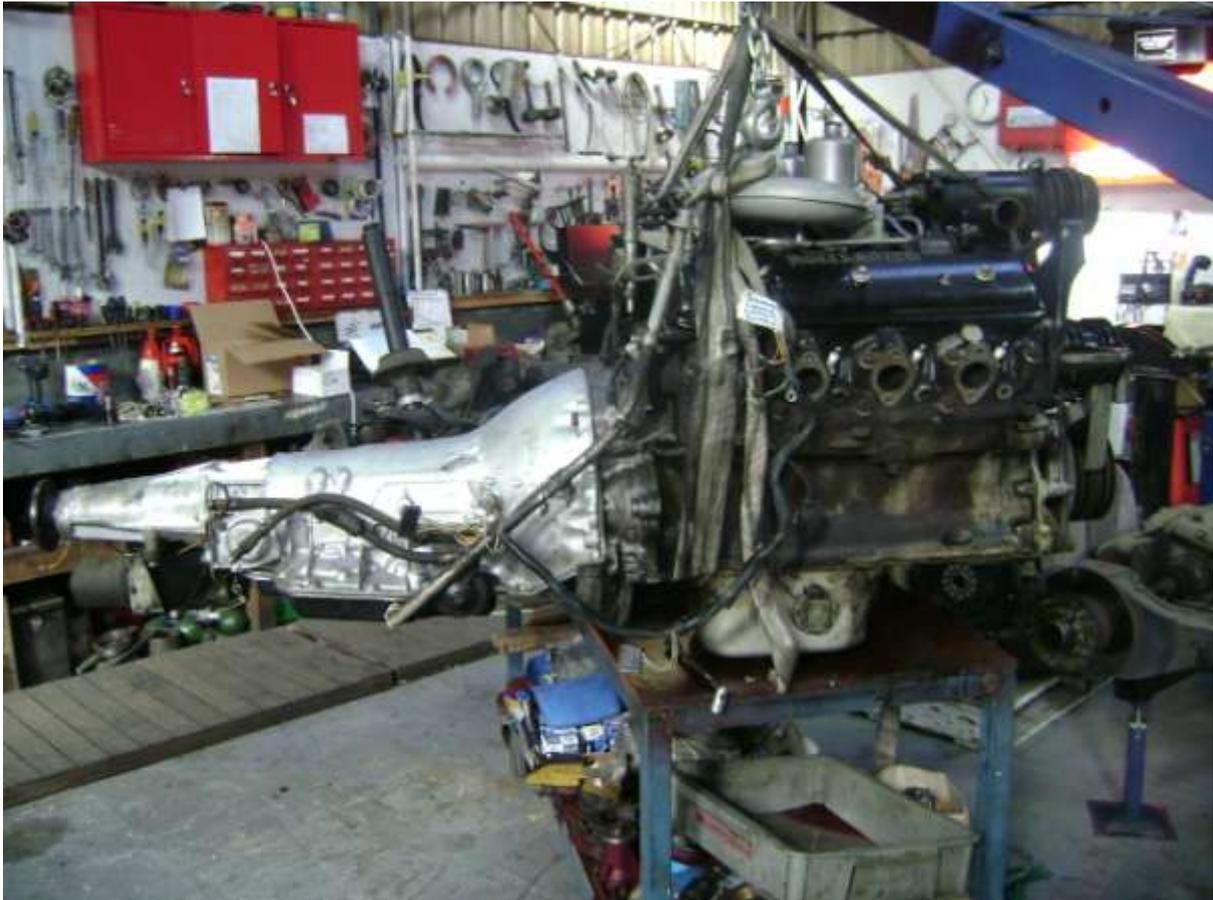
Above, the engine and transmission have been separated from the sub frame. The extraordinary route the transmission filler pipe takes can be seen clearly. Note the slicks on the side of the engine block under the exhaust manifolds indicating the usual tell-tale weep holes leaking.

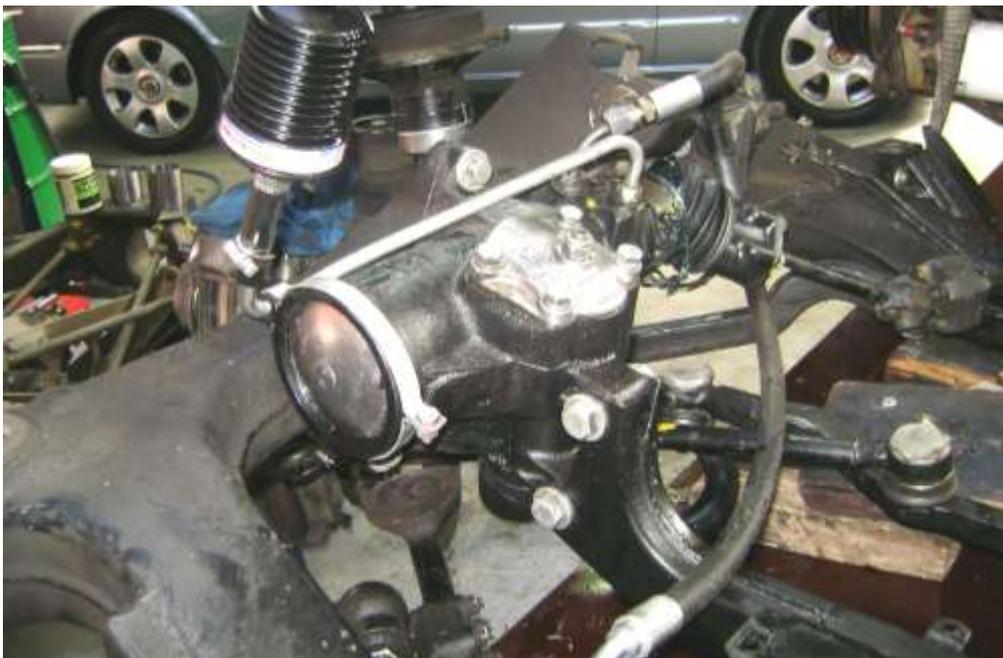
The steering box is left attached to the sub frame. The front cross member is actually bolted to the box and carries most of the weight of the engine. The high pressure hose that supplies pressure to the box can also be seen.

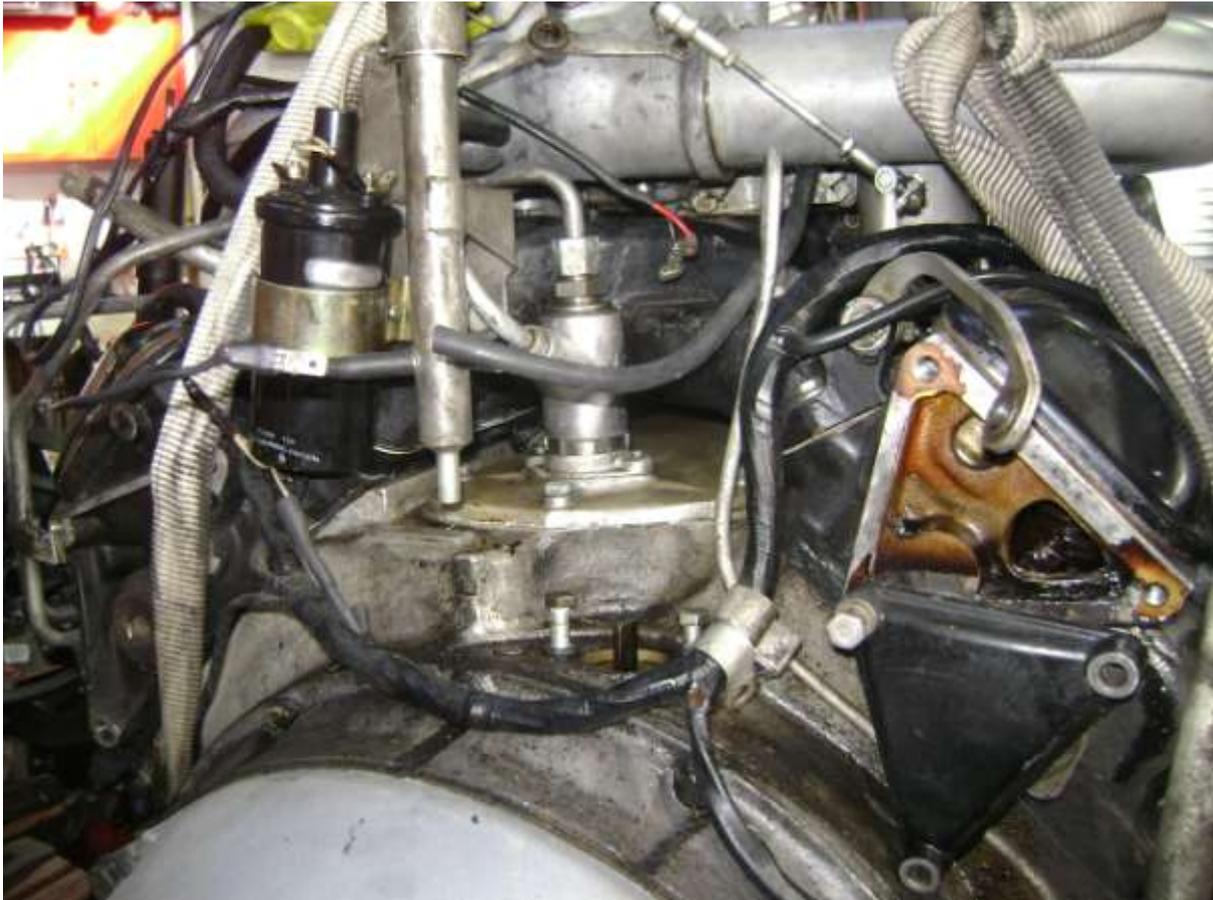
Have you ever wondered what all the mess is at the back of these engines – well here it is. Wiring looms, some of which are seen here plug into points on the engine toe board. They are unhooked from around the engine compartment and simply left on the top of the engine when it is removed. The hydraulic pump for the number two system can be seen attached to the engine valley plate. The cylindrical gadget to the pump's rear is the collector of noxious overflows etc from the fuel system.

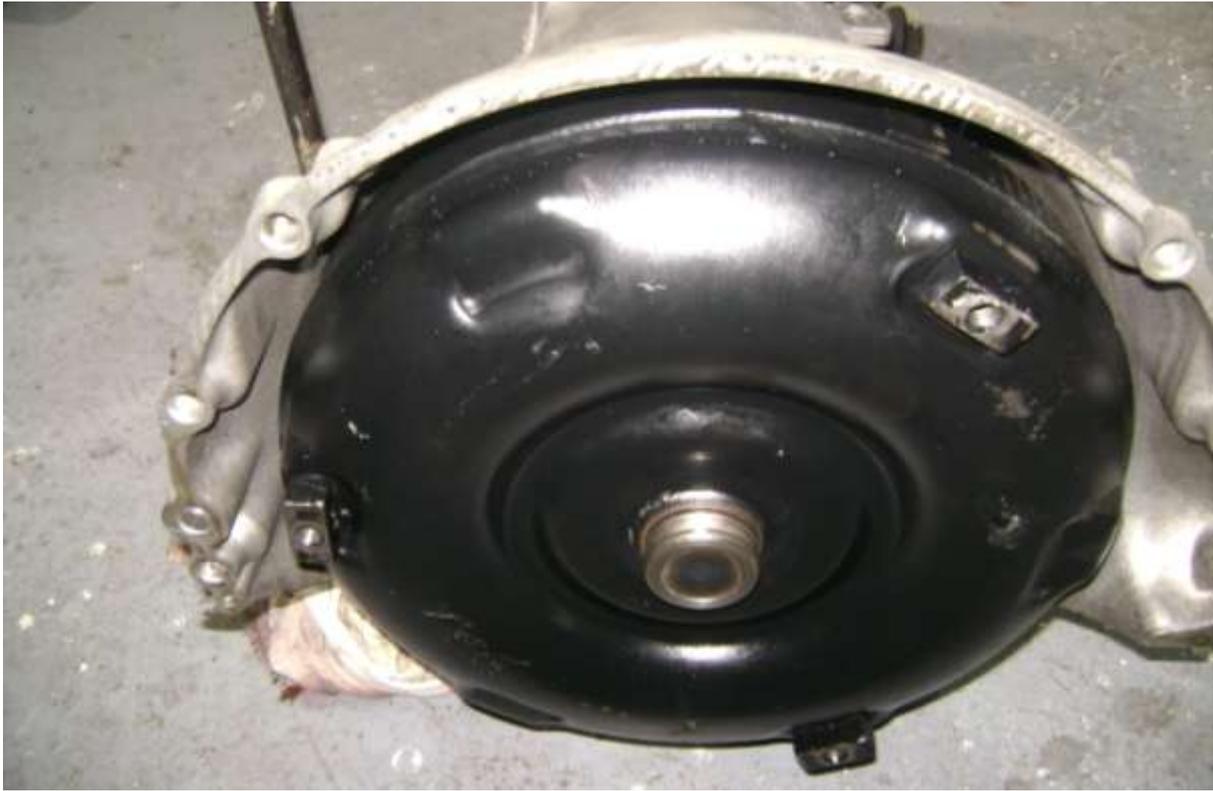
The front end of the converter showing the three mounting points. The converter is bolted on through the drive plate, the bolts accessed through a small plate on the underside of the main housing. Converters are common to many cars. If a transmission is overhauled and there is the slightest trace of damage in the sediment the unit is sent to specialists to be cut open (they are a sealed unit) cleaned out overhauled and returned as good as new for a very reasonable fee.

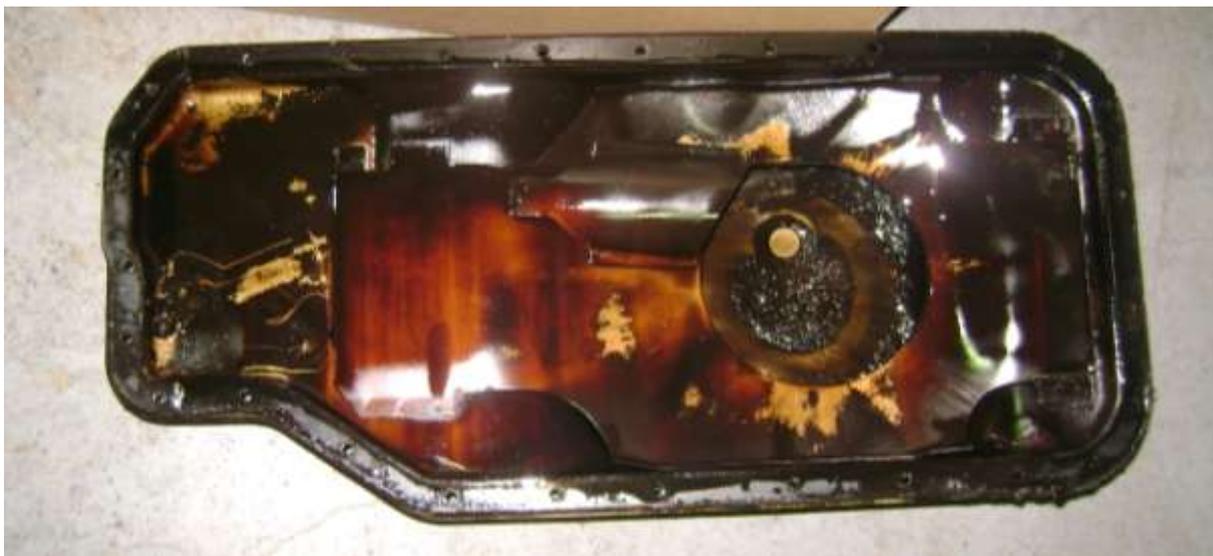
The sump. They are not easy to get off but well worth the effort. It is likely that this engine at some time was sufficiently overheated to destroy some of the tension in the piston rings resulting in 'blow by' of gasses which contribute to the mess seen above. The sediment can get to the point of restricting the intake filter for the oil pump.

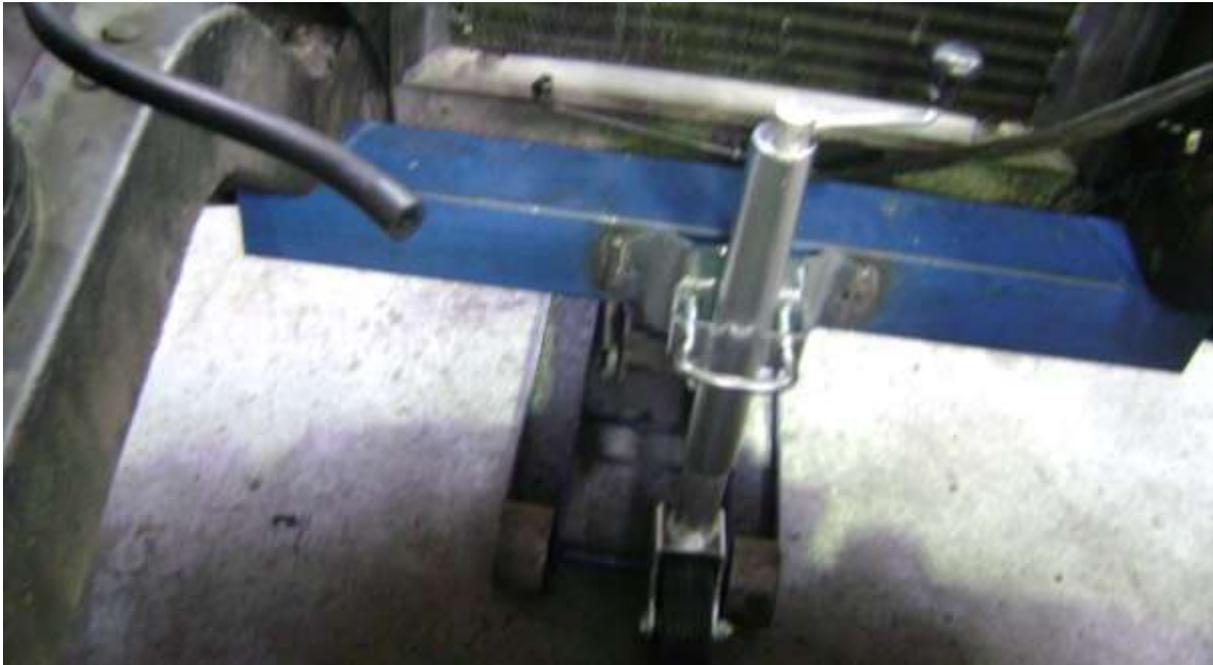
Meanwhile. What to do with a two wheel Shadow. A temporary support for the front end was quickly drilled and a standard jockey wheel welded in place which proved too flexible.

Further work needs to be done in this department as this exercise will not be the last!

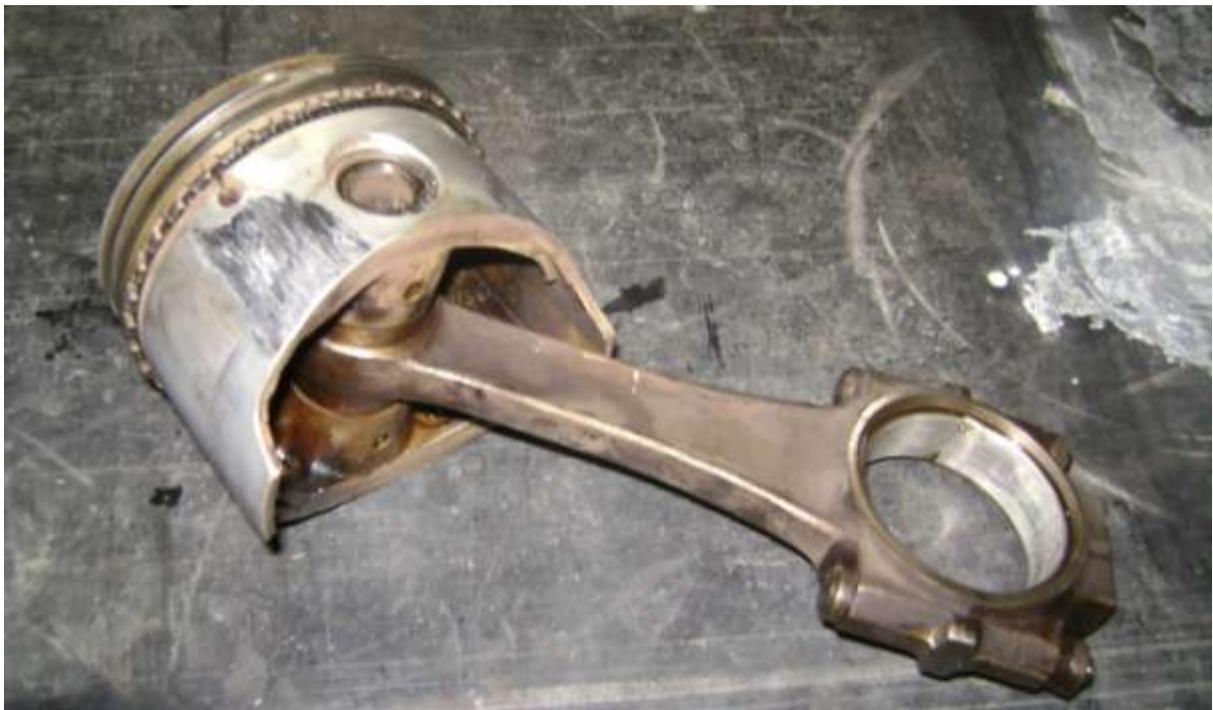
By now some will be wondering why all this elective masochism was resorted to. The reason as it turned out is above. The noticeable and definite heavy 'click' was from the A4 piston seen here with a nice skirt couge. This would undoubtedly have distorted the piston and produced an original piston slap. A corresponding score was in the liner. The reason for the event was as likely a local hot spot on the liner due to constricted cooling. The liner at A4 in the earlier models originally had sufficient clearance to allow water flow but when the

passages are not thoroughly cleaned out, silt mounts up and blocks circulation. Apparently later blocks did have greater clearance at the rear.

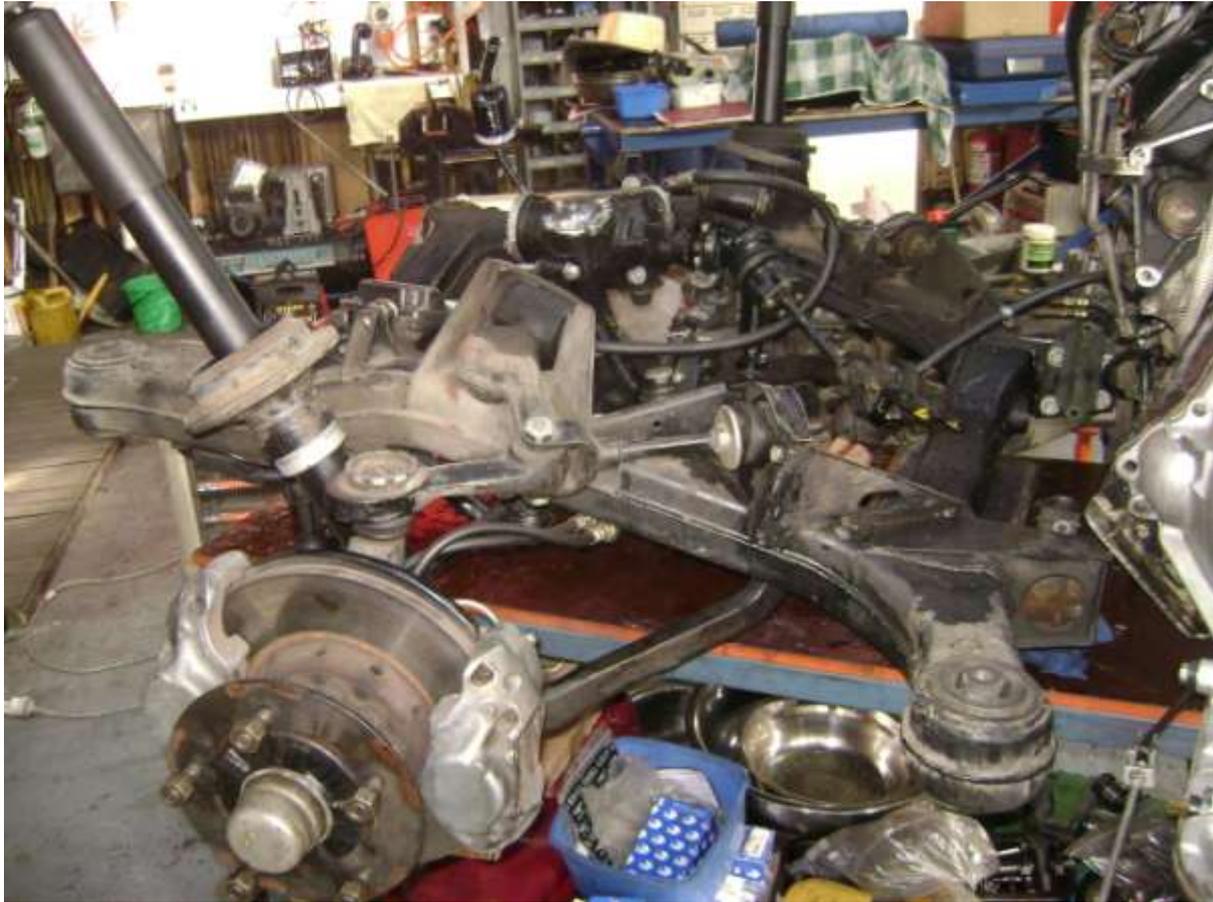
What a mess but after your eyes have focussed you can see most of the sub-frame, the shock absorbers, the steering box on the far side, the steering shaft and CV joint. The mounts on each corner can be seen also. These are the rubber silentbloc type and eventually perish. A

lot of enthusiasts think these are the old pot scrubber mounts but these were superseded very early in production. While the Spirit uses much the same sub-frame the mounts are much deeper and held in place by screwed retainers.
