TEE-ONE TOPICS

Number 85

SOMETHING TO TRY WHEN YOU HAVE A SPARE MOMENT

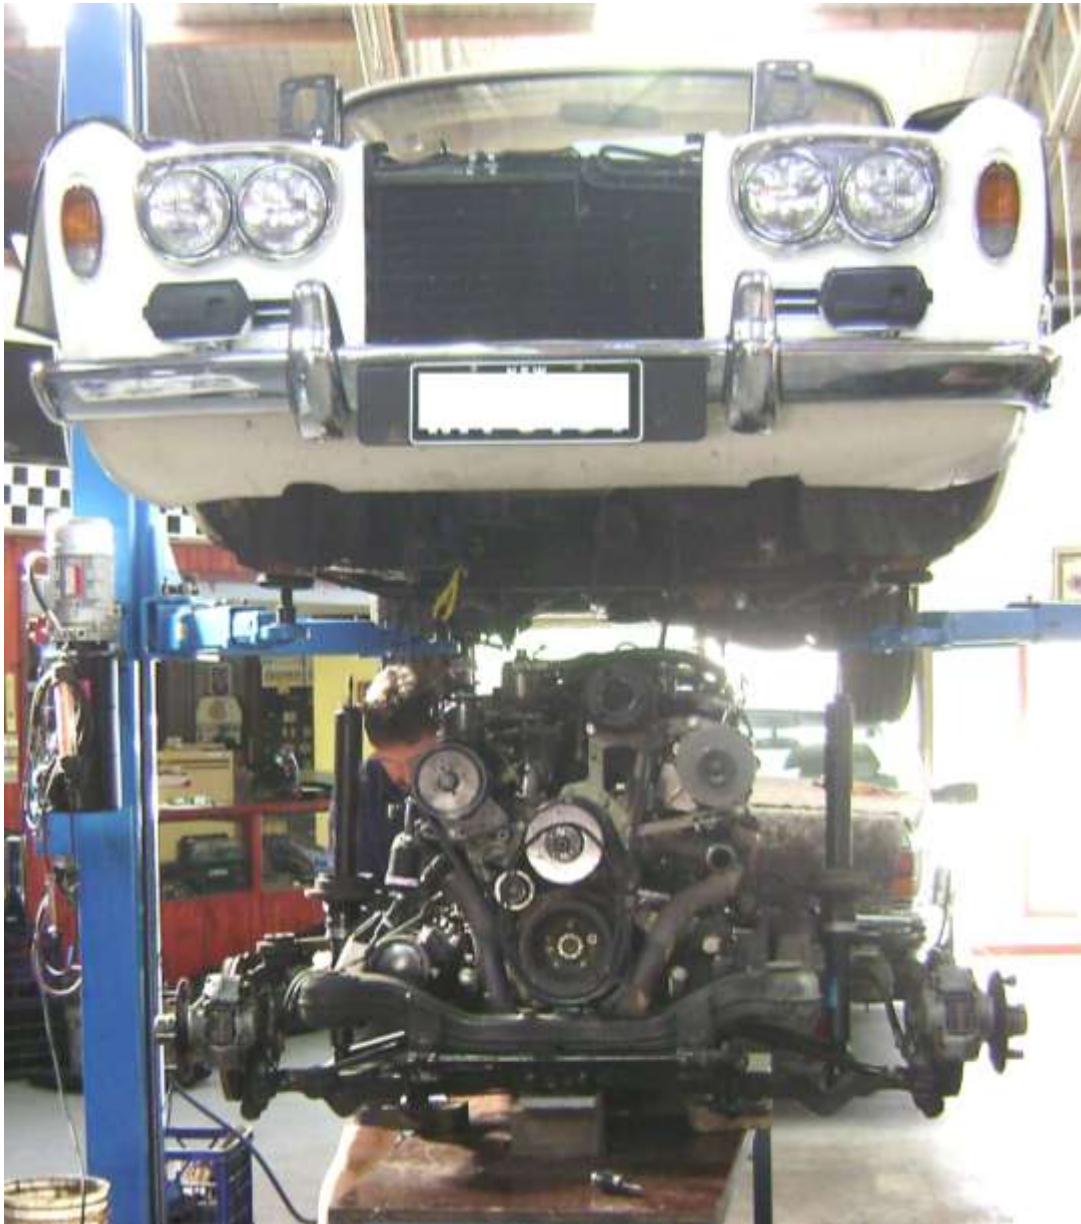
Well you will also need a patient friend with a side lift hoist, some more friends to help with the separation and a courageous heart to tackle the job of removing the engine on a Shadow. What you are looking at is the entire front end assembly of the sub frame, the complete

suspension, all the steering, the transmission and the entire engine. This is actually the original Factory approach using a different hoist and quite a bit more gear. If you are curious look it up in the Technical library. Most engine removals involve separation of the engine from the transmission and lifting the power unit straight out of the chassis. This is possible with the Shadow but extremely awkward given the surrounding clutter and unlike former models it has a very important structural bit across the front of the car that is welded very firmly and exactly in place!

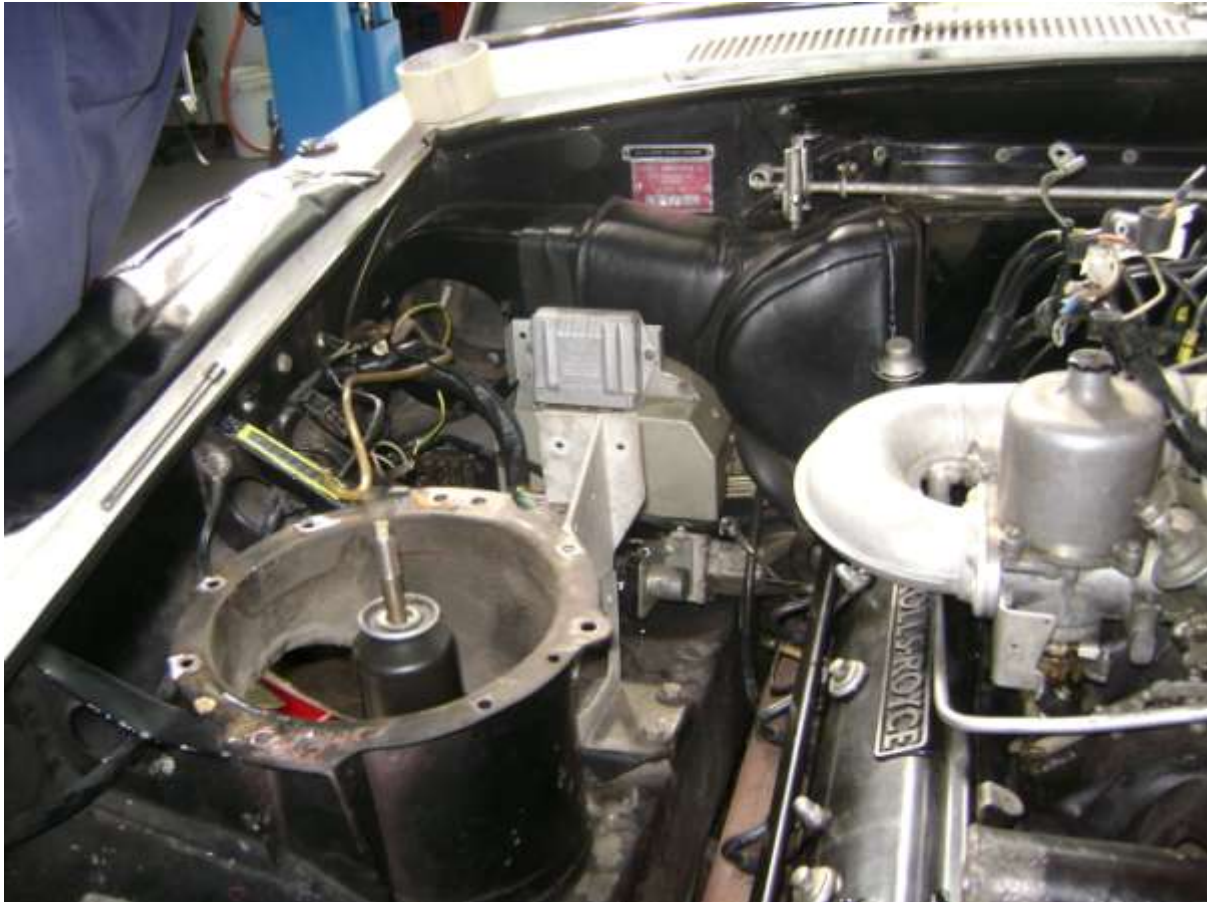
Having removed the bonnet and drained everything in sight including the hydraulic reservoir, the sump and the transmission, the coolant (including the block plugs under the exhaust manifold, if they are blocked try a long sharp screwdriver to drill through the muck and if that doesn't work get ready to have coolant over you, the floor, the hoist and several of your helpers.) You can leave the exhaust manifolds on but most of the exhaust system forward of the 'B' pillar should come off. The radiator can stay in but the fan and belts need to come off. Actually we took the radiator out to avoid possible damage and give a bit more room to manoeuvre.

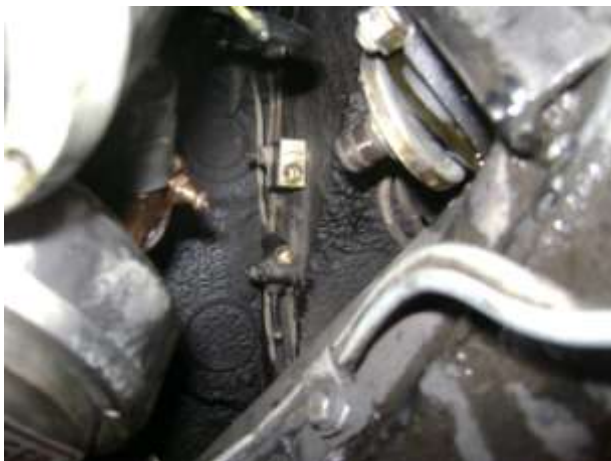
At left the two central items are the connection points for the whole high pressure circuits for the brakes and suspension. These connect to the accumulators seen at left of the picture through wire bound high pressure flexible lines, the cost of each will get you a

wonderful night at one of the country's premium hotels! The message is treat them with respect!

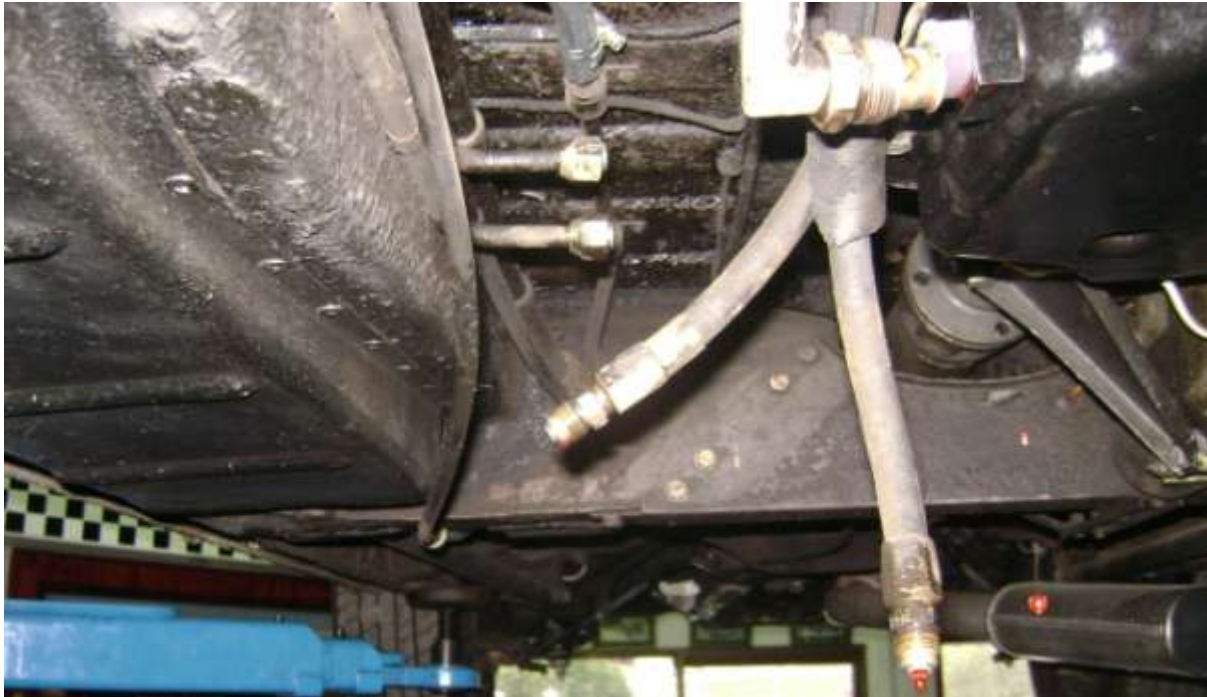
These two flexible lines send and receive transmission fluid via steel pipes seen to their left close to the car floor, to the lower end of the radiator where a separate core is fitted for cooling. The output flange at the rear of the transmission can be seen unbolted. It is not necessary to remove the propeller shaft. The cover for the legendary rat trap is at left.

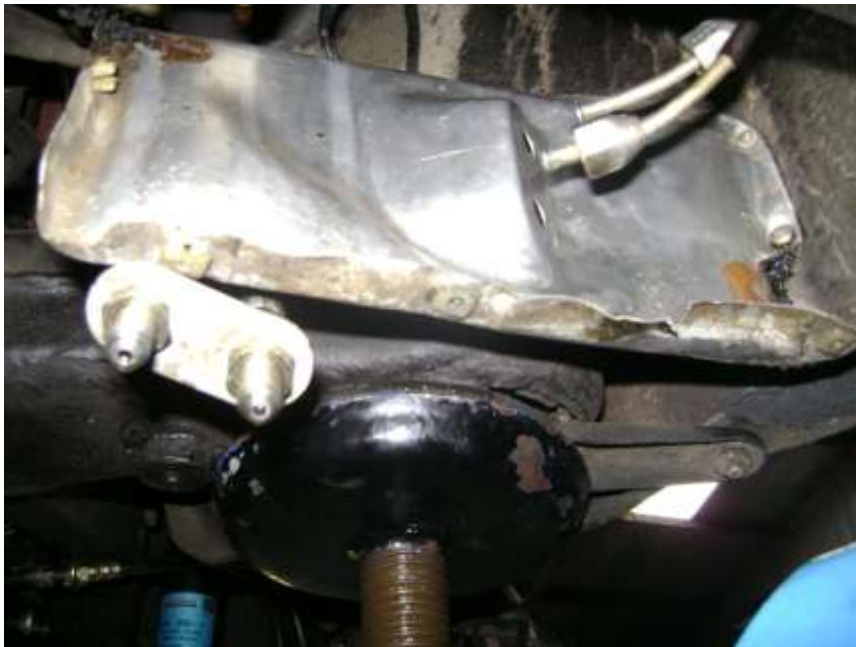
The aluminium plate at the left is the front closure for the rat trap. The pipe ends at left are the two flexible lines between the body and the sub frame. Until early in the Spirit run which is basically the same it was thought provision should be made for movement between the two. Later Sprits have simple rigid pipe connections. These lines carry hydraulic fluid from the brake distribution lines to the

myriad of pipes that infest the car. Each represents a separate system.

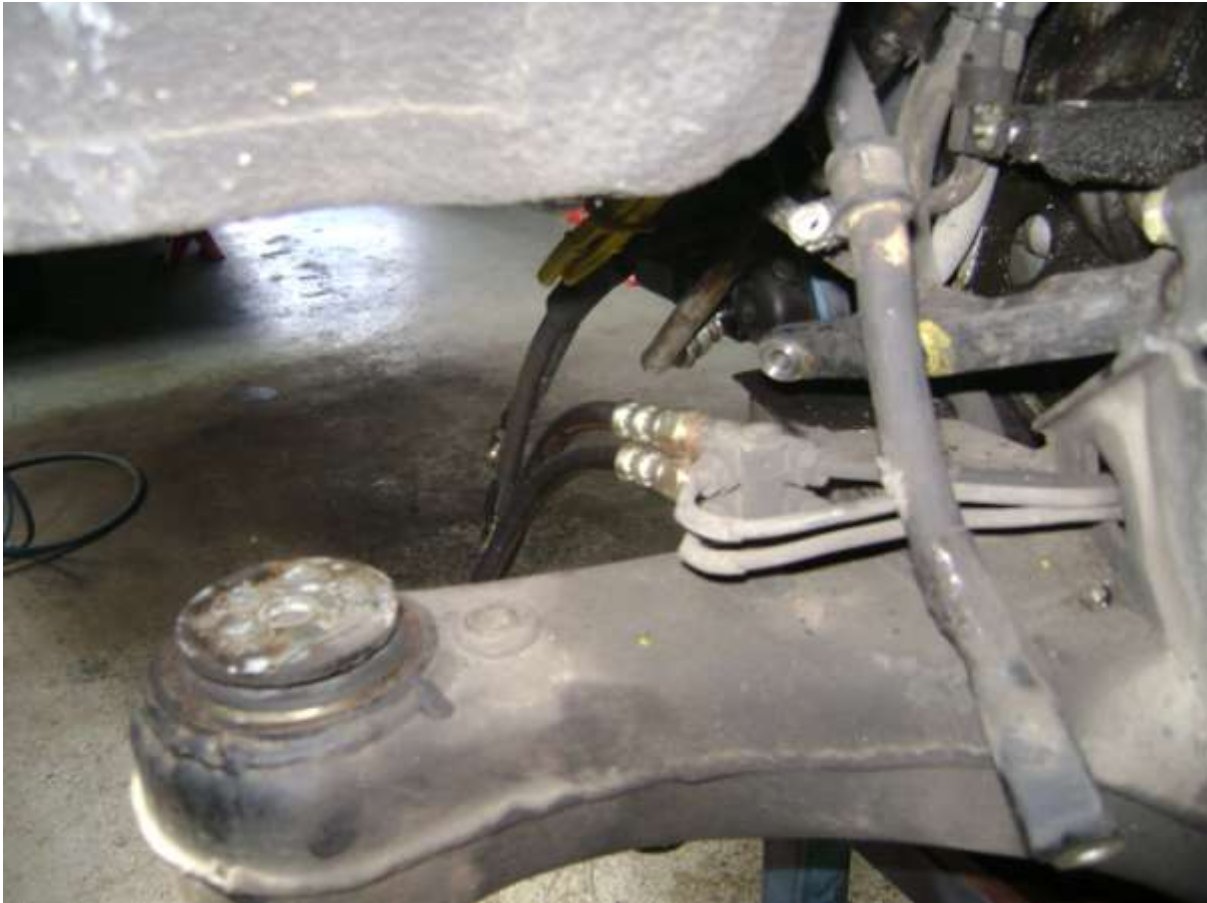
The connecting hoses seen on the previous page can be seen dangling from the junction blocks mounted on the rear of the sub frame. One of the four mounts of the frame to the body of the car is seen at left. The heavy cable draped over the frame brings all power to the car from the rear mounted battery and connects directly to the main starter terminal.

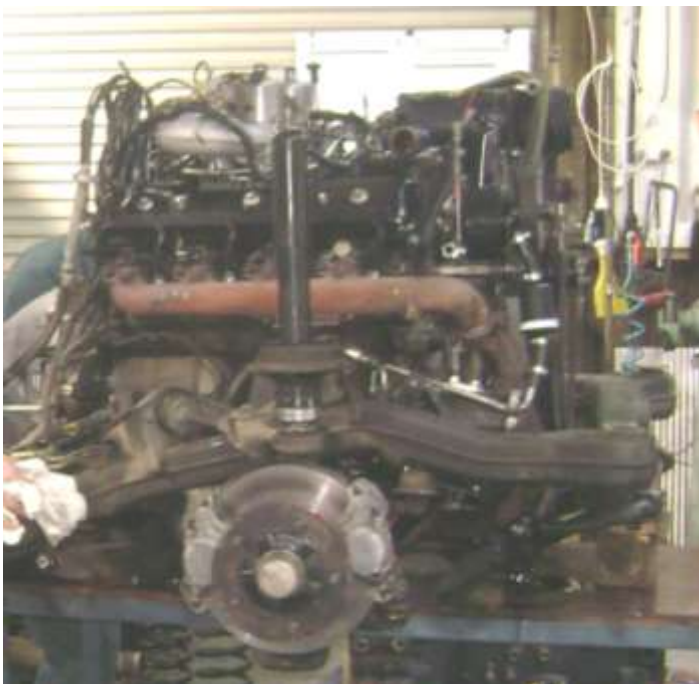
The complete mess has been left sitting on a very stout steel table and the body lifted away. The front mounting points for the sub-frame can also be seen as well as the anti-roll bar mounted beneath.

Incidentally the concertina cylinder immediately on the right hand end of the exhaust manifold is a transmission filter. I have fitted these to a myriad of cars to filter the returning oil for the power steering that comes back from the cooling matrix sitting on top of the radiator core. The main feature of these little units, readily available at any transmission place, is the incorporation of a magnet which

pulls all the bits of steel nasties that circulate in the steering circuit.

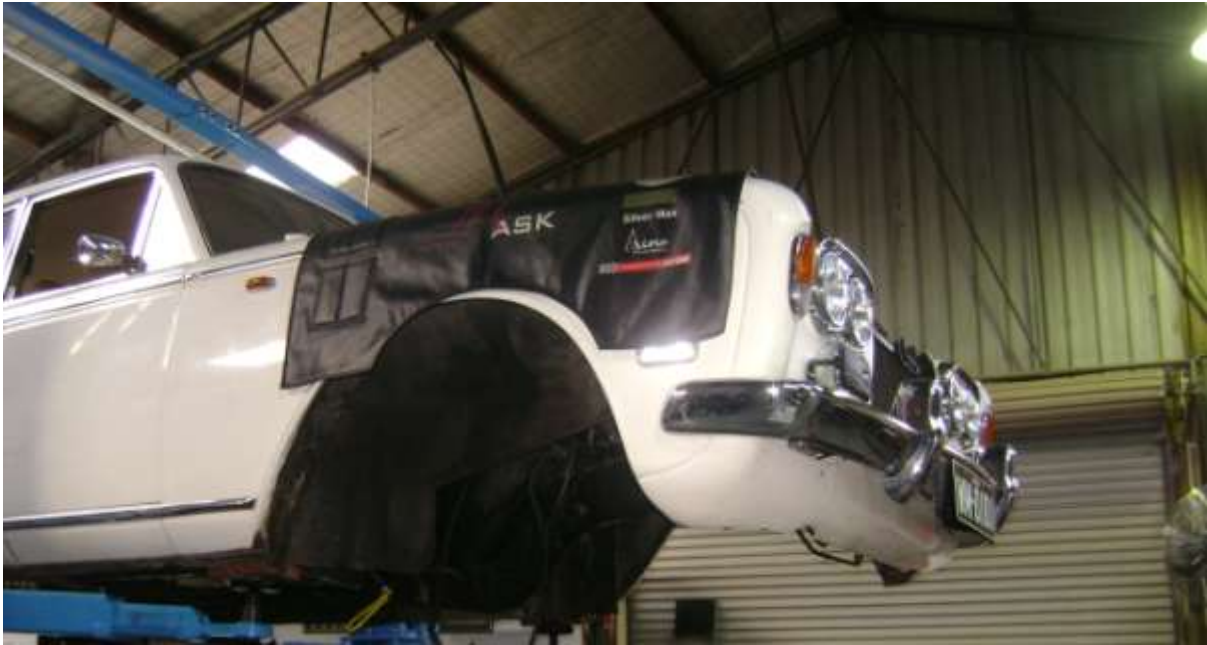
Surely this is a testimony to structural engineering. Even with the engine and transmission in place the lifting points are the same – there is no sagging!

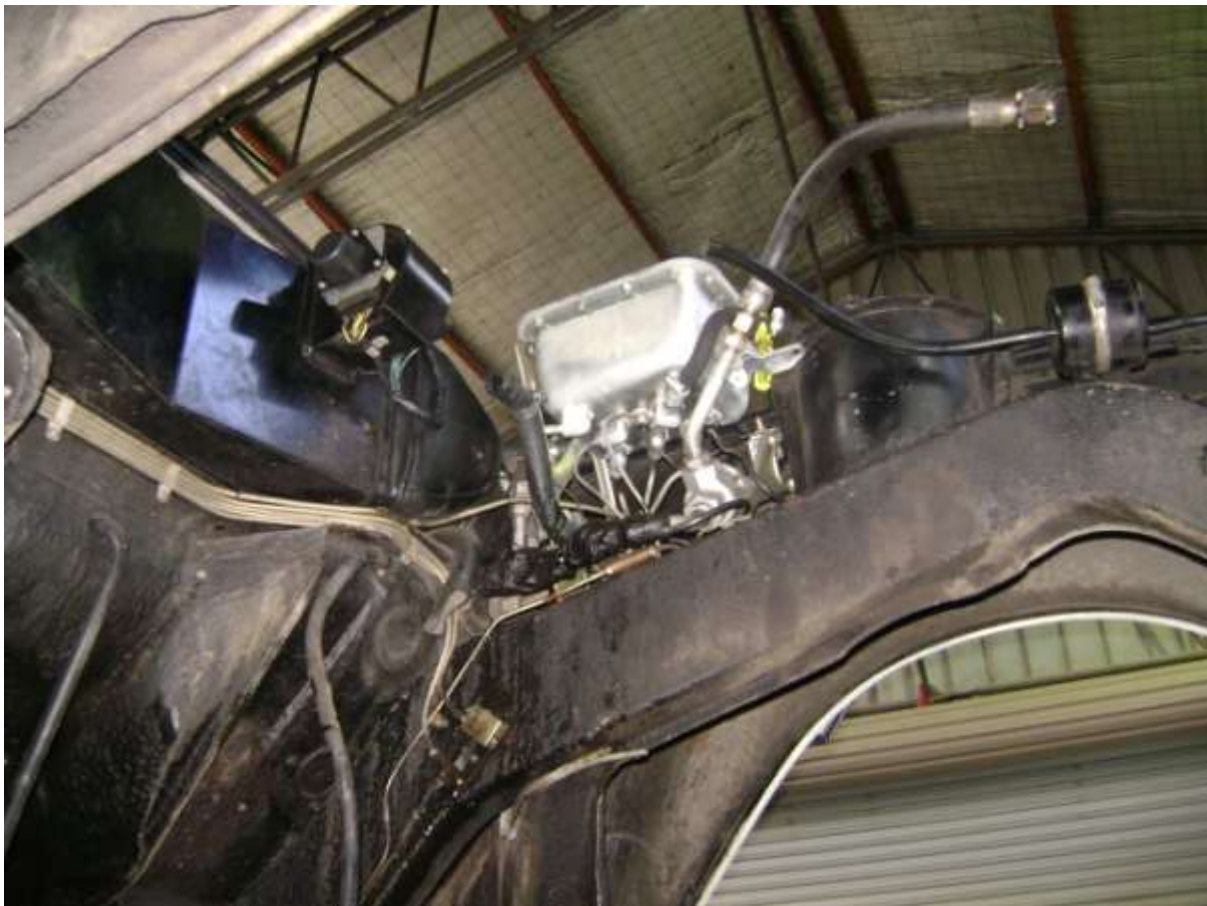
It is here that the owner if he has been properly briefed holds his breath. If the car has had a ‘front ender’, bum repairers do not or don’t care to pick up kinked side members which

buckle under impact. This car is obviously pristine. The other clue to automotive hari-kari is the spring towers themselves, one of which can be seen here. In a repaired car that has been done badly these are clearly not vertical due to distortion, something that is difficult to spot when the car the car is assembled. Again these were perfect. The owner is now breathing.

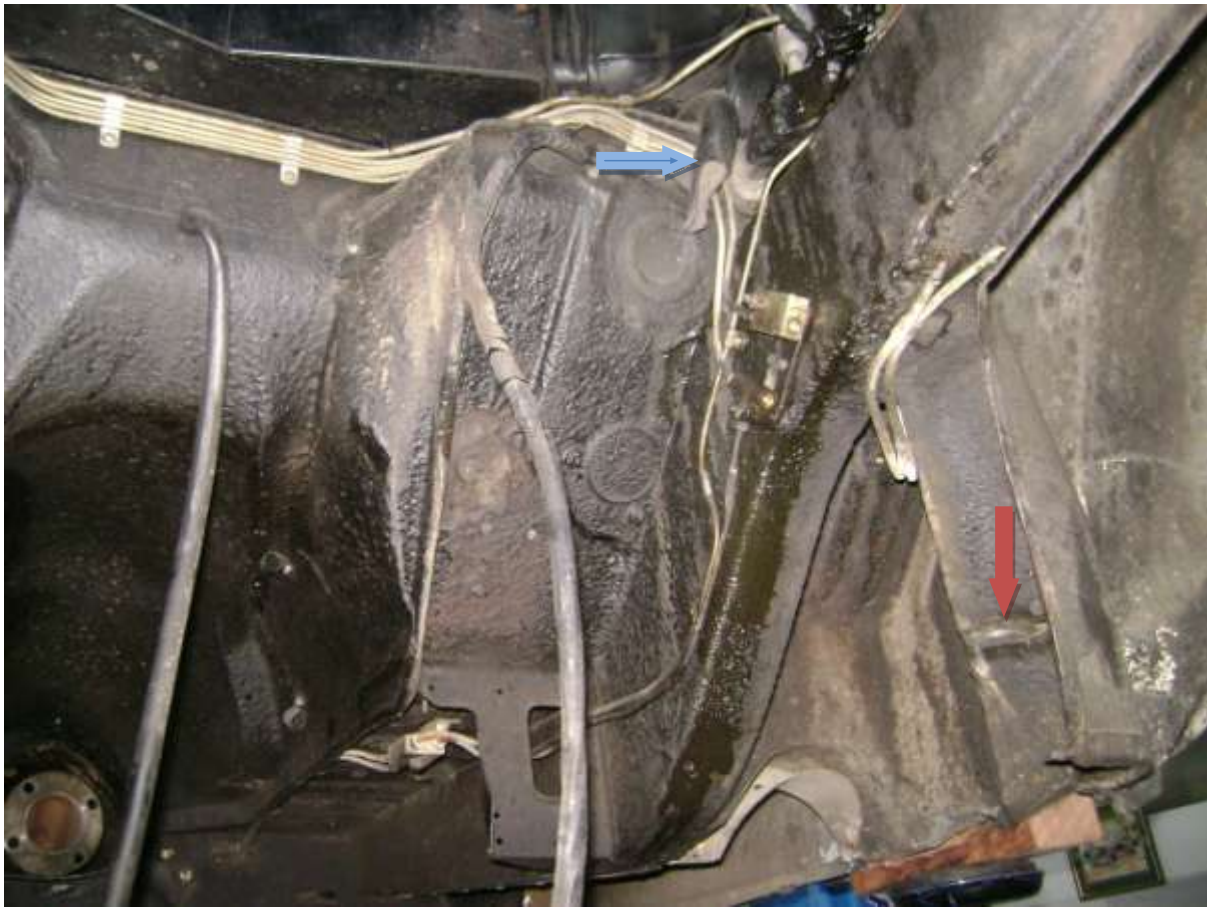
This is a good time to tart up the parts you can never really get to. The left rear sub frame mounting point (arrowed red) can be seen together with provision in the toe board for left hand drive cars as well as the rat trap mount which also changes side across the Atlantic. The blue arrow points to an often obscenely described rubber pendulous, moulding. There are two of these which drain the heater box, the top of which is open to the weather. The end of

them (this one has been 'clipped') is shaped to allow fluid out and keep dust etc out. They perish and fail to do their job. Now is the time to replace them.

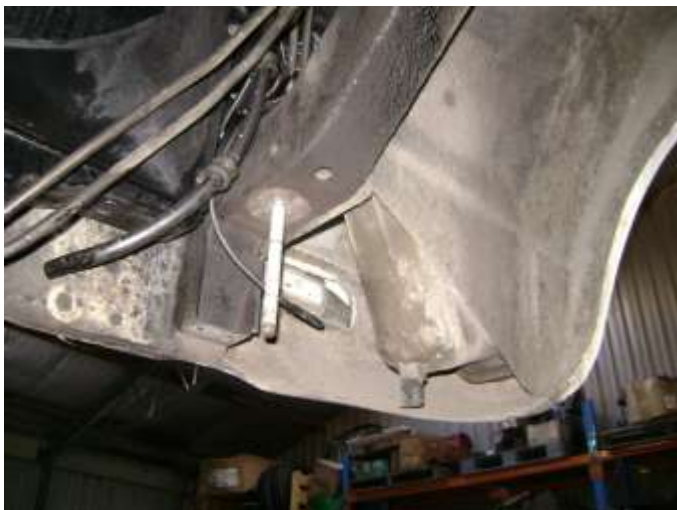
At left is the right front mount for the sub frame still with its bolt hanging through. The angled pipes are on their way to the bottom of the radiator core with the transmission fluid and the angled box tucked in behind the mudguard is the bottom end of the air cleaner! The bit hanging off the latter's bottom is a water drain should you do some river fording.

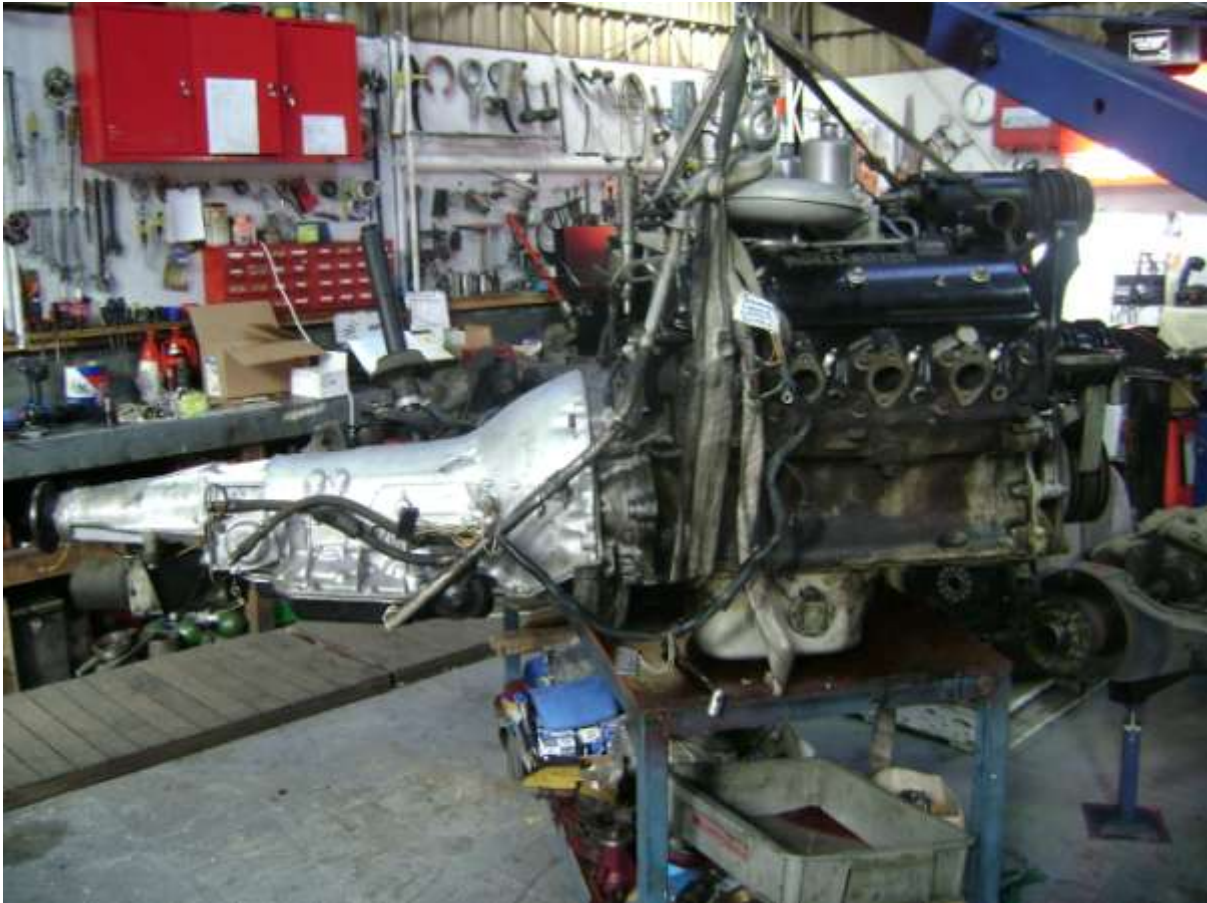
Above, the engine and transmission have been separated from the sub frame. The extraordinary route the transmission filler pipe takes can be seen clearly. Note the slicks on the side of the engine block under the exhaust manifolds indicating the usual tell-tale weep holes leaking.

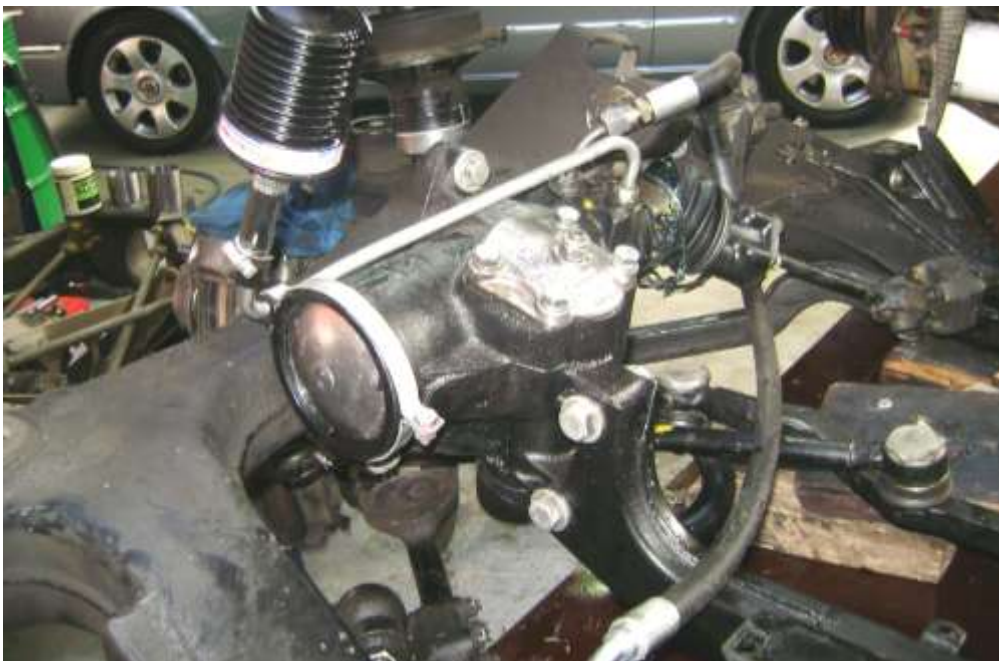
The steering box is left attached to the sub frame. The front cross member is actually bolted to the box and carries most of the weight of the engine. The high pressure hose that supplies pressure to the box can also be seen.

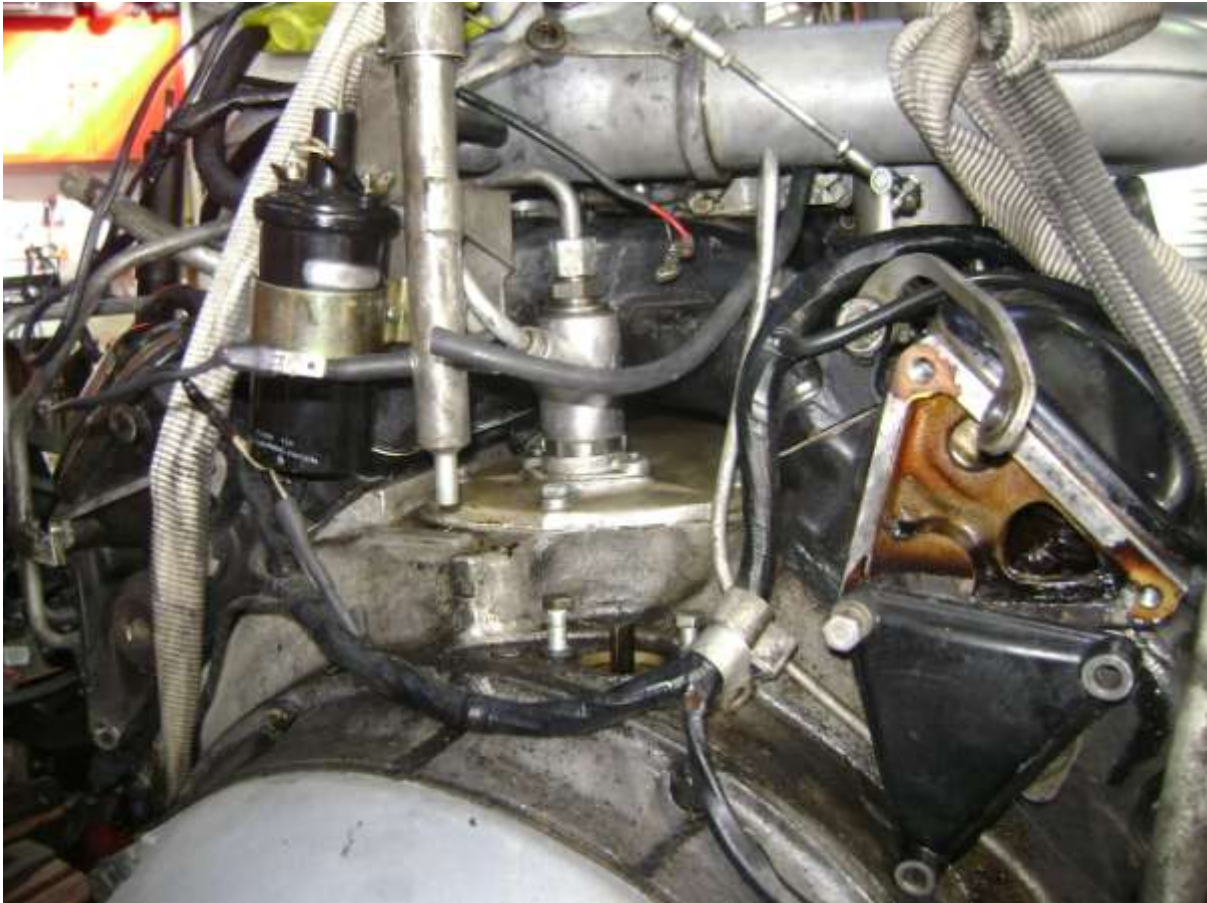
Have you ever wondered what all the mess is at the back of these engines – well here it is. Wiring looms, some of which are seen here plug into points on the engine toe board. They are unhooked from around the engine compartment and simply left on the top of the engine when it is removed. The hydraulic pump for the number two system can be seen attached to the engine valley plate. The cylindrical gadget to the pump's rear is the collector of noxious overflows etc from the fuel system.

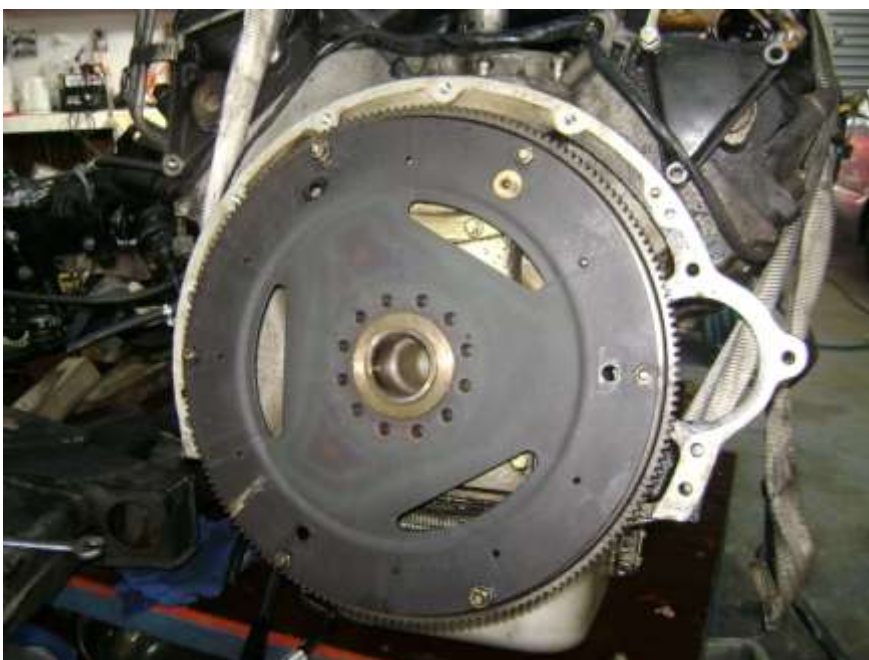
The transmission has been removed. Generally cars with automatic transmissions do not have flywheels since the torque converter when bolted to the drive plate seen here is sufficient in mass to perform the function of the flywheel. The converter is help on by only three bolts the holes for which can be seen here. Later cars used four bolts.

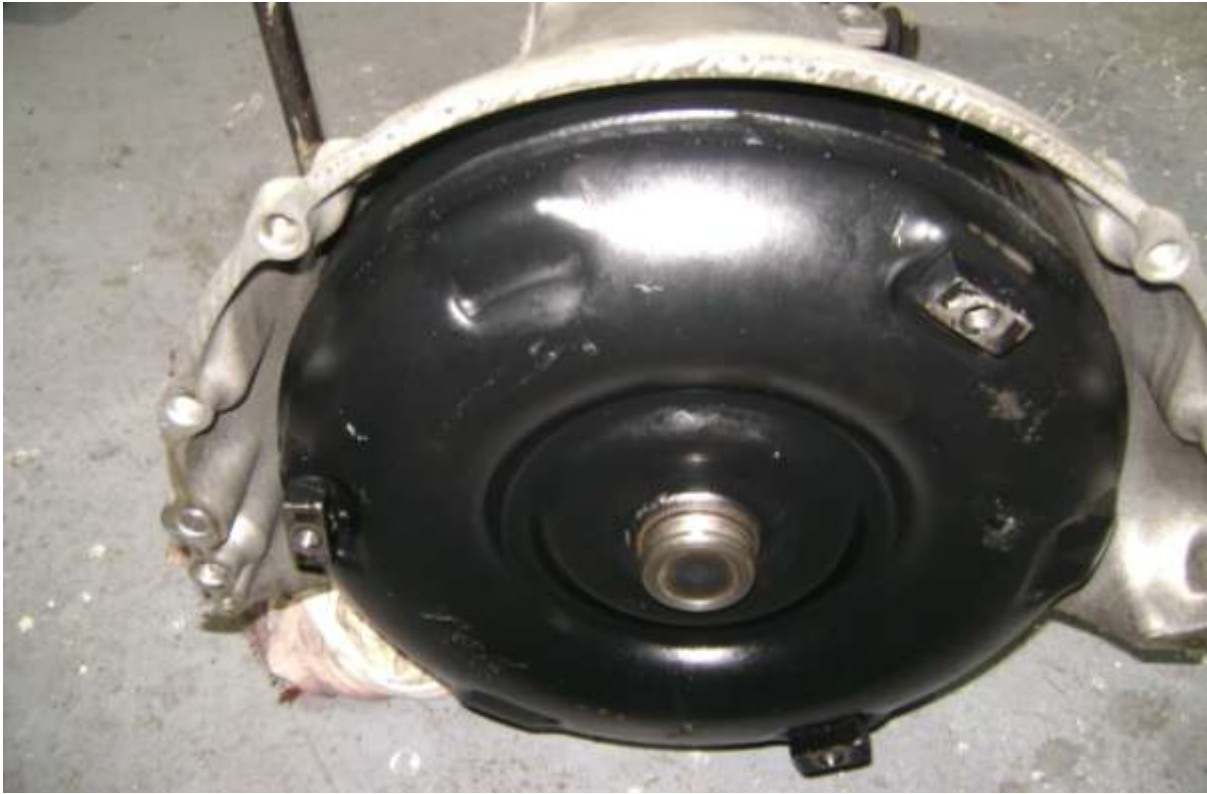
The front end of the converter showing the three mounting points. The converter is bolted on through the drive plate, the bolts accessed through a small plate on the underside of the main housing. Converters are common to many cars. If a transmission is overhauled and there is the slightest trace of damage in the sediment the unit is sent to specialists to be cut open (they are a sealed unit) cleaned out overhauled and returned as good as new for a very reasonable fee.

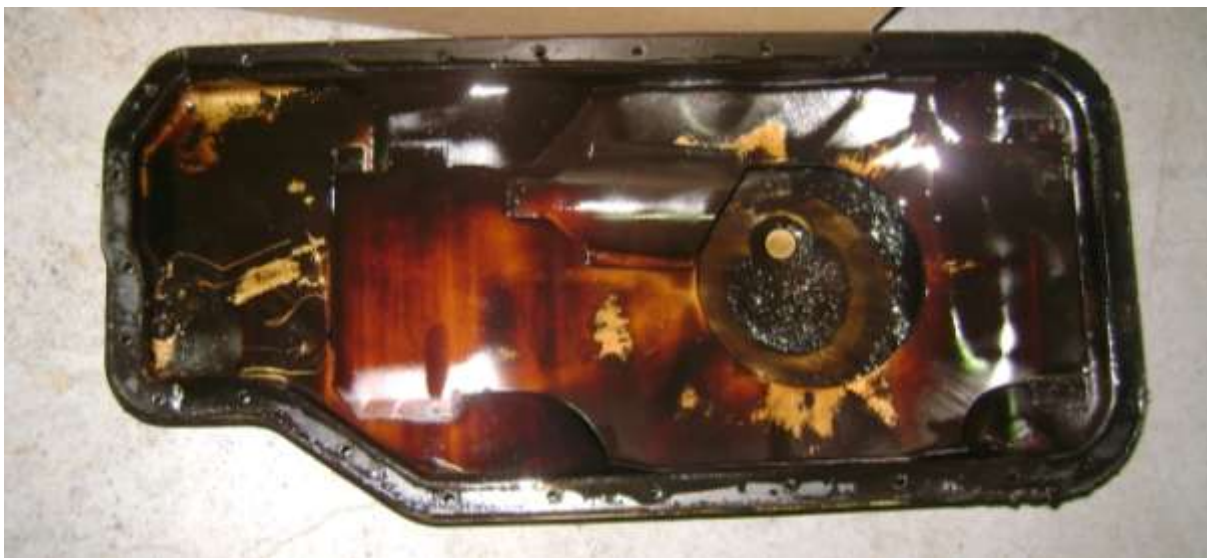
The sump. They are not easy to get off but well worth the effort. It is likely that this engine at some time was sufficiently overheated to destroy some of the tension in the piston rings resulting in 'blow by' of gasses which contribute to the mess seen above. The sediment can get to the point of restricting the intake filter for the oil pump.

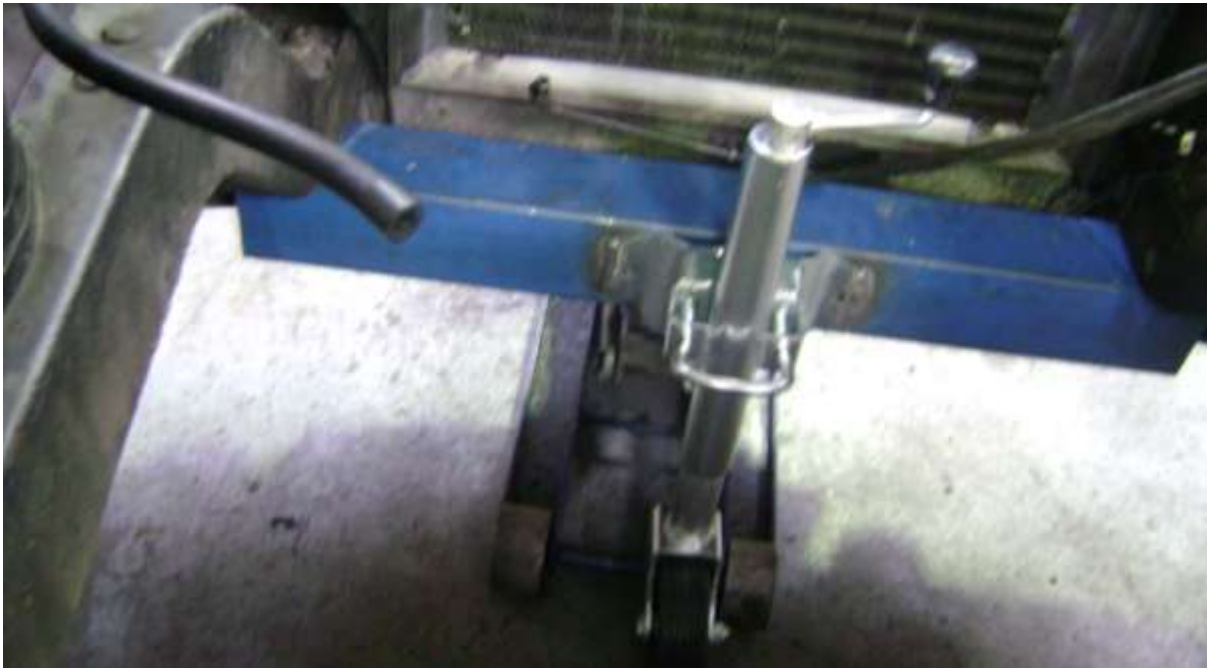
Meanwhile. What to do with a two wheel Shadow. A temporary support for the front end was quickly drilled and a standard jockey wheel welded in place which proved too flexible.

Further work needs to be done in this department as this exercise will not be the last!

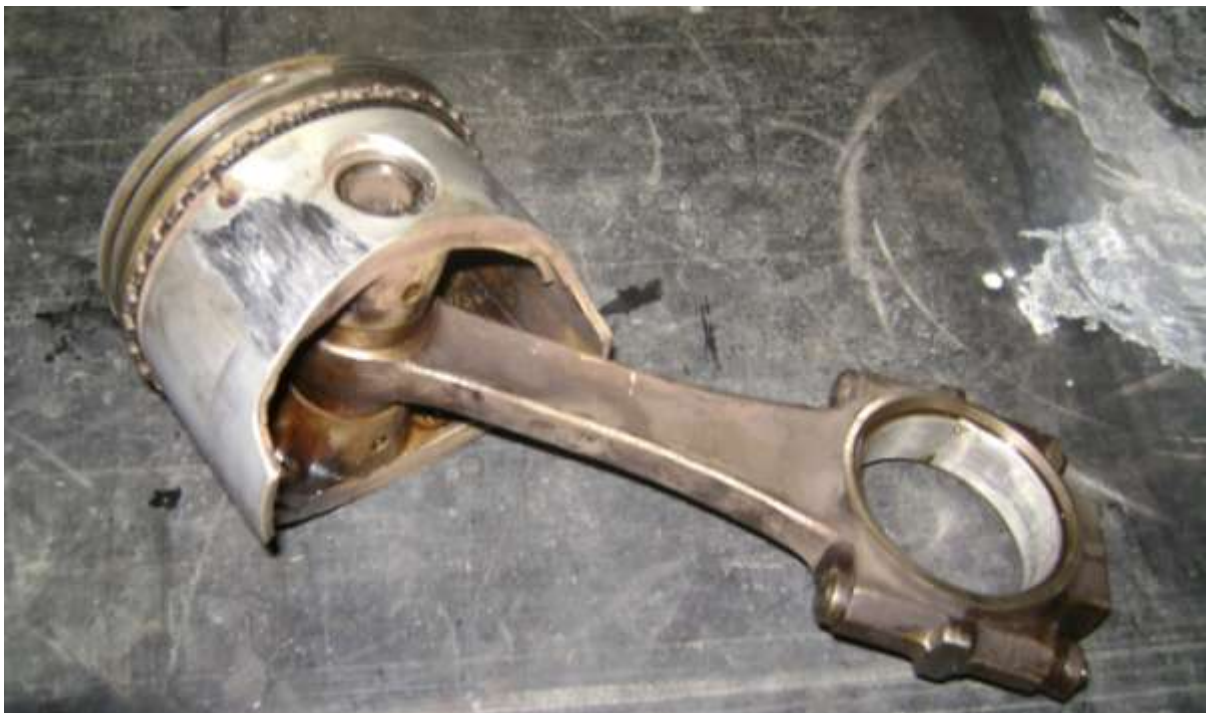
By now some will be wondering why all this elective masochism was resorted to. The reason as it turned out is above. The noticeable and definite heavy 'click' was from the A4 piston seen here with a nice skirt couge. This would undoubtedly have distorted the piston and produced an original piston slap. A corresponding score was in the liner. The reason for the event was as likely a local hot spot on the liner due to constricted cooling. The liner at A4 in the earlier models originally had sufficient clearance to allow water flow but when the

passages are not thoroughly cleaned out, silt mounts up and blocks circulation. Apparently later blocks did have greater clearance at the rear.

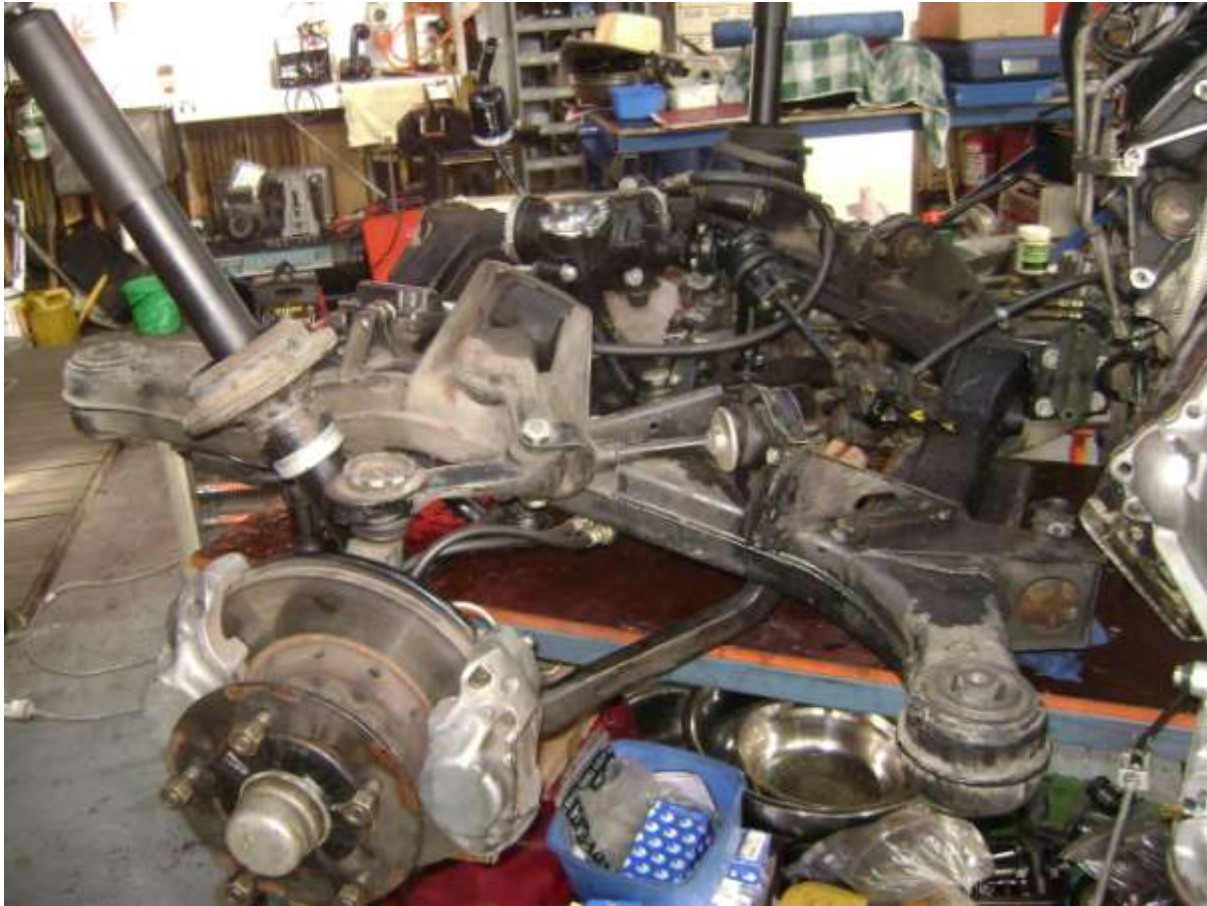
What a mess but after your eyes have focussed you can see most of the sub-frame, the shock absorbers, the steering box on the far side, the steering shaft and CV joint. The mounts on each corner can be seen also. These are the rubber silentbloc type and eventually perish. A

lot of enthusiasts think these are the old pot scrubber mounts but these were superseded very early in production. While the Spirit uses much the same sub-frame the mounts are much deeper and held in place by screwed retainers.
