NOT EVERY CLOUD HAS A SILVER LINING

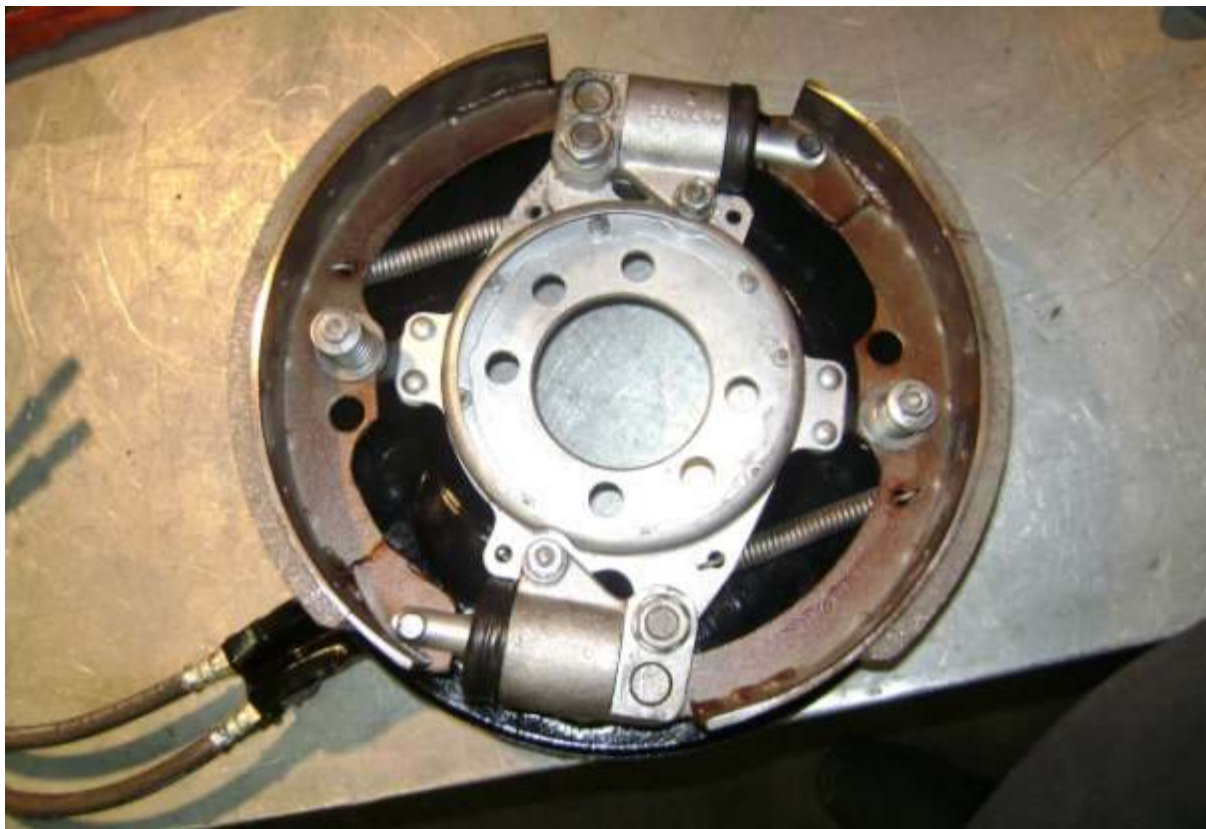
Here we have the complete brake assembly from the left front wheel of a veteran S2. Purists will note that the brake linings have been bonded to the shoes rather than riveted. There have been isolated instances of linings having parted company with their shoes but in my experience this has been largely precipitated by trying to run brakes with grossly over-ground drums. The shake back stops referred to in the text are seen at 9 o'clock and 3 o'clock. Note the pull back springs which anchor the swivel end of the shoe to the fulcrum point at the back of each wheel cylinder. The silver coloured plate with projections is the mounting plate for the front brakes. The wheel cylinders are held to the plate by two bolts, a very large stepped bolt and a small steadying bolt. The round object below the large anchor bolt, is the pin on which the shoe pivots.

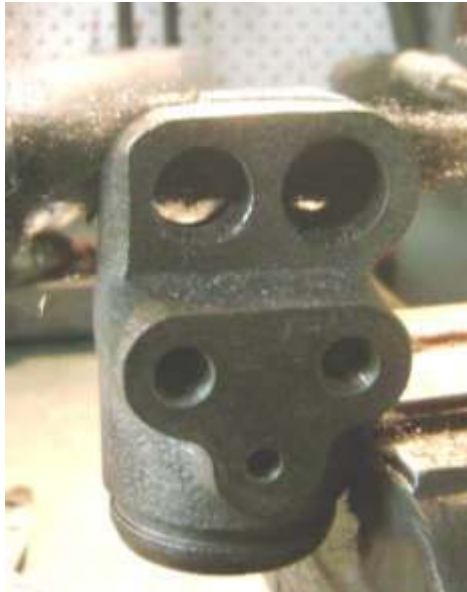
At left is one of the wheel cylinders having its 'mounting slot' cleaned with some steel wool. The two large holes admit the large mounting bolt and the pivot pin. The two smaller holes are the inlet for the brake fluid and the other (the upper one) the bleeder screw.

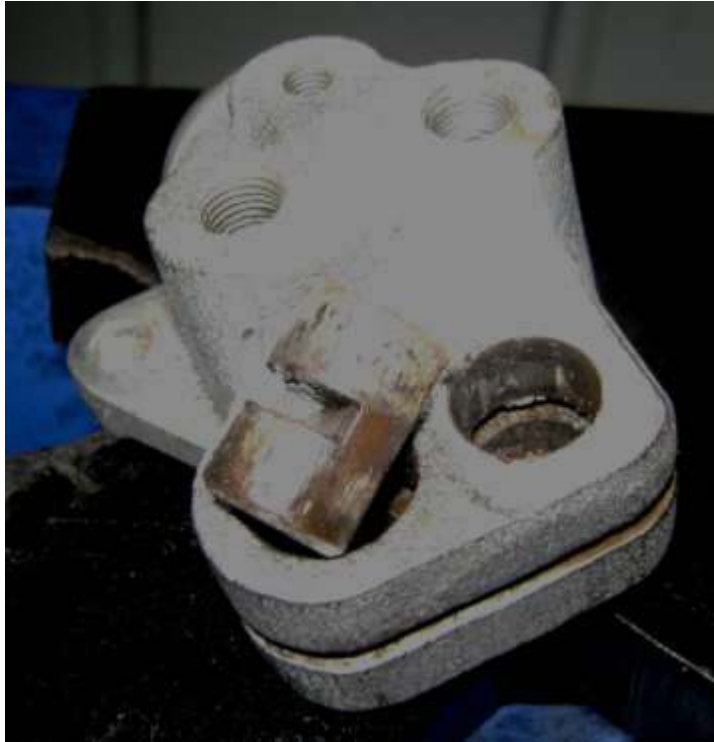
At left is an over-flashed picture of the pivot pin having been pressed out of the back of the wheel cylinder. This took some tons to move after much soaking in WD40 and applications of heat! The crud in the hole can be seen clearly.

A strong note of caution. The mounting 'projection' with the split has little strength laterally so if you need to press the pin out, a suitable tight fitting plate in the slot while pushing will prevent subsequent heart ache. The best plate of course is the backing plate. Note the slot in the pin which engages the 'horn' of the mounting plate. In this example the pin was frozen in the back of the cylinder and obviously had been during the last overhaul. Unless the pin is free to rotate albeit slightly the brakes cannot centralize properly.

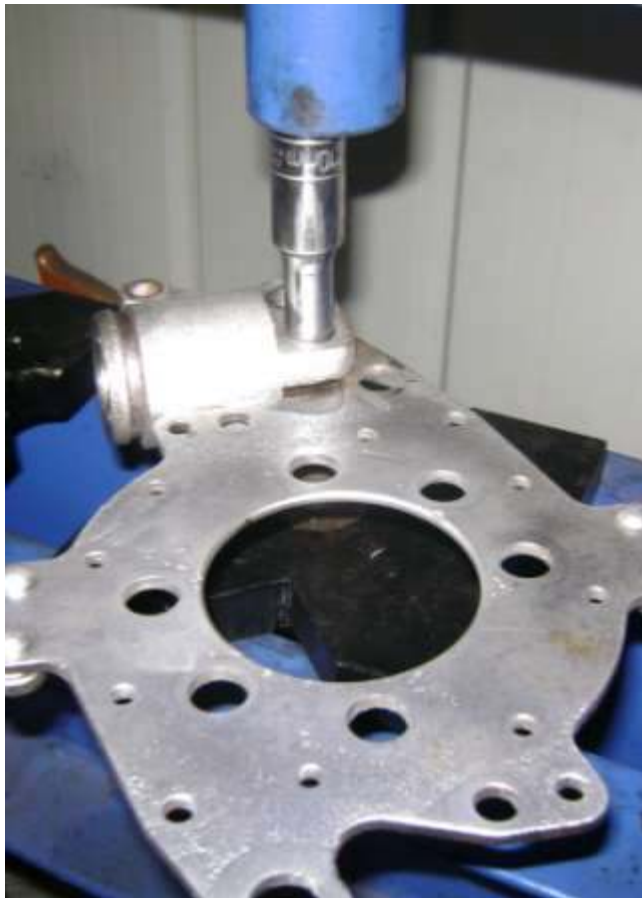
And here is the job in progress. As always with amateurs, supporting jigs and pressing arbors need to be improvised. In using the backing plate to support the back of the cylinder don't make the mistake of pushing it too far in lest you engage the slot in the pivot pin. In such a case the earth will move before that pin!!!

The six large holes in the mounting plate are for the very stout bolts to mount the assembly to the stub axle.

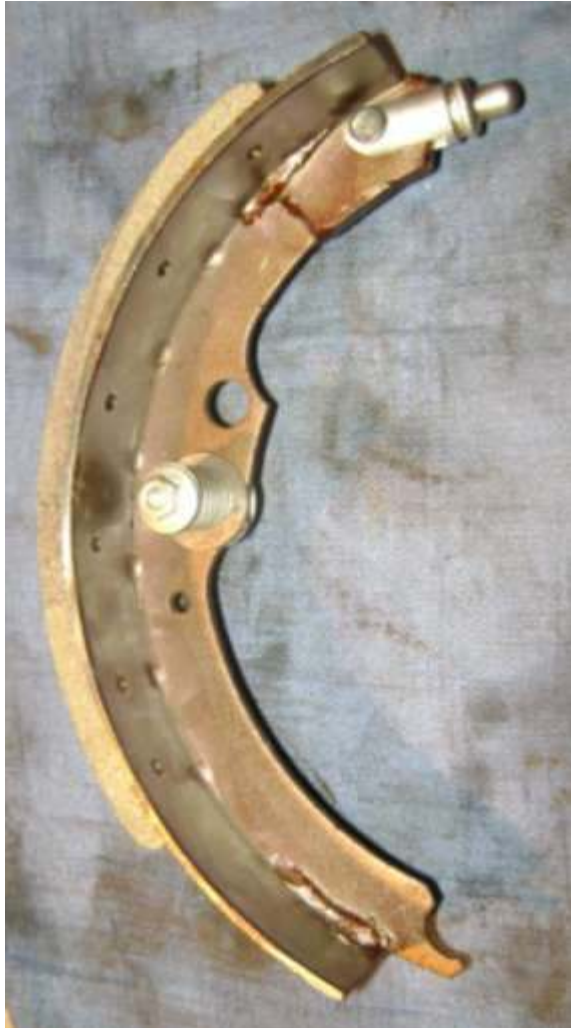
Here the rivet holes are a reminder not to pull the drums off when the concours judges are in the neighborhood! The strut at the top of the shoe in the picture needs to have the clevis removed, cleaned and generally tarted up and refitted with a new split pin.

In the middle of the shoe is the shake back stop which consists of a special bolt with a large head which is on the underside of the shoe web as you are looking at it. Then comes the first friction washer, the edge of which can just be seen and then having poked the bolt through the web the second washer is fitted followed by a spring, a chamfered washer and a 7/16th inch nut.

There is no adjustment. The nut is screwed down as far as it will go. What is not seen is the hole in the web in which this assembly slides which is quite large allowing the shoe to do its job and centralize in the drum.

Not infrequently the web where the washers sit in the picture is cracked. This seems to be the result again of running these brakes on oversized drums. The pistons in the cylinders keep pushing, the shoes are worn beyond their limit and the steady posts that these shake back stops sit on can't travel outward any further so the web cracks!

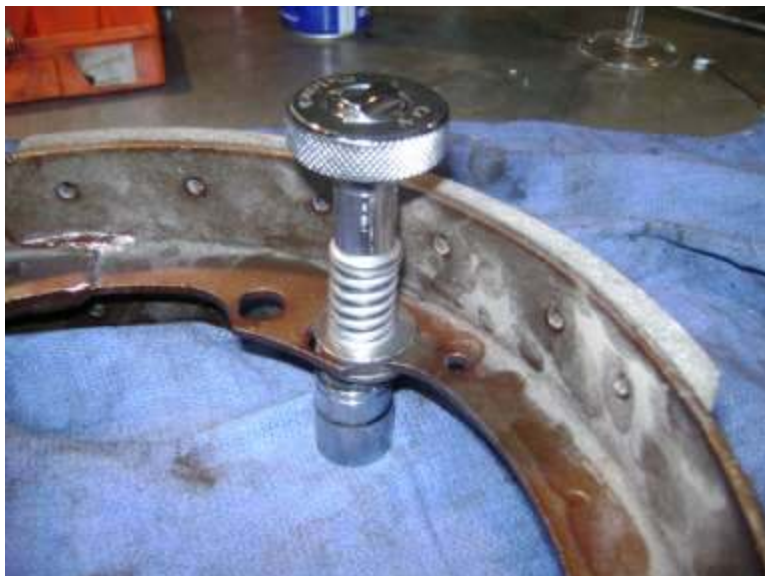
Getting the nut on that shake back stop bolt is not the easiest as it involves a partial compression of the shake back spring. This is one way to do it. A socket is placed under the stop bolt head. A 'slave' nut is placed in the socket wrench and the wrench and ratchet hand wheel is placed over the head of the shake back bolt thread. The slave nut stops the second nut from simply idling away on top of the bolt. The hand wheel tool is not necessary but is easy to lean on while turning! The web slot that the shake back stop slides in can be seen peeking out to the left!

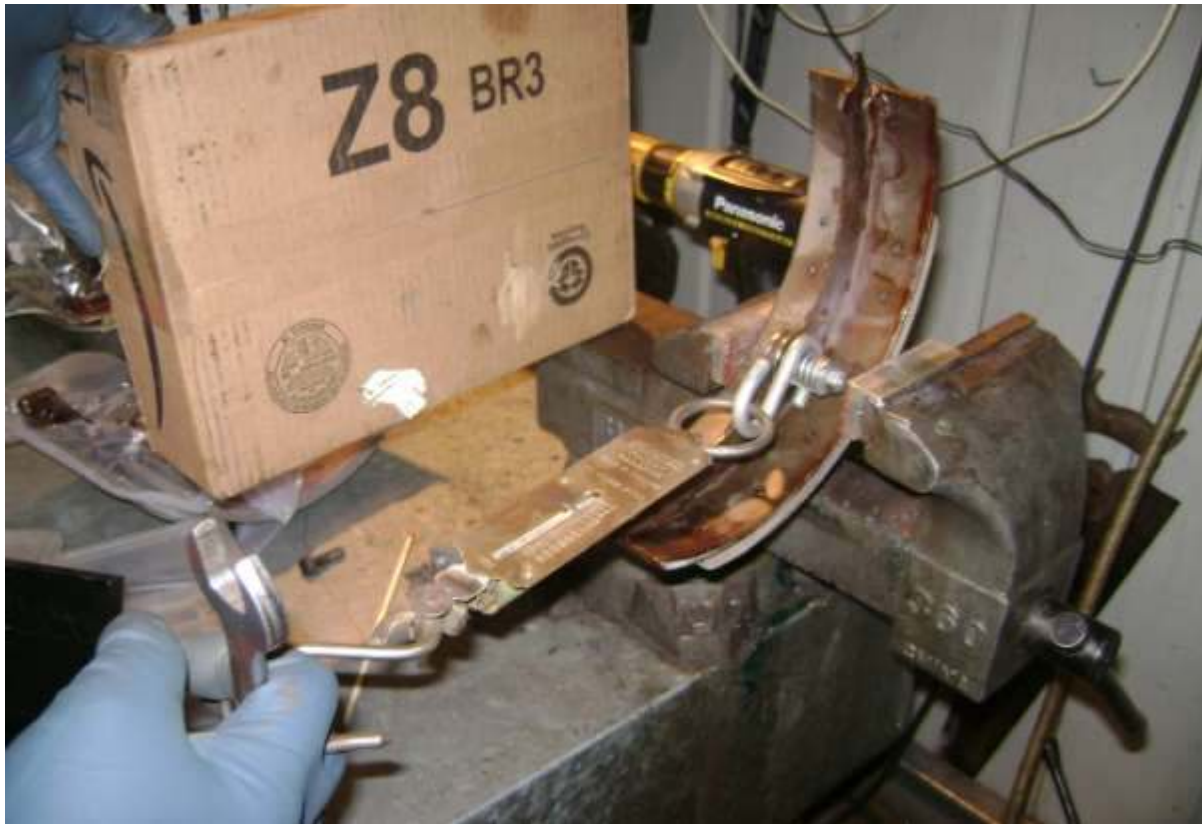
This is the last step to get the shoe ready to install. The spring balance needs to have a range to 50 lbs. The shoe is clamped so that the web slot is horizontal and the spring balance is pulled in the same plane as the slot. The reading when the shake back stop assembly just starts to move should be 20 – 30 lbs. Obviously no lubricant is used in this area. If the reading is too high it may help to polish the web where the washers slide. Sometimes with bonding linings, a finish is applied which will throw the setting. If the reading is too low and these springs do sag, borrow or buy a good spring and have your local spring maker cobble some up for you and your mate who has a similar car!

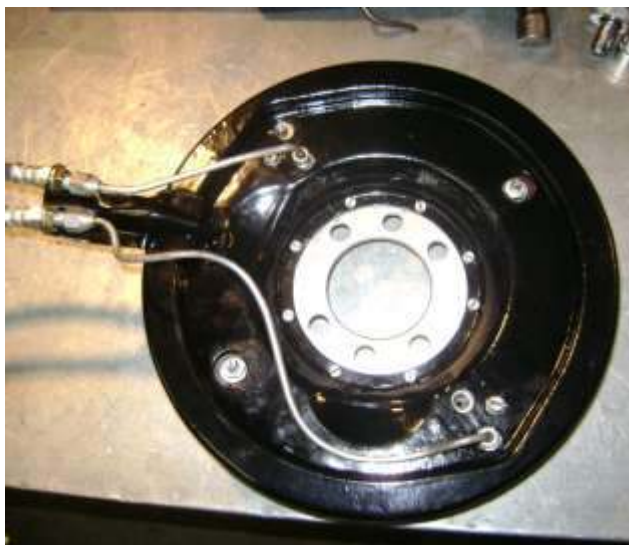
Meanwhile on the other side – the backing plate which really does little else but keep road muck out, has been fitted. The main mounting plate can be seen in the middle. This is sealed originally with paper gaskets between the backing plate and mounting plate. The delivery pipes for the brake fluid are connected together with new flexible hoses and new retaining bolts and washers. The ends of the posts on which the shake back stops sit on can be seen at 8 o'clock and 2 o'clock complete with lock nuts. When removing or fitting the brake shoes it is well to remove these posts to avoid bending them. It is also a good idea to clean them and check for previous damage. The posts have a secondary function in that screwing them in and out pushes the shoe away and towards the backing plate. This allows you to set the surface of the shoe parallel to the axis of the stub axle and the inner surface of the drum. When this is done the hole is covered by a dust cover.

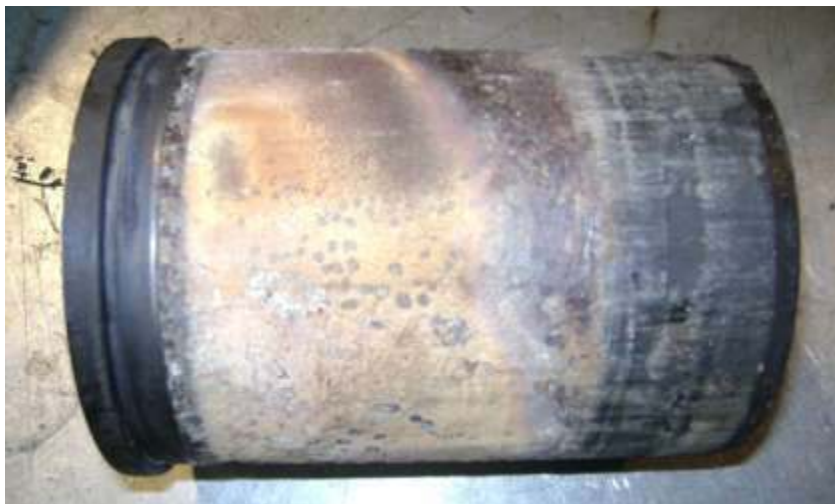
As you will have read in the workshop manual the liners when installed have to sit about .002” above the surface of the block. When the head is installed with a new gasket this provides enough ‘crush’ to seal things up! To achieve this dimension the Factory had the facility of a stack of liners which through the vagaries of manufacture all differed slightly. But there is a further embuggerance. The recess into which the lip of the liner sits, whilst being beautifully machined sometimes slightly distorts, also, the actual hole in the block that the lip sits in can also distort. Both situations can be rectified with a bit of expert machining at a good engine shop.

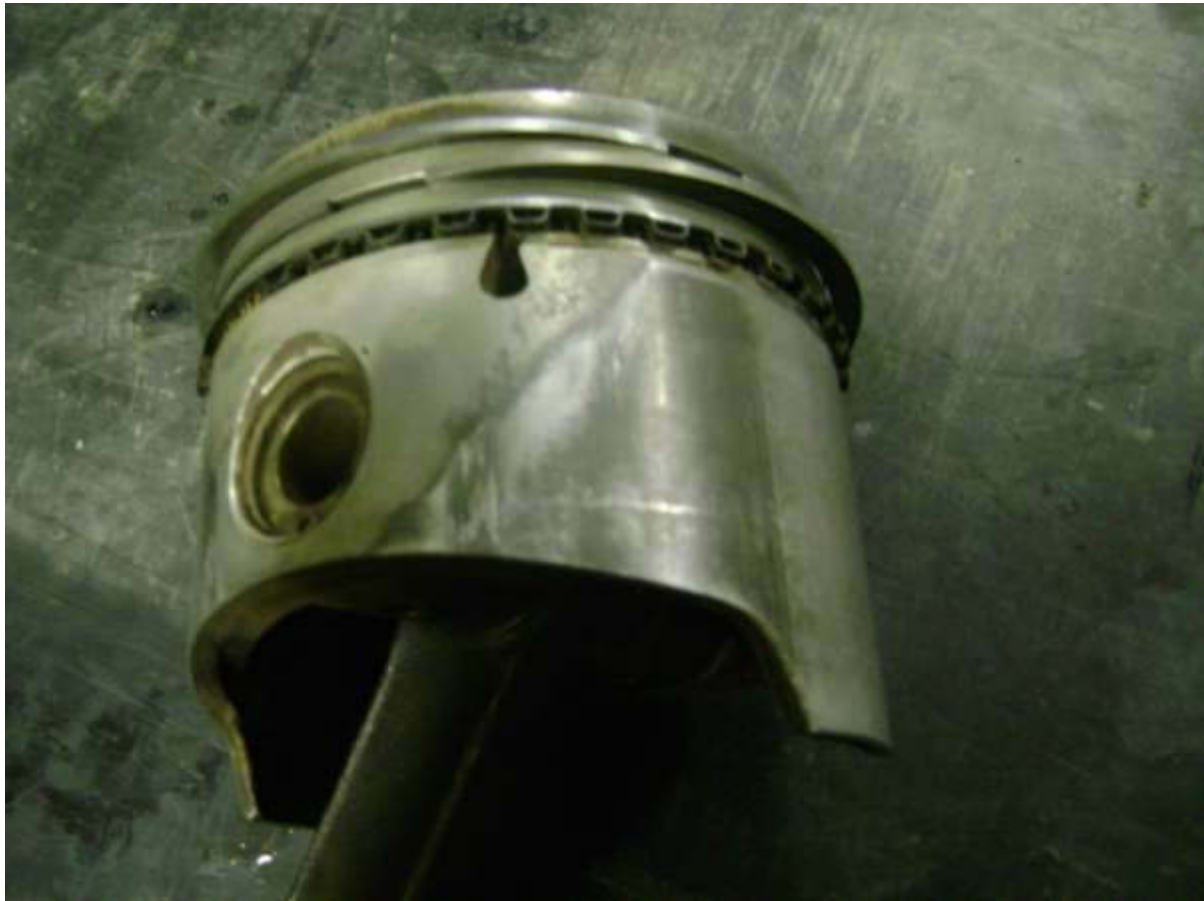
As we all know while the bore of the liners are round the pistons are not, they are oval. Not by much mind you but the designers of these incredible old inventions have to stand multiple canon-like smacks on the head plus changes of direction and speed many many times a second. There is also the small matter of an inferno impinging on the crown of the piston. The heat buildup in the unit has to be dissipated with great speed or the whole thing will melt. The grooves that the rings sit in have to somehow hold them so that they don't flap up and down; neither can they, through expansion, grip the rings and stop them performing their compression retaining and oil scraping function. One other thing, heating the piston up expands it; a clear candidate for seizure in the bore. To overcome this, the greater diameter of the oval piston is across the thrust faces which are at right angles to the crankshaft and if you look at the picture you will see where the resulting wear takes place on the unit as a result.

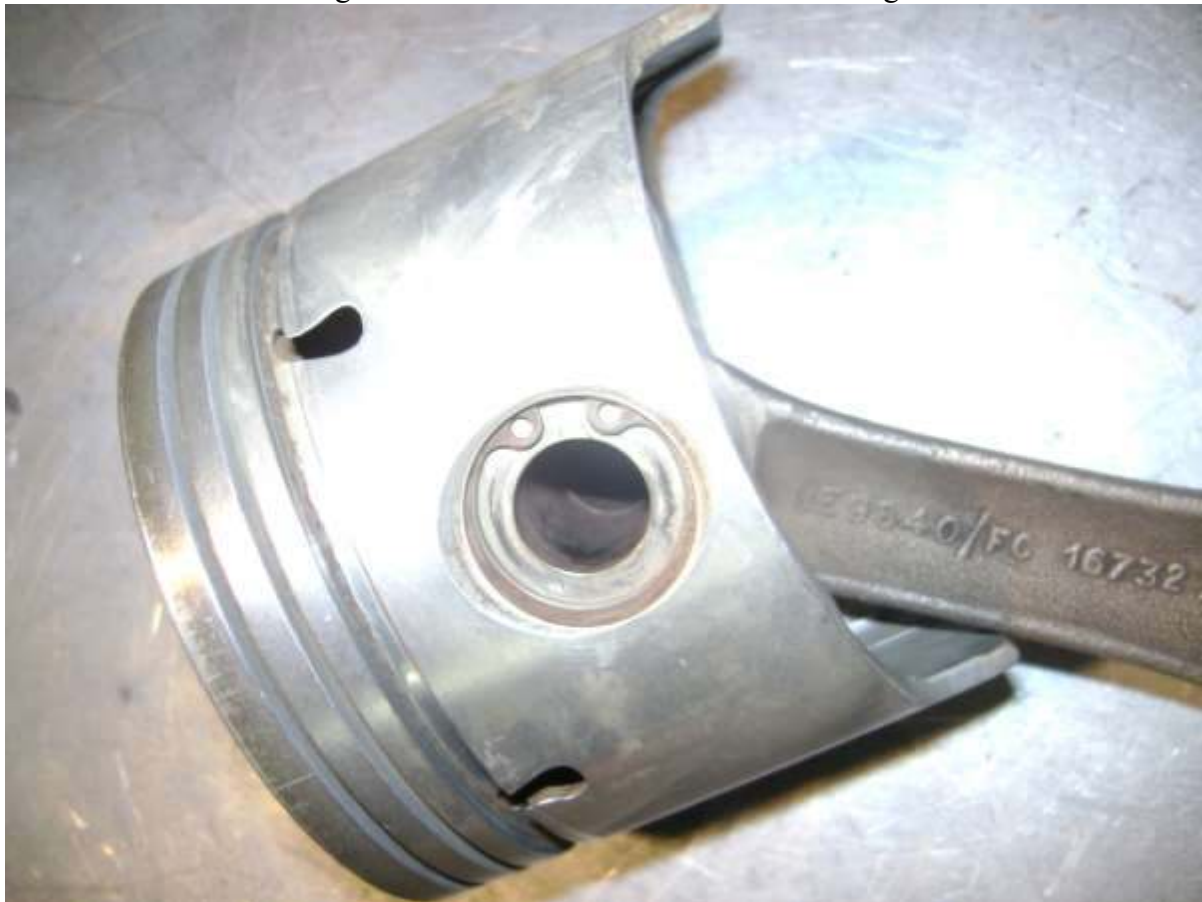
Here we have the piston nice and clean showing its circlip ready for removal. One of the nice touches in manufacture is that the piston is stamped with its bore number and grade, the gudgeon pin has the bore number on it and the connecting rod AND cap have the bore number on them!

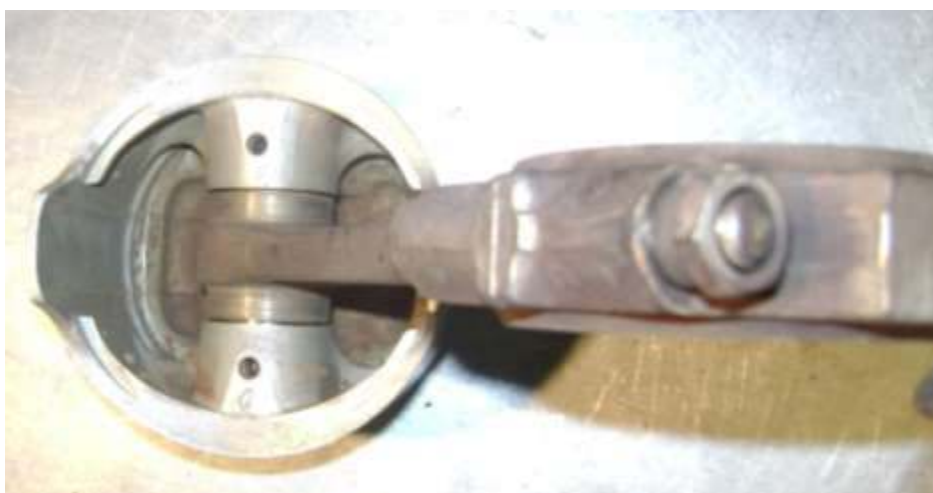
A view of the underside and the holes in the piston bosses to admit oil to lubricate a very hot gudgeon in an even hotter piston

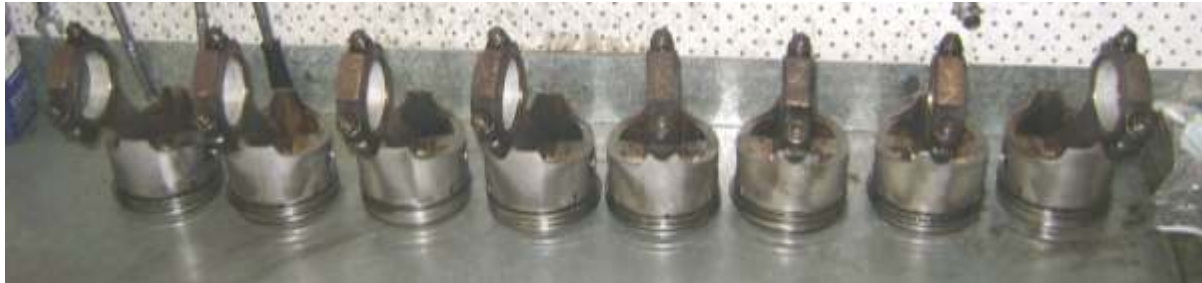
When you look at this lineup you sympathise with mechanics having to overhaul the later 12 cylinder motors!

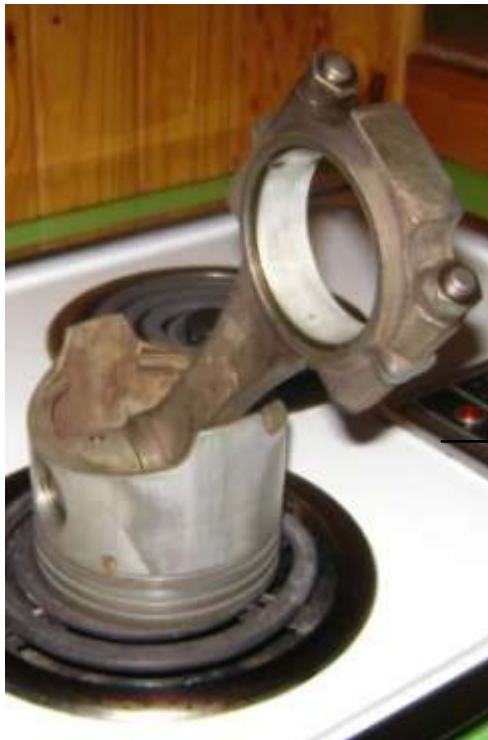
I don't think 'Home Beautiful' had this in mind when they voted our kitchen as 'Kitchen of the Year' (the date is obscure!). Gently heating the piston which being aluminium expands faster than the steel gudgeon piston. Of course the circlips have been removed before this culinary step. I found that heating the thing until I could just not stand to touch it, seemed to do the trick.

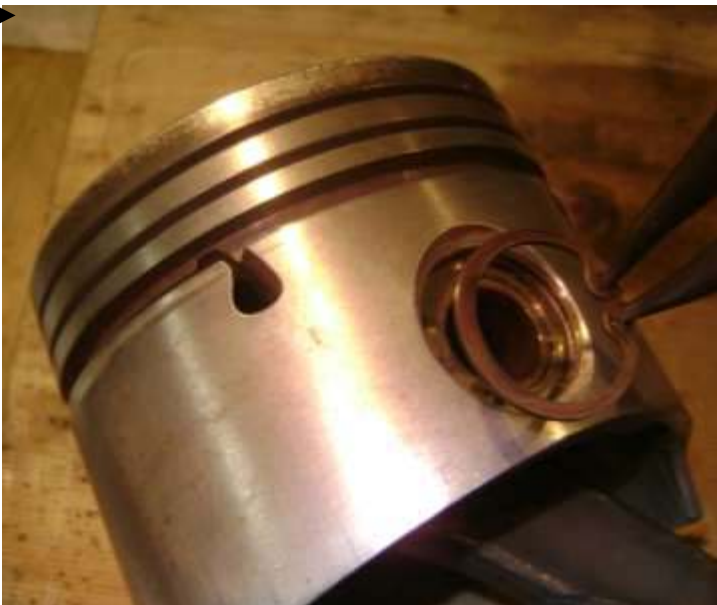
Extracting the circlip. Not the lowest groove the oil ring groove, this had to be widened to accommodate after market rings which are considered by some to be superior to the originals, which to be fair were made and designed with the technology of 35 years ago!

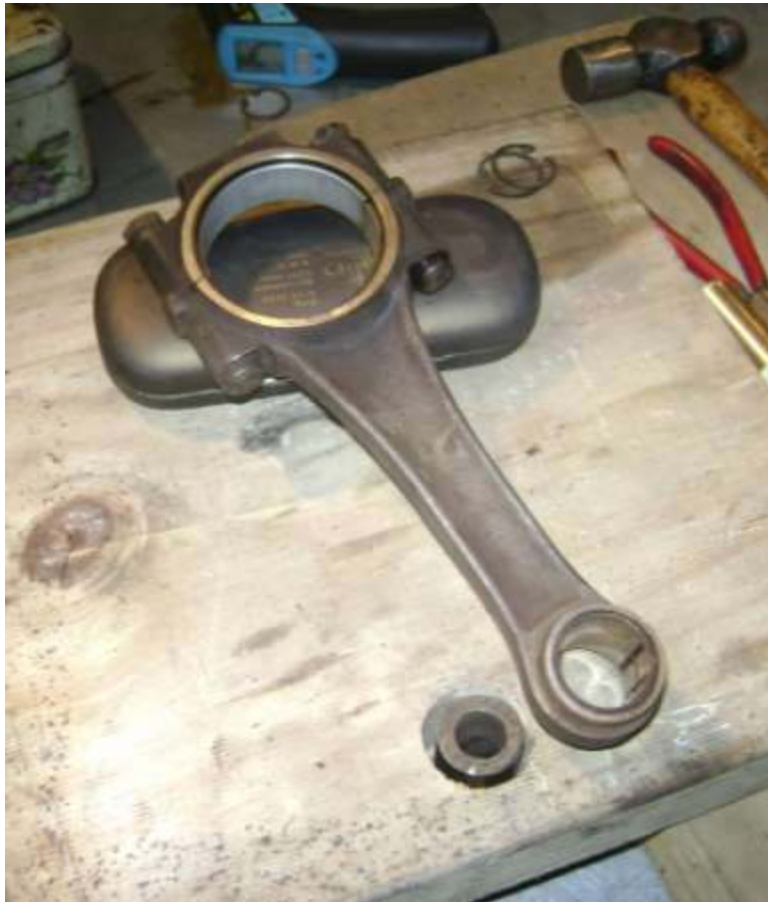
→
A light tap with a brass drift persuaded the veteran pins to slide out. Note the depression in the crown of the piston. This was one of a number of variations to cope with apart from government regulations, the abysmal quality of fuel at the time of manufacture. This is a 'low' compression engine. The high compression piston was sans depression. The glasses case is not standard but beautifully supported the big end of the connecting rod during the operation. The half moon slices are to accommodate the overhead valves as they lunge in and out of their seats!

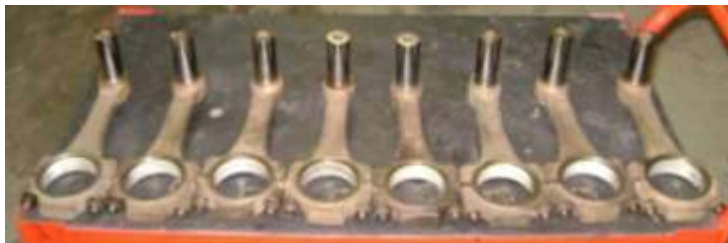
↑
And here they are all lined up like kids for their daily mouthful of Saunders Malt Extract (remember?). These rods have a frightening task just staying in one piece so they are made, balanced and inspected with great care. The bolts are equally critical and if there is the slightest doubt about one it must be replaced. The carnage that follows the breakage of one of these little bits is heart rending!

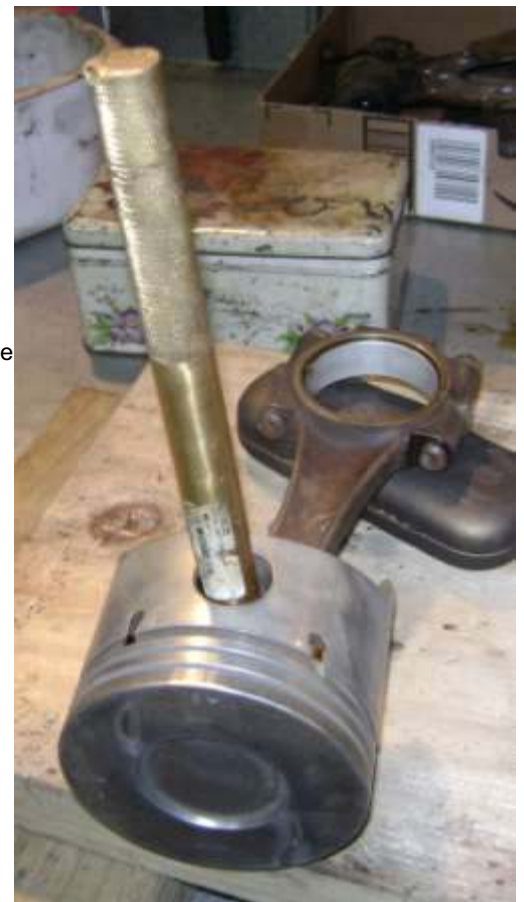
←
And here is a very special tool. The requirement was to support the piston while the gudgeon pin was pushed/pressed/bashed out without distorting the piston! Complicated cradles were planned but a solid pine block with a large hole bored through it did the job. Here the piston has been removed and the gudgeon pin waiting to be collected. I noted that the etching on the end of the pin was always facing the same side as the etching on the end of the connecting rod!

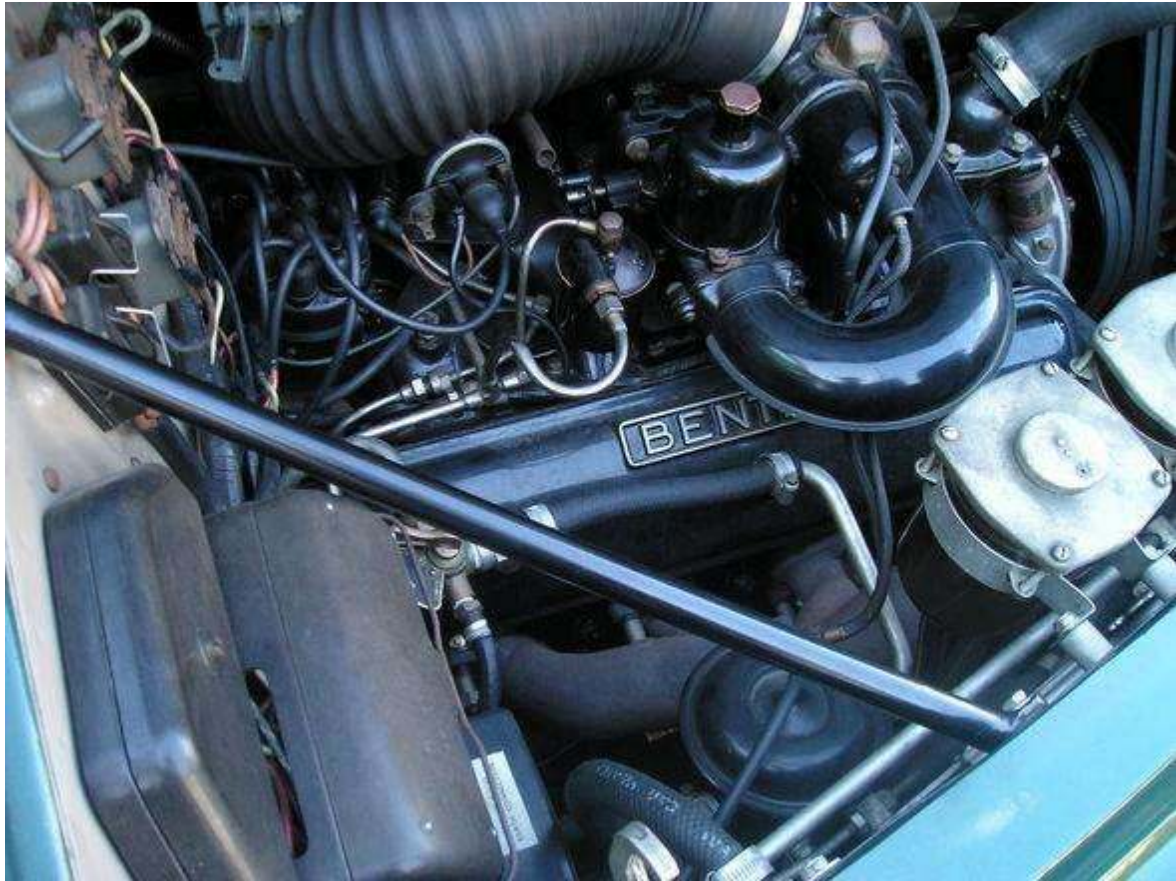
Clearly the car had been restored although looking at the fuse box cover and the iconic junction box above it is surprising that the restorer had not heard of the use of judicious buffing and good old Brasso to return the items to their pristine state. For those that don't have one of these cars, the small round black painted object immediately below the slanting stay rod, is a vacuum servo for the water tap for the heating system. The Factory used these originally on the S1 (sic) cars. When the vee eight was born electric actuators did the job far more efficiently even if a bit noisily. The vacuum systems had a strange quirk. If the engine was heavily loaded such as on a steep climb with a fully loaded car and the throttle was much

opened the vacuum would drop off and all the little spring loaded heating bits would slam shut. The older set among my readers will recall the vacuum wipers on early Holdens which would simply stop on a steep hill. The same car but much later model used vacuum for heating flaps and the same problem would occur there. Let's enjoy the interior of this car we
