CANCELLATION OF END OF YEAR

OVERHAULING REAR CALLIPERS ON SZ CARS

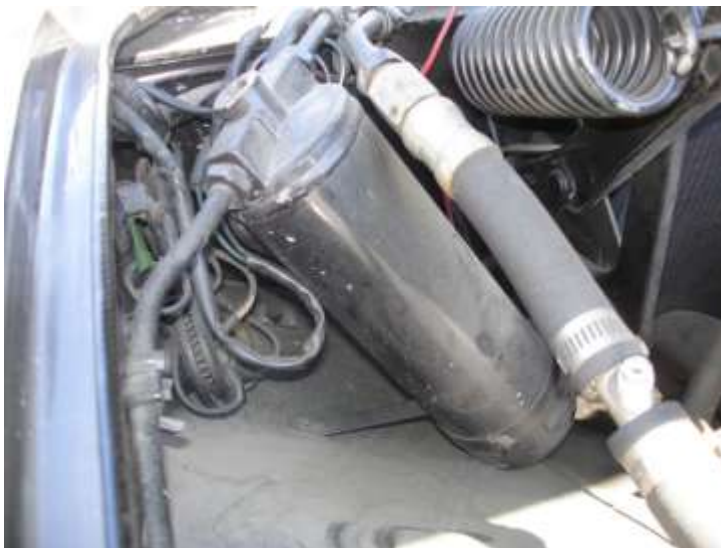
Shadow Air Conditioning

Most owners will be familiar with this cylinder jammed into the left front corner of the engine compartment. This is a drier. Any moisture in the circulating gases will quickly freeze as the pressure increases and fine ice slivers will get under valves and other crucial bits and the whole system will fail.

Initially when the system is charged it is evacuated to as low a vacuum level as possible usually about •0065 psi and some operators sweep the system with nitrogen to minimize the possibility of water vapour remaining. Even then there is a risk so a drier is put in the lines and that is your cylinder in the corner that we see in the picture. It is filled with a desiccant, a compound that absorbs water, variations of which you find in small bags in new camera boxes and the like to prevent rust from water vapour.

If you change to the 'new' refrigerant it is essential you change the drier along with some 'O' ring seals in the system. This is all academic since in this country work on air conditioning systems HAS to be done by a licensed operator! But the information above is something you should be aware of so you can drop the bon mot while the work is being done. And when the operative announces that the drier fitted to your Shadow is no longer available, do not despair as a shortened version is available and works adequately albeit with a modified bottom mount to replace the one seen in the picture.

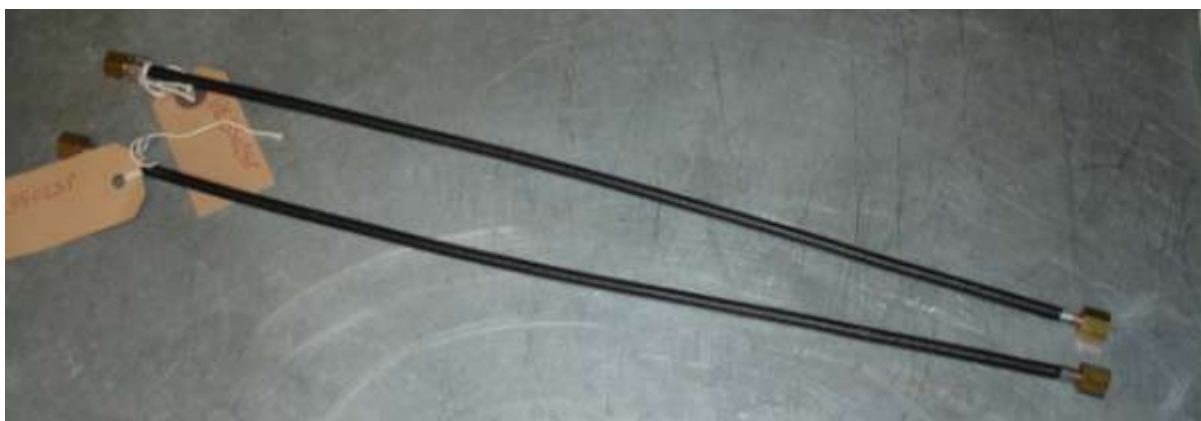
STOVE PIPE LEAKS

The above items are the new version of an old fitting which goes back to the start of the vee eight in 1960. Their function was simply to pipe a small quantity of induction air through the choke coils to heat them up expand them and open the choke. The heating is done by passing the piped air through a 'U' shaped tube in the 'B' bank exhaust manifold. Originally the pipes were lagged with asbestos cord which looked very business-like. With age the cord frayed and the pipes looked like a dog's breakfast. Worse still the pipes rusted and burnt with the heat and eventually if they didn't snap off at the manifold they at least punctured which allowed cold air to enter and the choke would close up a bit and your wallet would open a bit to pay for the extra fuel.

The last price I had for Factory replacements gave me a week in intensive care for shock so I was delighted to find the above aftermarket items from Introcar in London www.IntroCar.com at a very reasonable price.

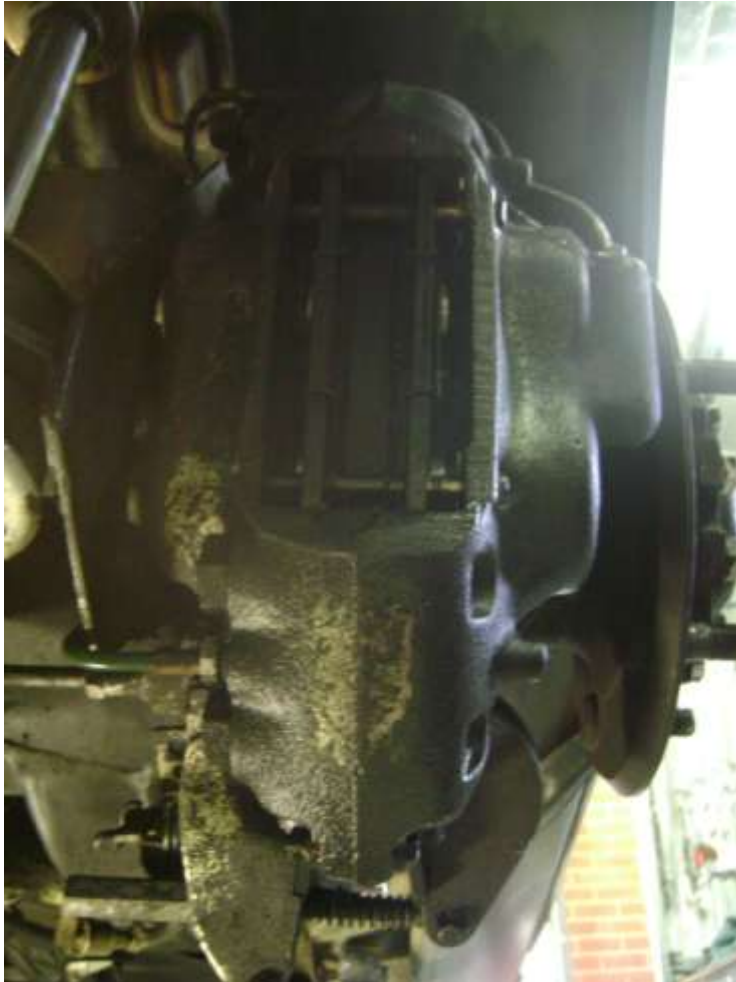
One of our members complained that his Spirit under heavy braking would frequently skid. He wasn't sure which wheels or why. Crawling underneath revealed the above which have actually been cleaned! The callipers were swimming in LHM. This effectively reduced the rear braking to nil so the whole effort to stop the car fell to the front wheels which presumably eventually gave up and skidded!

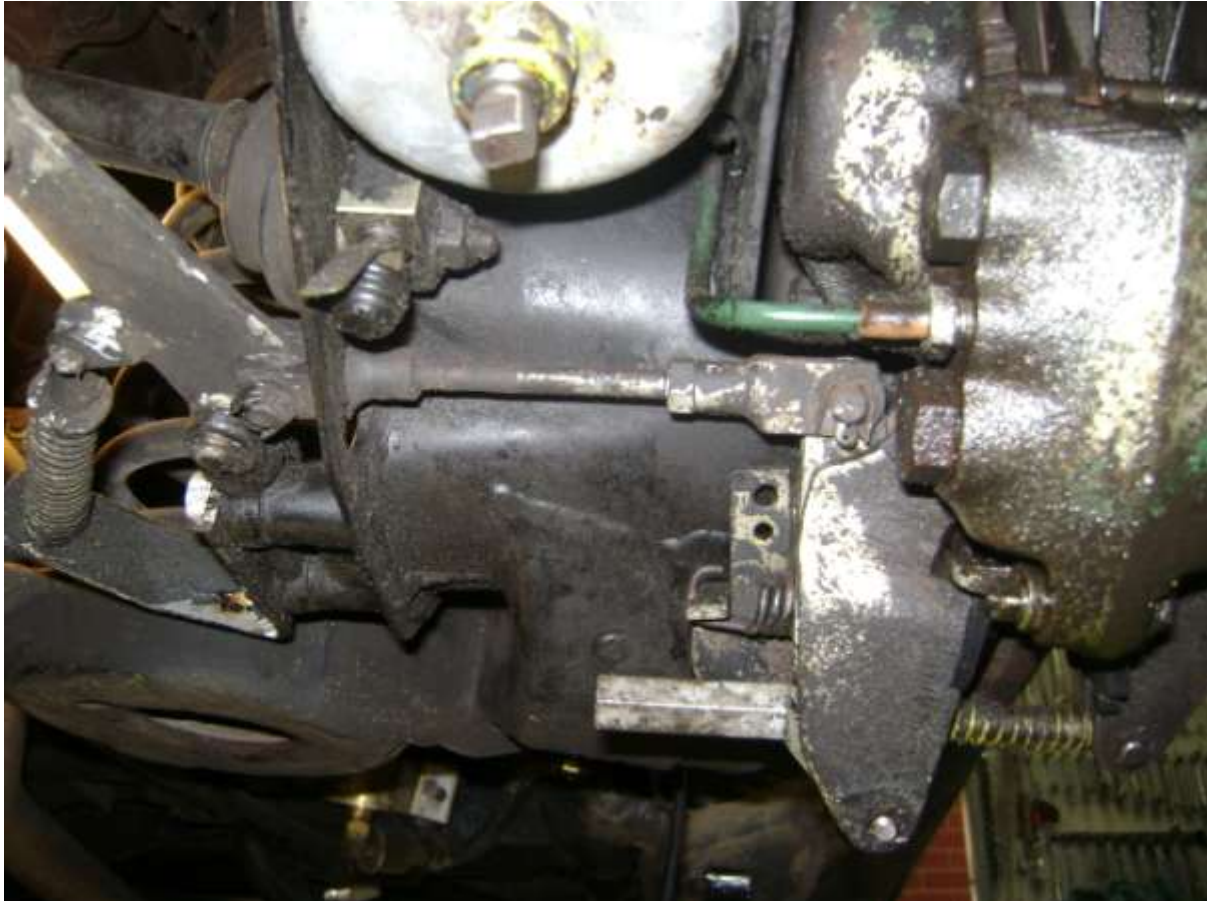
Above we have the worm's eye view. The large washer at the top is the lower end of the suspension strut. At lower left of the strut is one of the bleed nipples complete with ribbed dust cap for the caliper, remembering that there are two systems operating in the one unit! Next down is one of the parking brake operating rods with the actuating mechanism to the left. To note here is that the rod passes through the left hand strengthening plate, one of the two supporting the lower end of the strut!

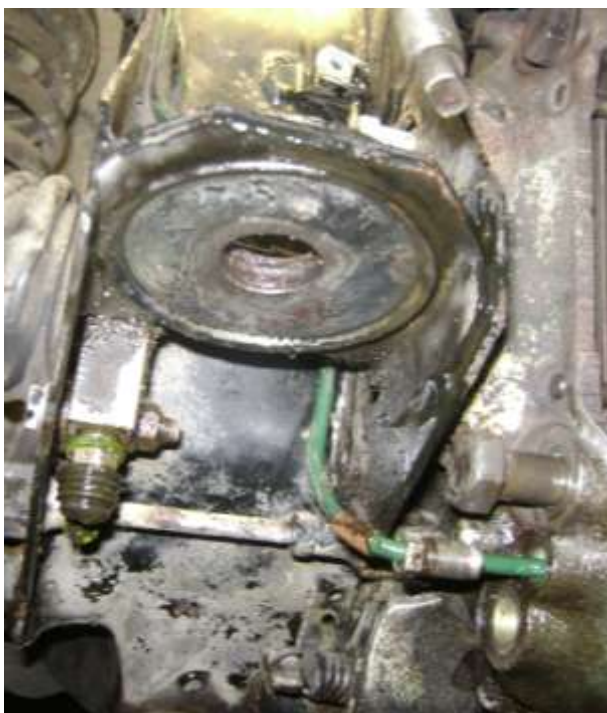
It is not necessary to remove the strut from the suspension arm which has been done here. But the platform for the strut mount with its vertical supporting plates can be clearly seen.

Bottom left shows that one of the four caliper bolts that hold the two halves together has been removed. This was done to allow access to the supply nipple seen withdrawn from the caliper. The heads of the two large bolts allow only an open 7/16" AF spanner to be used on the nipple so if it is very very tight there is a good chance it will burr and you may have to repair to your garage shrine for prayer and whisky!

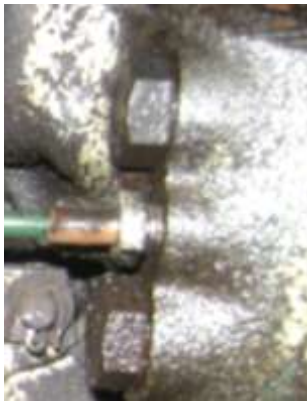
See what I mean????

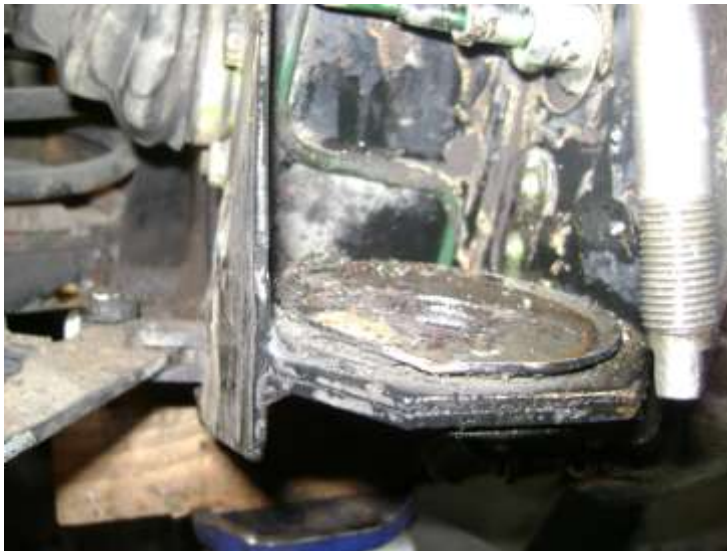
Here most of the pipes have been removed. The jungle consists of the two supply pipes (one for each system) the transfer pipe that runs from one side of the caliper over the top to the other to feed the piston on the other side and lastly the bleed nipple pipe for the lower cylinder.

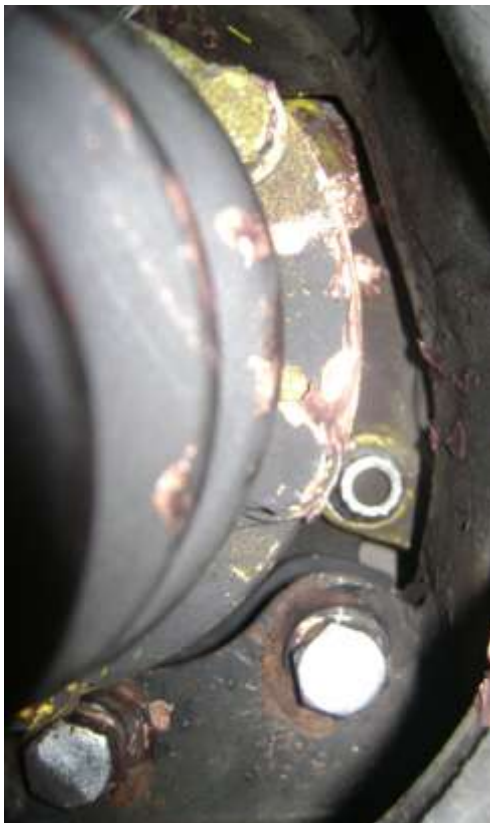
Next task is to unbolt the caliper. The attachment is the same as the front except that given the space restrictions and the very high poundage the attaching bolts are torqued to, special headed bolts are used. Here the lower caliper bolt can be seen, the other larger bolts are half of the four that hold the whole axle assembly onto the suspension arm.

The view to the left is inside the end of the rear end of the swinging suspension arm. The nearest and brightest bit is the end of the Lobro joint where it bolts onto the rear wheel stub axle.

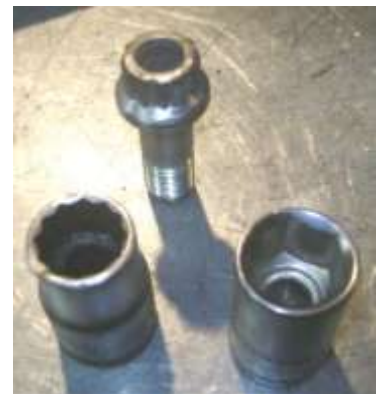
You should not take fright at the sight of these bolts. They are known as double hexagon head bolts or dodecagon heads, given that they have 12 'sides'. A standard multi point socket fits them very nicely!! Above is a picture of a standard multi point socket and a simple hexagon socket. The latter can't be used on these bolts!

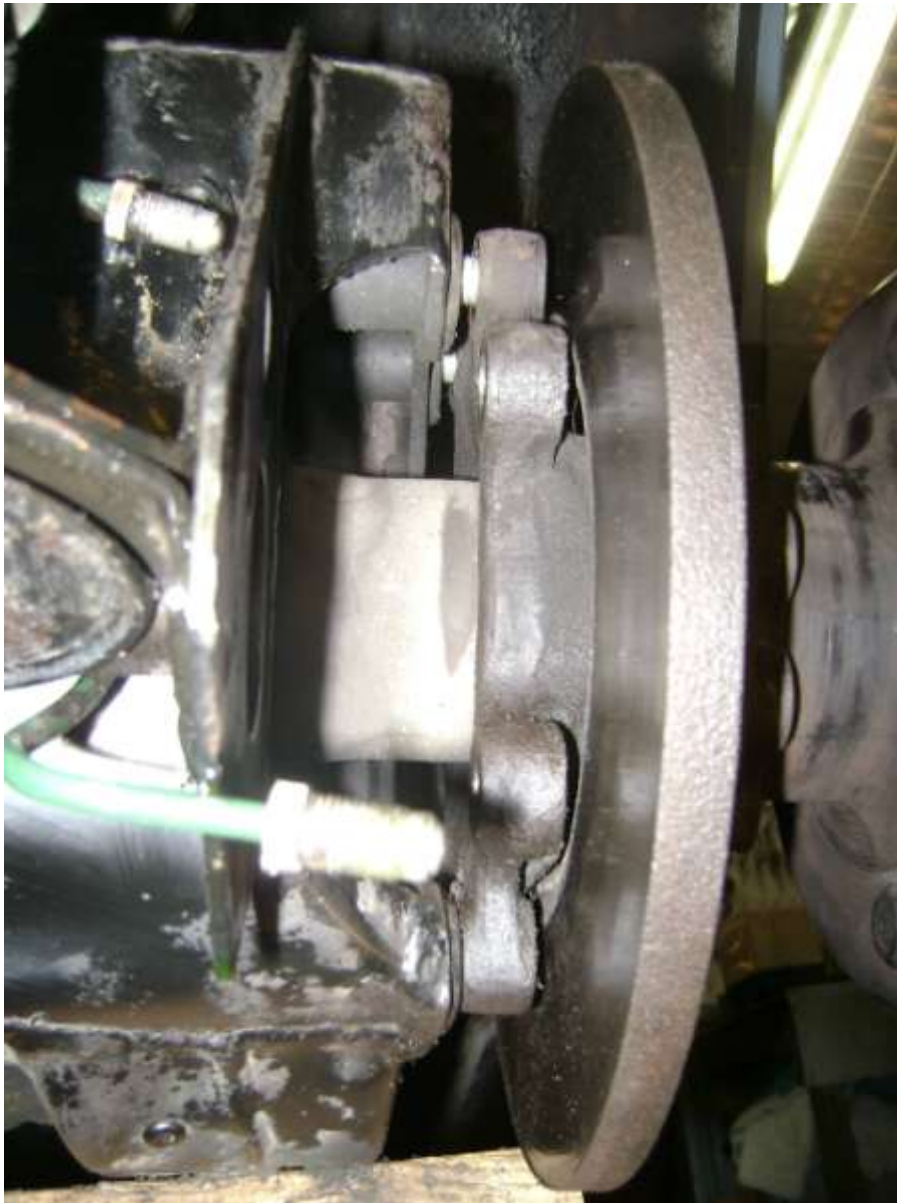
Now comes the interesting bit. You are looking at the rear of the right hand rear brake rotor.

The mounting lugs for the caliper can now be seen.

The calliper has been removed but because a few bits of it slightly protrude into the holes on the rear strut mounting plate beside it, the whole axle and calliper assembly need to be loosened and the assembly moved outward allowing the caliper to be withdrawn to the rear.

This simply involves loosening the four hub retaining bolts a few turns and pushing the axle outward. It can't be pulled too far lest you split the Lobro joint on the end of the axle.

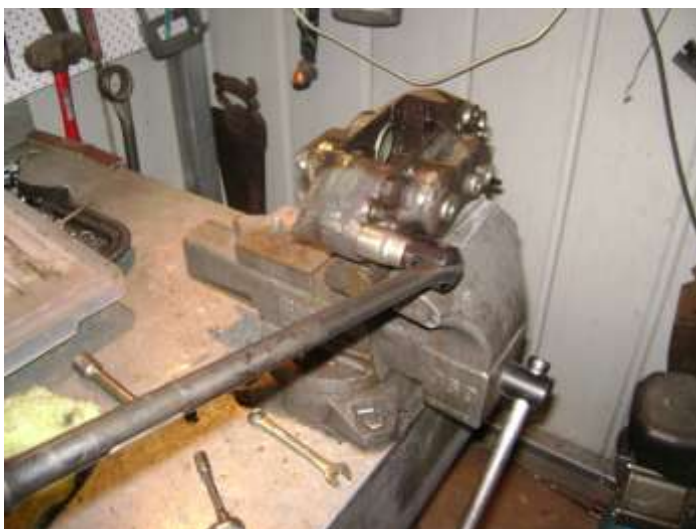
There is nothing special about the callipers if you have done them before. Here we are unbolting the two halves to clean them. Note the break bar because once again these bolts are very very tight

Altruism hopefully is not dead. Think of the next poor bugger who has to undo these bolts including the ones above the calliper mounts and the rear axle bolts. I spent an hour screwing these virginal bolts out dipping them in the good stuff and replacing them!

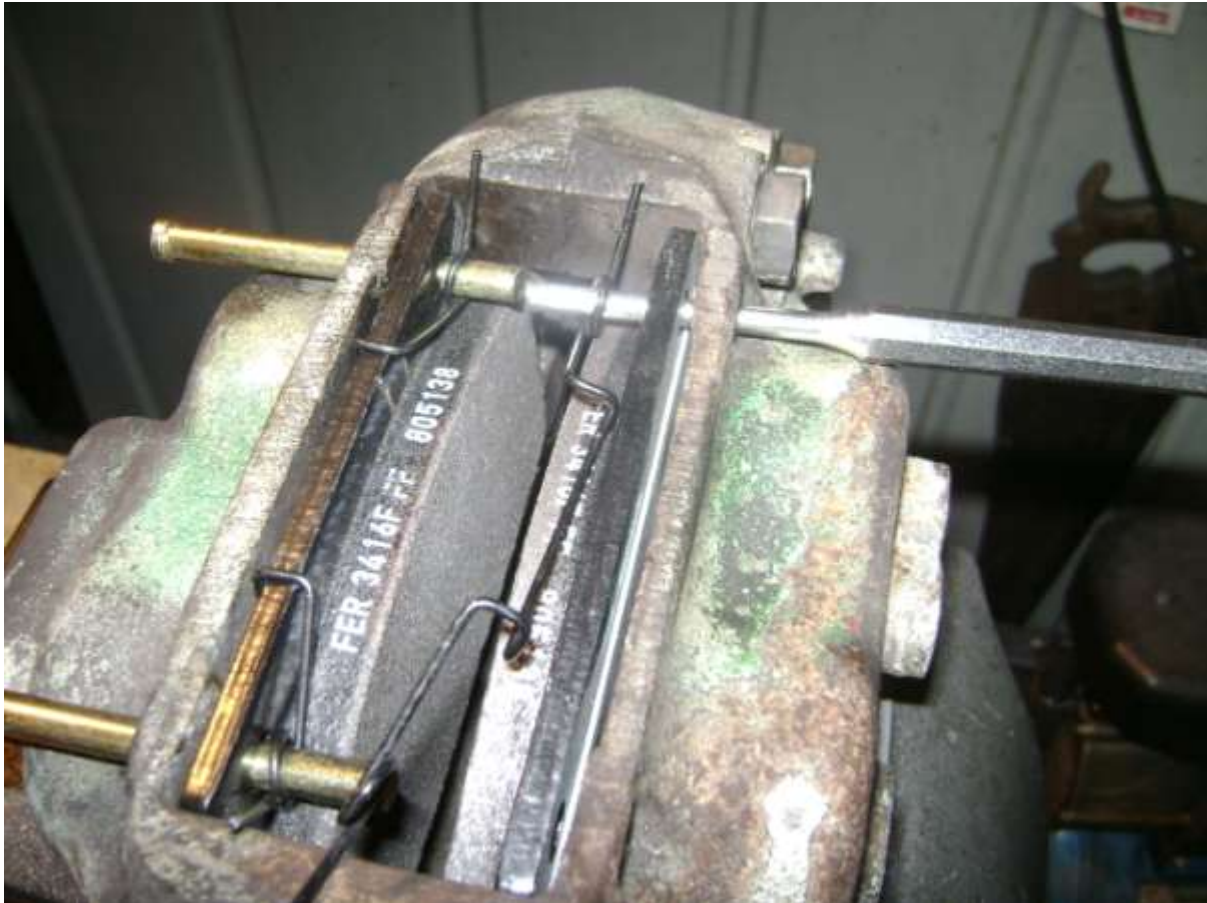
And finally here are the new pads going in with their anti-rattle springs. The latter can be like trying to get a live tarantula into a small pepper pot but the judicious use of a suitable centre punch makes life a lot easier! Overall if you have the time and facilities to do this job you will need at least 20 hours spare. Multiply that by your man hour rate and it may be worth your while and you should achieve a great level of satisfaction!

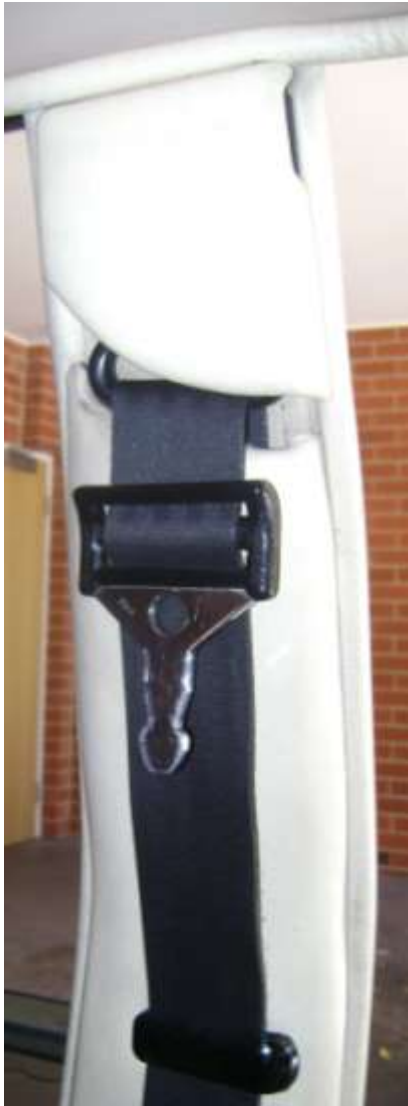
The dinky little cover for the upper belt mount is pure Roycery. The top is held by two little prongs and at the bottom by a clamp held by two small self tapping screws. You start from beneath with a torch and a Phillips Head screwdriver. To get the cover off having removed the two hidden small screws, drawn the bottom of the cover away from the 'B' pillar then push it up firmly to release it from the prongs. Practicing on the driver's side pillar, I was startled to find wires and things that did not look very seatbeltish. Then I remembered my curiosity as to why this cover had side slots in it and the other did not! One of these can be seen in the picture. It appears that the wires and bits were the upper temperature sensor for the automatic air conditioning system and the slots let the fuggy air in to talk to them.

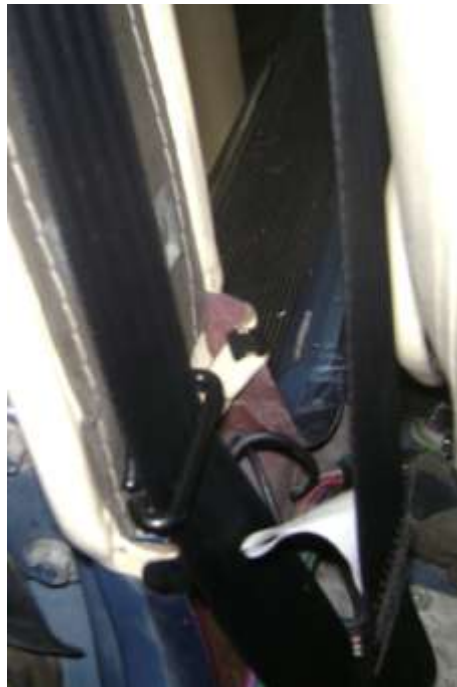
The long 'B' pillar cover is held to the floor by a couple of bolts and the screws securing the Stainless scuff plates on each door sill. With the little top cover removed, the log cover simply slides up an inch or so and then lifts off!

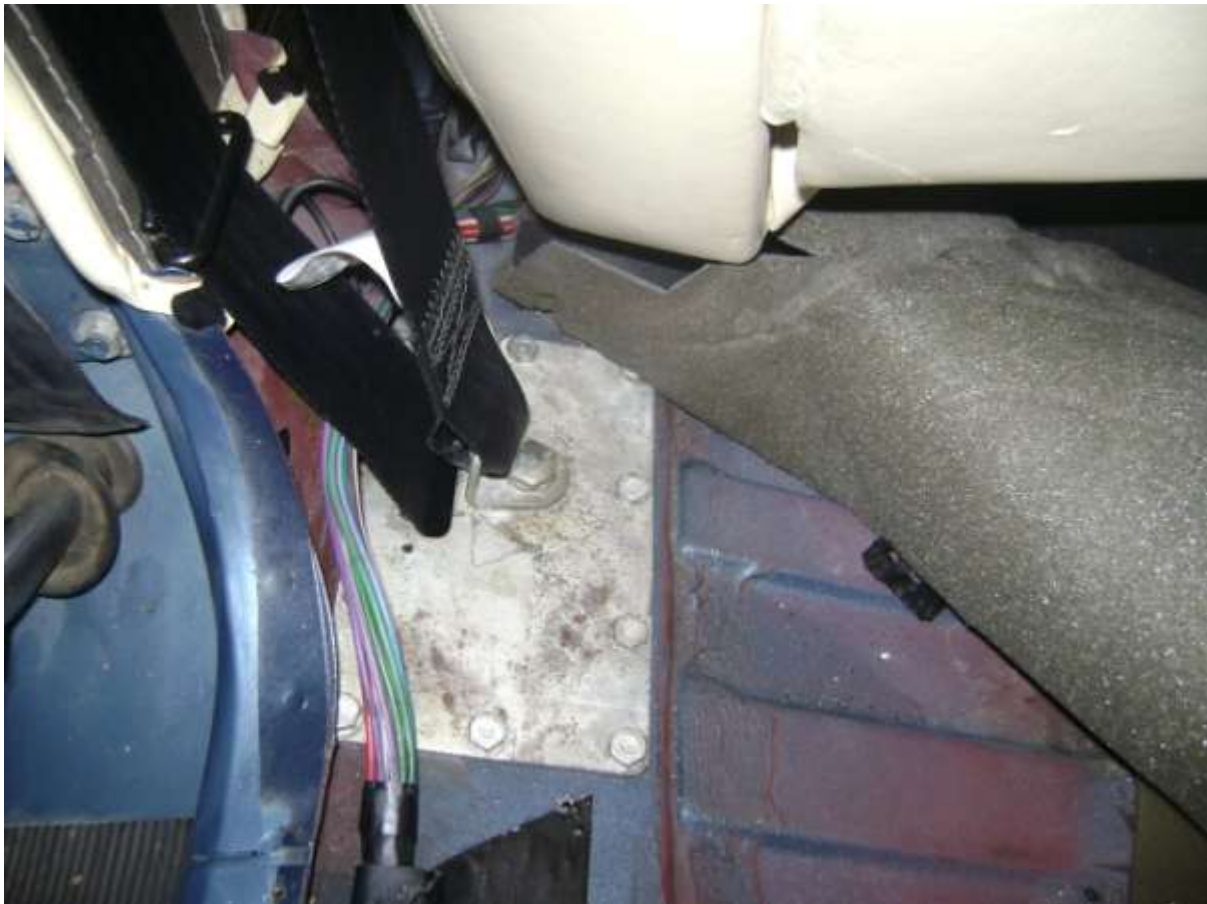
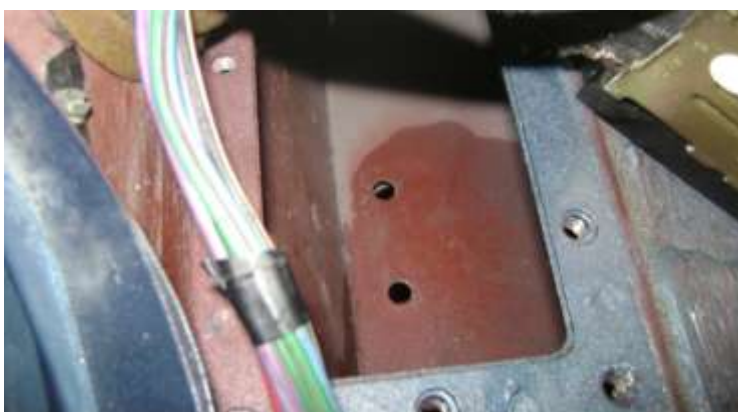
So that's where it is? Yes the front belts are secured in a hole in the floor just behind the driver's seat and

covered by a massive steel plate fastened to the floor by no less than 10 bolts. This is not to prevent the seat belt escaping but provides an anchor for the fixed end of the belt seen here. The belt underneath feeds through a slot which has a right angled insertion slot to thread the thing.

At left is a picture of the box opened and belt removed. Bolts are screwed from underneath and the retractor actually sits in a plastic bag to protect it from serious water invasion into the sill

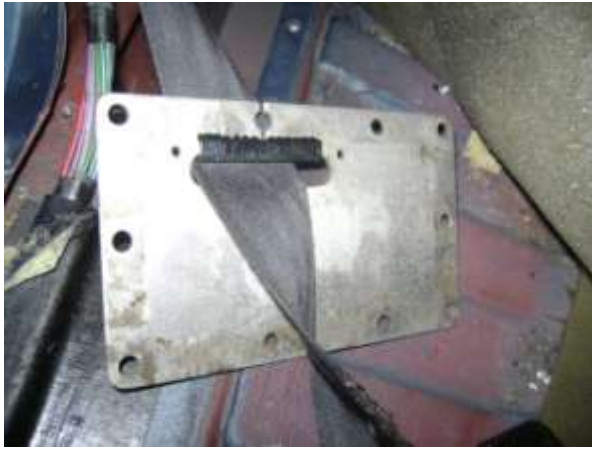
Here is the plate showing the insertion slot and the simple remedy to prevent chaffing of the webbing.

The unit is known as a vertical mount, which fits to the Factory angled mount the latter catering for the slope of the body sill.

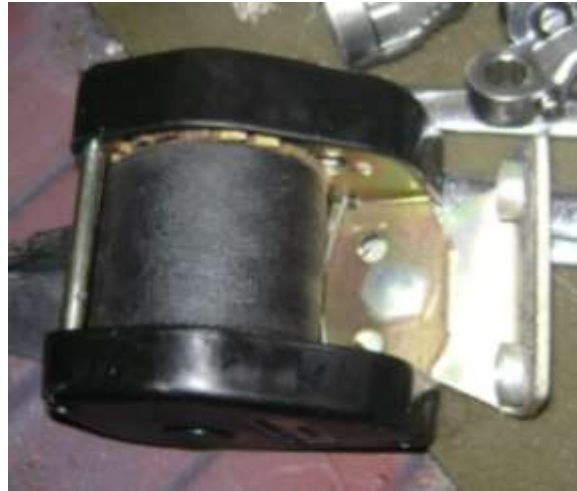
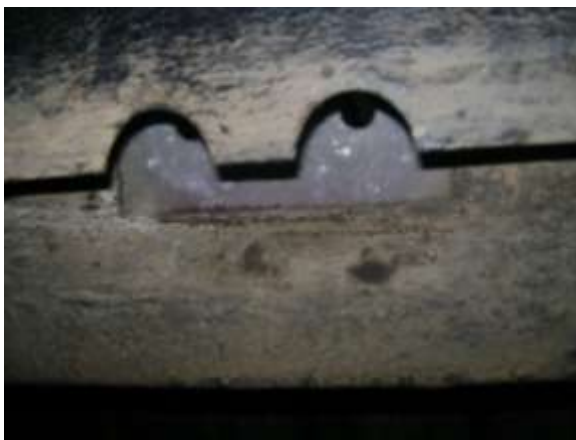
At left is a worm's eye view of the mounting holes

The retractor is designed to release the belt when it is vertical but will tolerate a 3° lean in any direction. This obviously dictates that when the mounting bracket is bolted to the sill and the sill is horizontal, then the belt must be vertical. This was my way of ensuring this – and it worked!

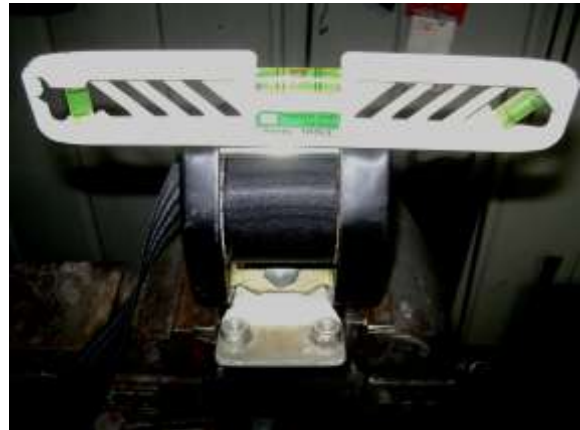
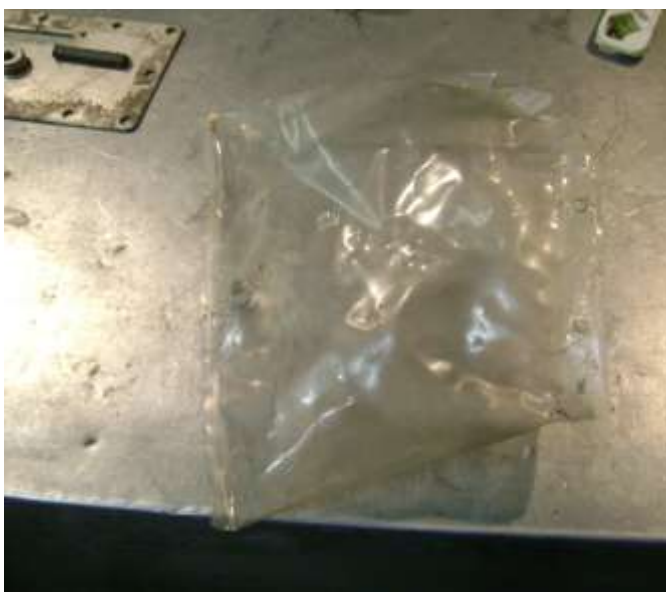
And this is the plastic bag in which the reel sits. The bag has two holes in it to accommodate the mounting bolts when they come through the bottom of the sill. Since the reel doesn't simply drop in, it has to be put in at an angle and swiveled; the chances of the plastic bag holes remaining lined up on the mounting bracket are somewhat slim!

My solution was to whip the heads off a couple of bolts and use the shanks as studs screwed into the bottom of the mounting bracket. These will hold the bag in place and give you some hope of lining up the mounting holes with the sill holes. Having got the studs through, careful holding of the reel while you unscrew the studs, one at a time and replace them with the correct bolts should see the most difficult part of the job completed satisfactorily.

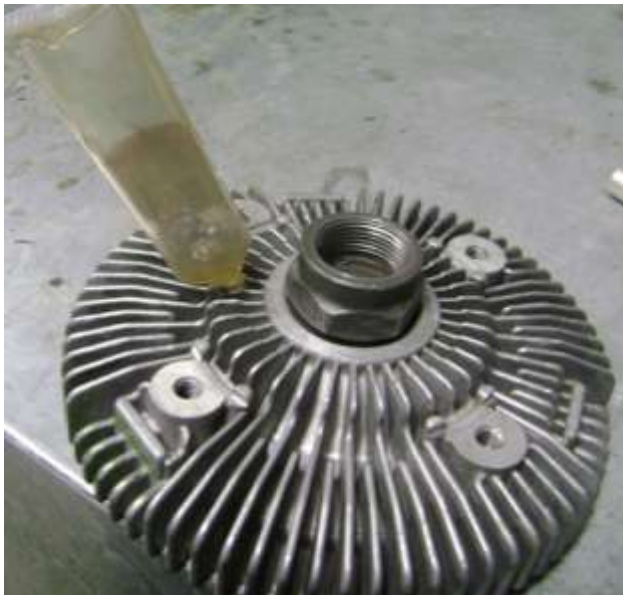
There have been various iterations used by the Factory. The early Shadows used a unit that apart from bolt mounting holes were identical to the ones used on the early Holdens. Whatever the unit used however they are very expensive to replace. It seems that there are only two scenarios of failure. First there is the failure of the internal bearings. This can be monitored by gently wobbling the fan blades forward and backwards. If there is any movement, replacement is indicated. The other fault is a lack of drive and you can see this very quickly when you switch off the engine. A good unit will stop the fan spinning in a few turns; a poor one will spin for quite a while. The problem is a lack of fluid in the coupling.

The fluid must leak very slowly but eventually there is not enough to provide drive. Richard Treacy put me onto the fact that Toyota, who has made more cars than there are grains of sand on the beach, has been fitting fluid couplings to their fans for yonks. When they lose their drive, you can unscrew a little plug and squirt in a tube (available as a Toyota spare) of silicon oil and order is restored.

Since we do not have the luxury of a little plug, Richard tried drilling a hole in the body, inserting the oil and sealing the hole. I had a spare coupling which had

good bearings and decided to give the idea a run. Problem was that nobody could tell me how much fluid this rather large unit held! I asked the Toyota spares man who advised filling it up. I stopped after three tubes and there was still room for more. Now the fan stops with the engine in less than a quarter of a turn and the fan noise is reminiscent of an AA380 on takeoff. So the next experiment is to put one tube full in the other unit and see how that performs!
