ANTI-ROLL BAR ANTICS

BUTCHERED TERMINAL BLOCKS

CHANGING THE BELTS ON A POST – 20,000 SERIES SPIRIT

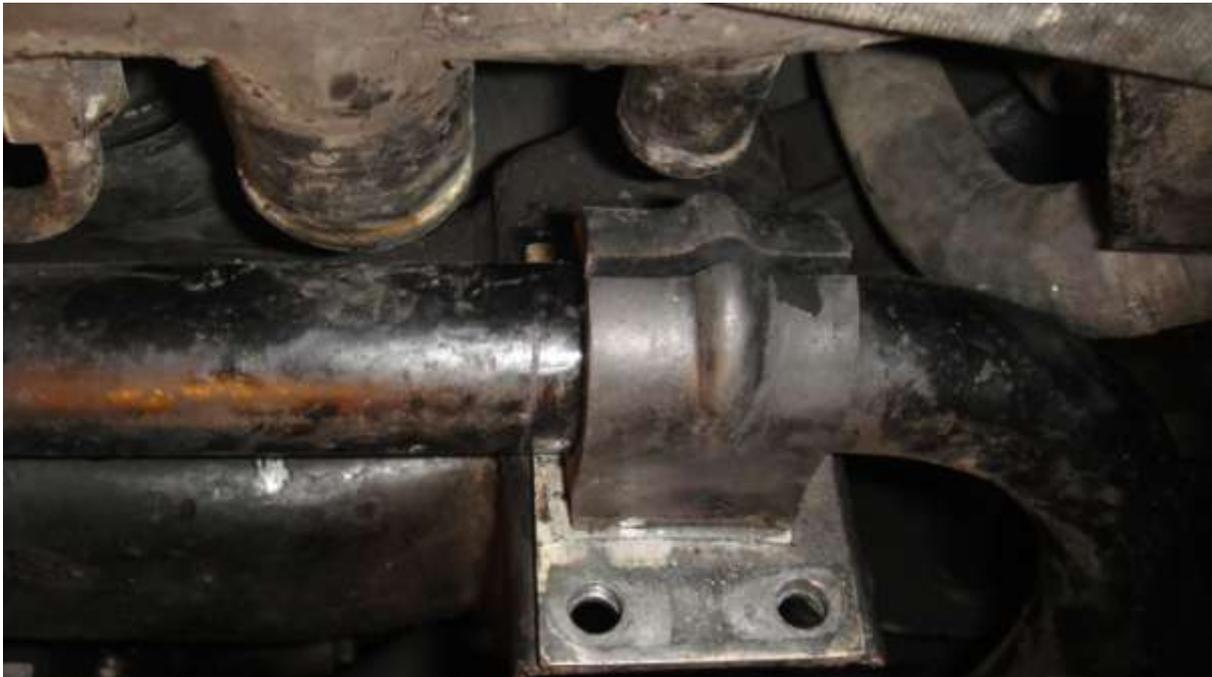
The owner then produced a Woolworths plastic bag of bits that had littered his driveway recently. A quick trip under the car and all was revealed. The bar seen above is mounted on the forward end of the car's subframe in two places, one of which can be seen above. What is missing is the retaining bracket that holds the bar. This is bolted to the subframe mount in four places; holes for the two lower bolts can be seen. The lower bolts are secured with washers and nuts. The two upper bolts, out of sight here, screw into threaded inserts in the mount. As Murphy would have it, one of these bolt hole threads was damaged and the other retained a significant piece of a bolt. These had to be drilled out and helicoils fitted to restore the threads. But as you can see the bottom of the radiator is in the road so that needs to come out. Actually this is probably not necessary as the unit is only held in place at the top with two accessible bolts and the thing can probably be lifted enough to get access to the damaged threads.

So the message is to all owners of Post55 cars, get down on your marrow bones and check these retaining bolts for tightness!

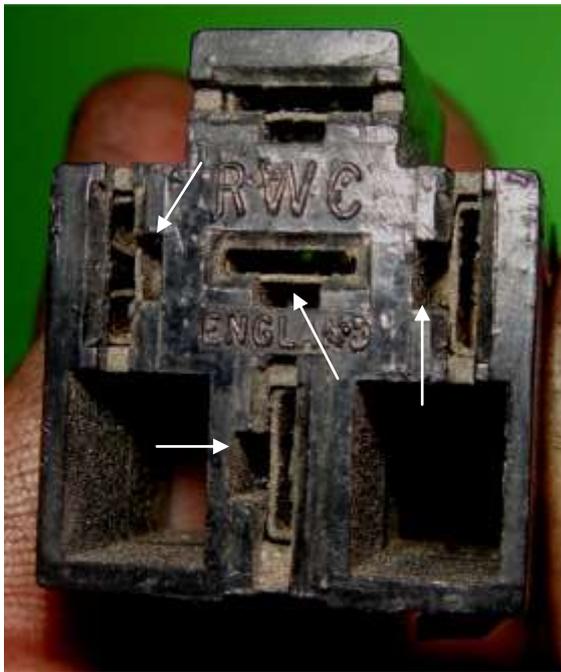
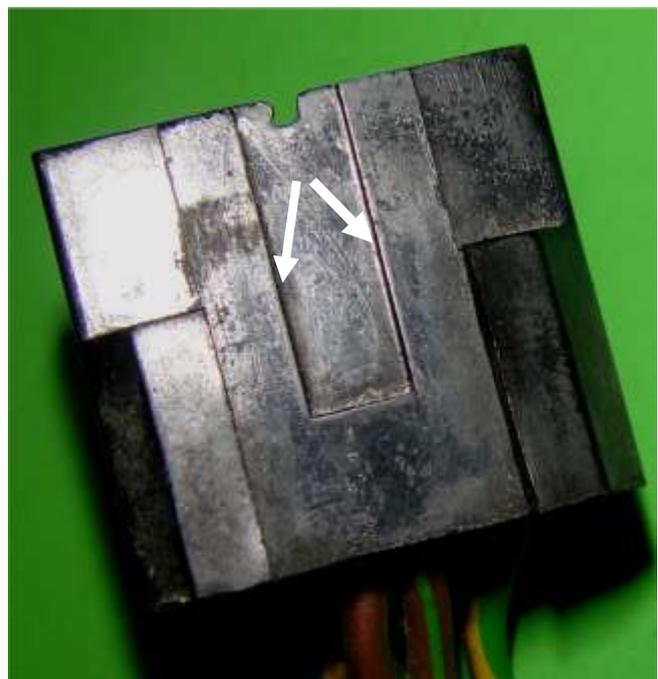
These fittings abound in all the post '80 cars to accommodate the myriad of relays that service the electrical system. They are neat, hard wearing, replaceable and easily fitted. Mr RWC England clearly shown here may have made these items especially for the Factory; I could not find them here. A friend suggested I contact our national parts of Crewe products and he supplied half a dozen by return post!

I had two casualties; the first, discovered when I bought the car, had detached itself from its locating tang after some Neanderthal had apparently wrenched the thing beyond its endurance while removing a relay! The bit that broke was one of the shoulders seen in the right hand picture and arrowed.

At left can be seen the tips of the various terminals that engage the prongs of the relays. These need to be removed from the used block by carefully sliding a thin but strong blade down the small release holes (arrowed) to depress a retaining tang and the terminal can then be pulled out through the bottom of the block. The 'new' blocks you get are good to practice on and can be cleaned up and all is as good as new. You will of course note exactly

which wire goes in which hole in the block. To fit them simply slide them in from the bottom until they click.

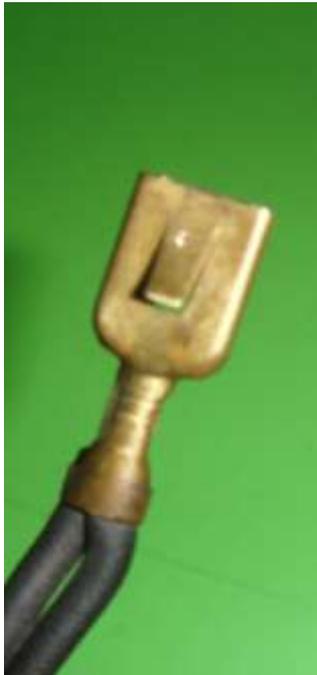
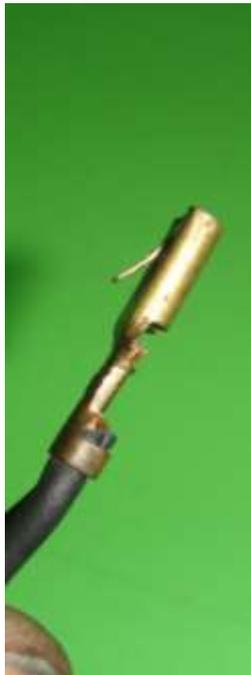
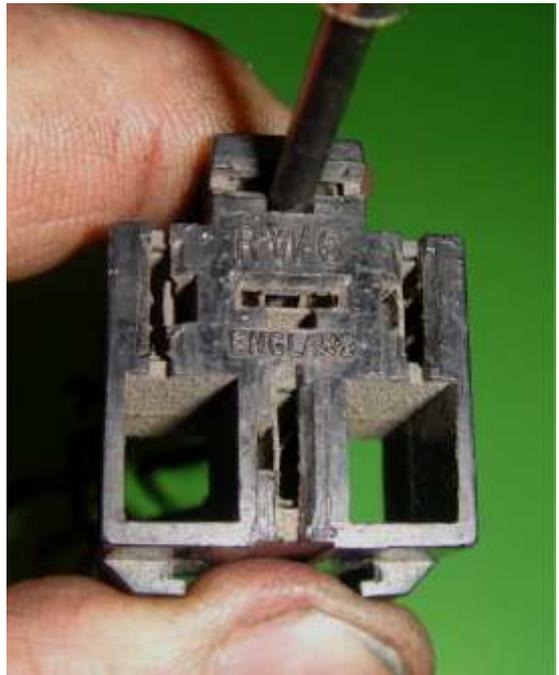
Removing the terminals and showing the tang that needs to be depressed before the terminal can be slid out of the block. The tool for depressing the prong I found most effective was a small electrical screwdriver. The right hand picture also shows the shoulders of the retaining groove that can be easily broken off by ham-fisted operators!

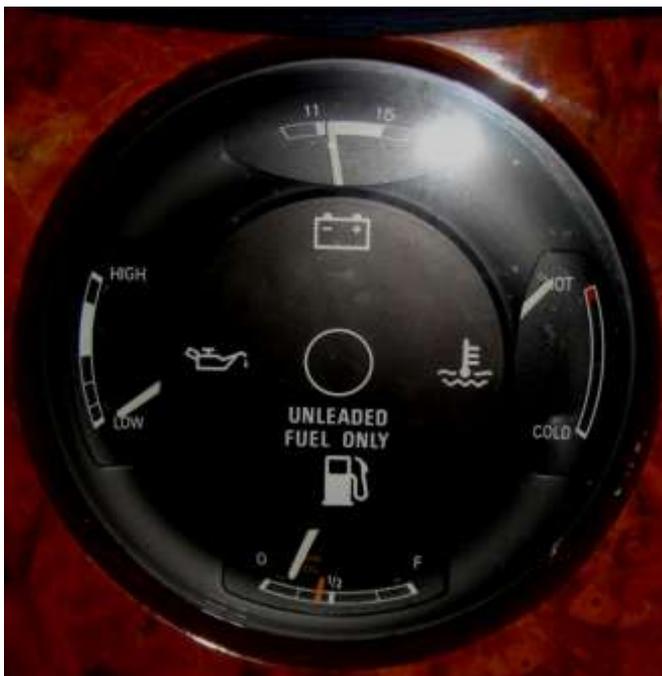
And I refer to the reading on the temperature gauge. Fortunately I have never seen this on the road although it does happen.

But in this case the gauge was being tested to isolate a common problem with these gauges, low readings!

To test the gauge simply pull the wire off the sender and earth it to the engine with

the ignition on and you will get a reading seen in the first picture.

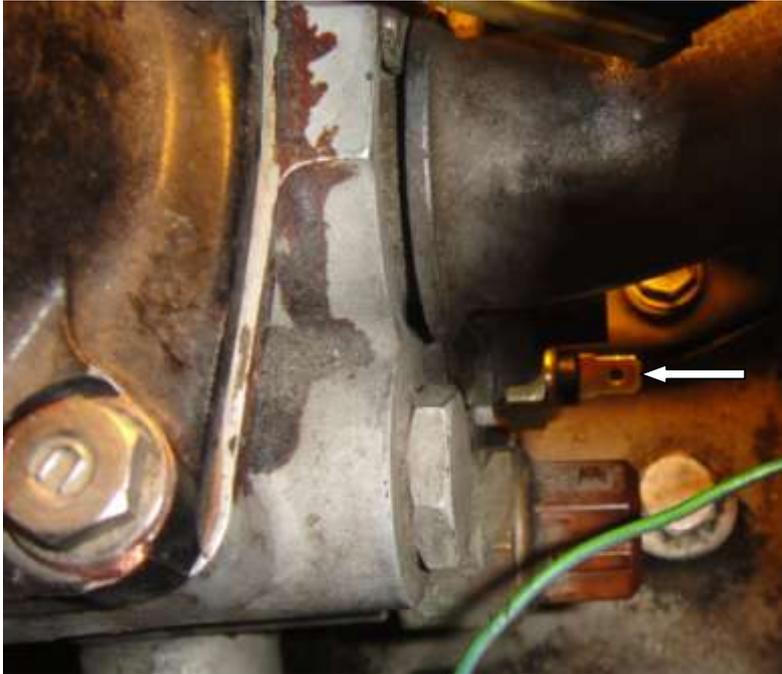
And here is the cause of low readings. The sender (arrowed) is simply a switch that varies in resistance indirectly as the temperature rises. Attached to it by a simple push-on connection is an active wire to the gauge. When the engine is very hot the resistance is low and power from this wire flows through the gauge and the switch to earth and the gauge reads high.

So where is the sender? In the picture above you are looking over the top of the radiator to the top of the engine and at left is the thermostat housing. The sender is one of a number that variously switch on heaters, fans and compressors to name a few. The same setup is used on the Shadow II's. To replace the sender, lower the coolant level by about four litres and using a long socket, screw it out and refit a new one with good old plumbers' tape! Put the coolant back in, connect up the wire, check for leaks and look for a temperature gauge that points due East!!

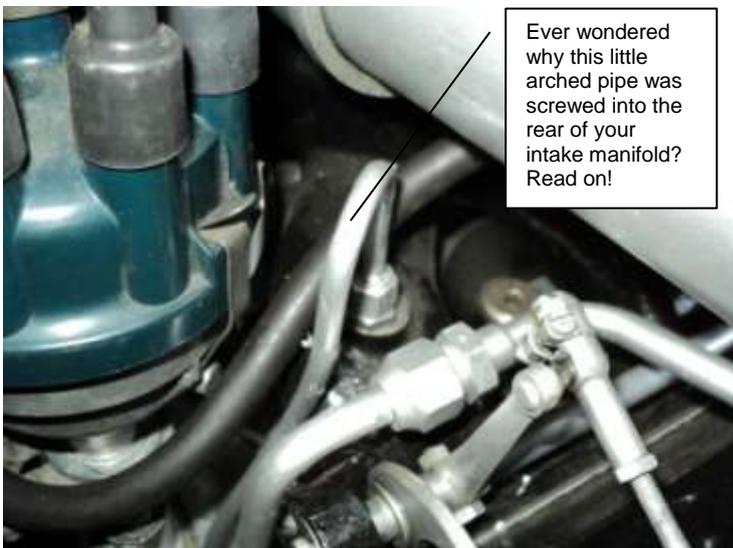
Ever wondered why this little arched pipe was screwed into the rear of your intake manifold? Read on!

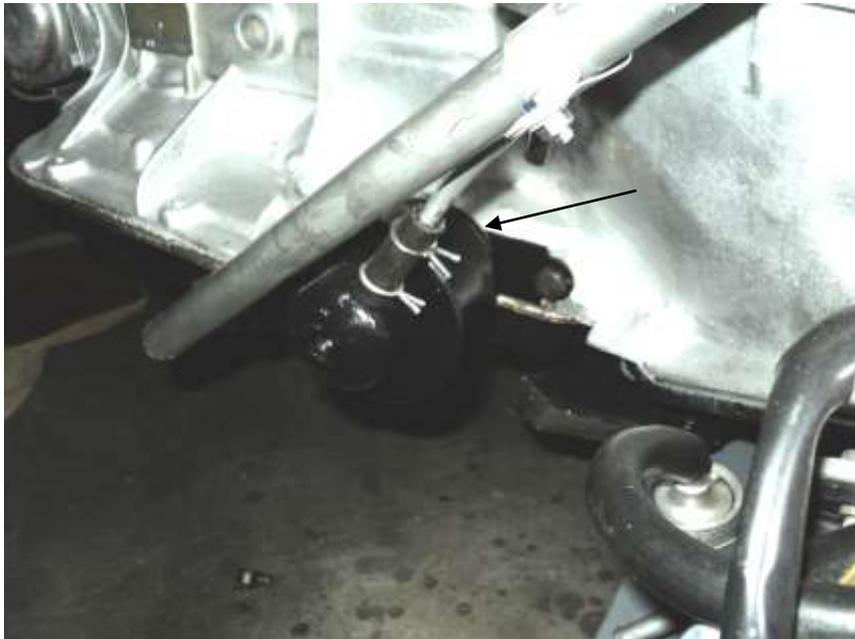
And here is the modulator at the other end of the pipe from the manifold. The large pipe is the filler and dipstick holder for the transmission. Note the rubber tube connection.

So here is the point of all these words, the connection between the pipe and modulator is rubber which perishes with all the grot around it. Simply whipping off the bit of tubing and replacing it could give you an interesting driving experience. Inside that piece of tube you threw away is a metal restrictor which has to be transferred to the new bit of tube.

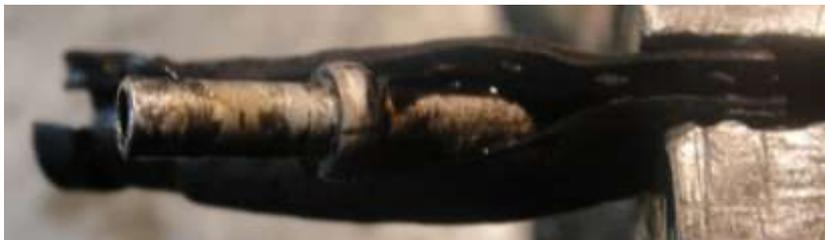
The restrictor being prised surgically out of the old bit of tubing.

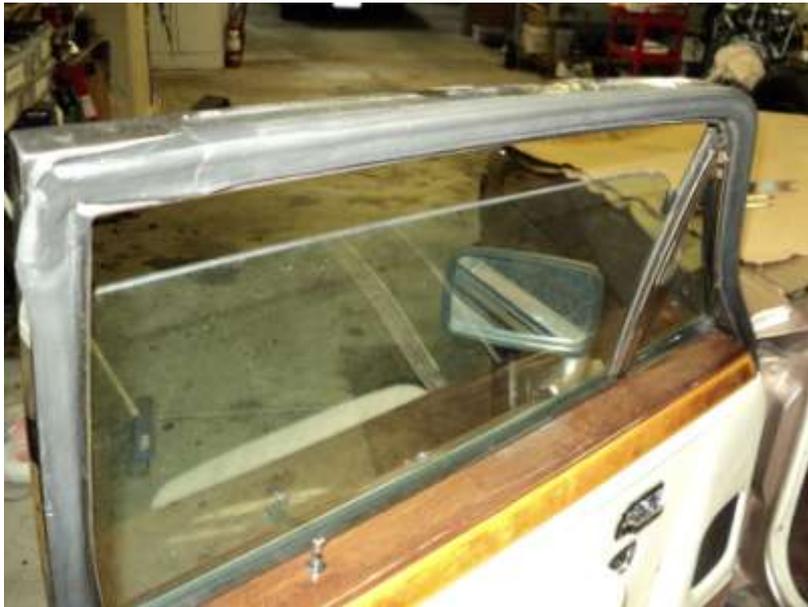
The Spirit was the first of our models to use curved glass – then a bit of a challenge to the designers. One legend was that partially open glasses on the earliest cars were apt to jump the guides and wave about in the slipstream at high speeds. One of the fixes was that little black plastic bit fixed to the leading edge retainer!

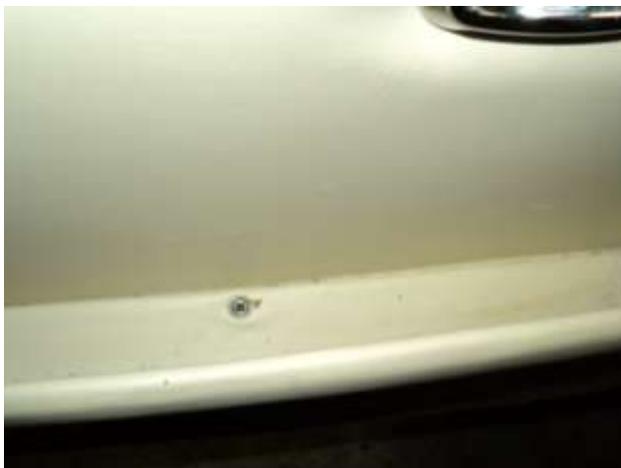
Step one to remove your hijackers arm is to remove the inner door trim. Always approach this with great care since it is very easy to mar some of the materials, a blemish you will see every time you look at the car. The workshop manual in our Technical Library <http://rrtechnical.info/> gives precise instructions. The little screw at left, one of two, holds the junk basket fitting to the door. These must be removed. The main panel is held with conventional push in clips which can be released by inserting a wide blunt knife behind the panel and up against each clip which you can feel and then prising the clip free by twisting the knife.

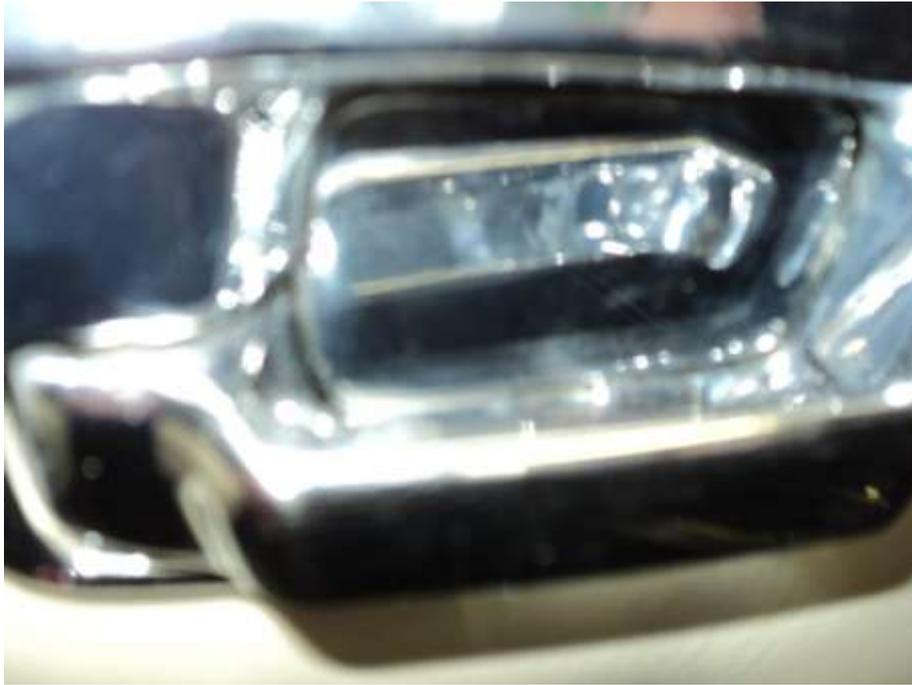
The night was getting late when I tried to take a pic of the iconic door handle. This assembly and the switch/es below it are screwed very firmly to the inner door panel. To conceal the screws an anodized insert is jammed into locating holes and there you have the pretty fixture. Step one is to remove the insert carefully as it is easily scratched. Cadge a dental probe from your friendly dentist, one with a strong thin hook at the end (the probe, not the dentist) and ease it out carefully.

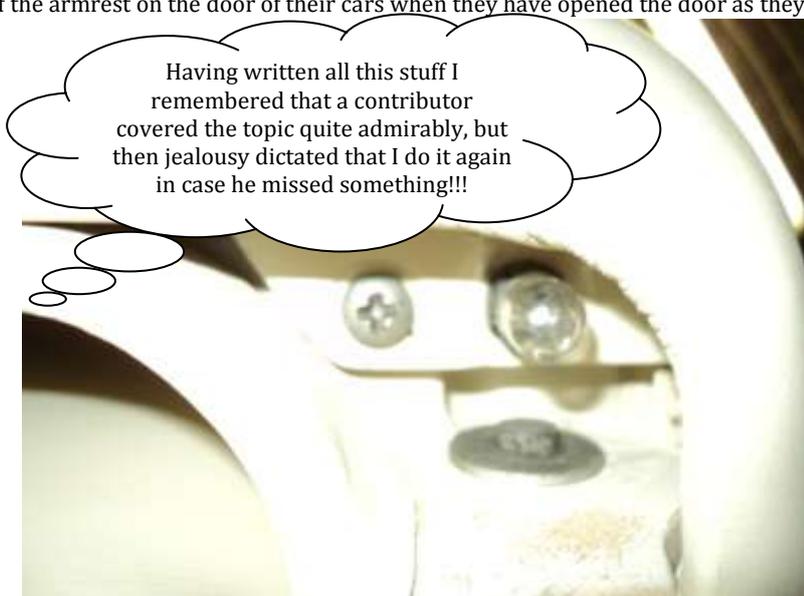
Some owners have seen this view of the armrest on the door of their cars when they have opened the door as they step down for their sobriety test and land on their back, wondering why the car was gently rocking! The star-headed screw (one at each end) secures the lower half of the arm rest to the upper bit. Having removed the screws be careful in parting the leather coverings on each bit, from each other. The leather particularly in later cars seems to be amazingly thin, probably something to do with mad cow disease. The hexagon-headed screw and washer, again two off, retains the armrest itself to the door. You could also note the tiny globe that lights up on door opening.

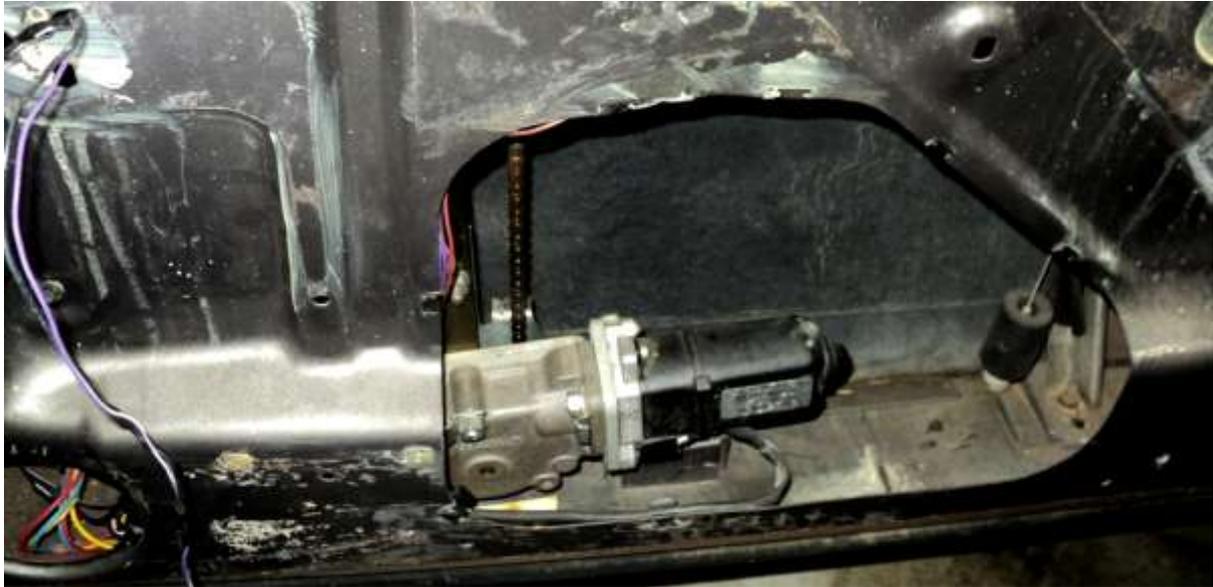
Well the door lining is off and there is the motor which is held onto the winding gearbox by just two studs and nuts. At lower left the broken coupler is emerging from the gearbox with the aid of your dentist's probe. Below that is a better view of the motor shaft adapter with a cross pin that engages the coupler and if you climb inside the door you can see a similar adapter on the input shaft of the gearbox.

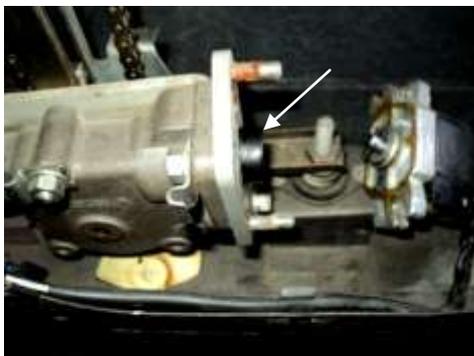
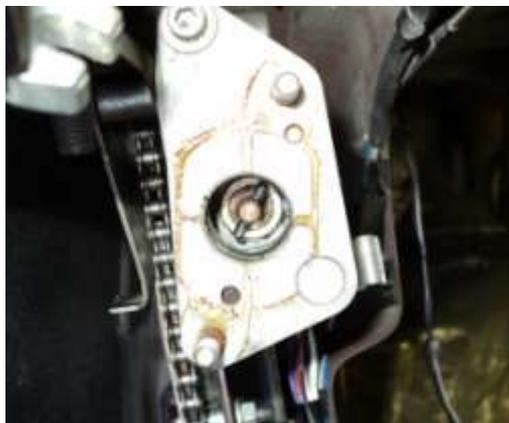
Probably the most difficult task is to extract the extract the broken bits of coupler, again an easier job with your probe!

Finally there is the release of your hijacker's arm. Never ever force a window down, something will break. That is what you should have told your captive. He will now be pleased to see the adapter made from a cheap socket, which can be used to patiently wind the window glass down, release him to the local constabulary then wind the glass home again.

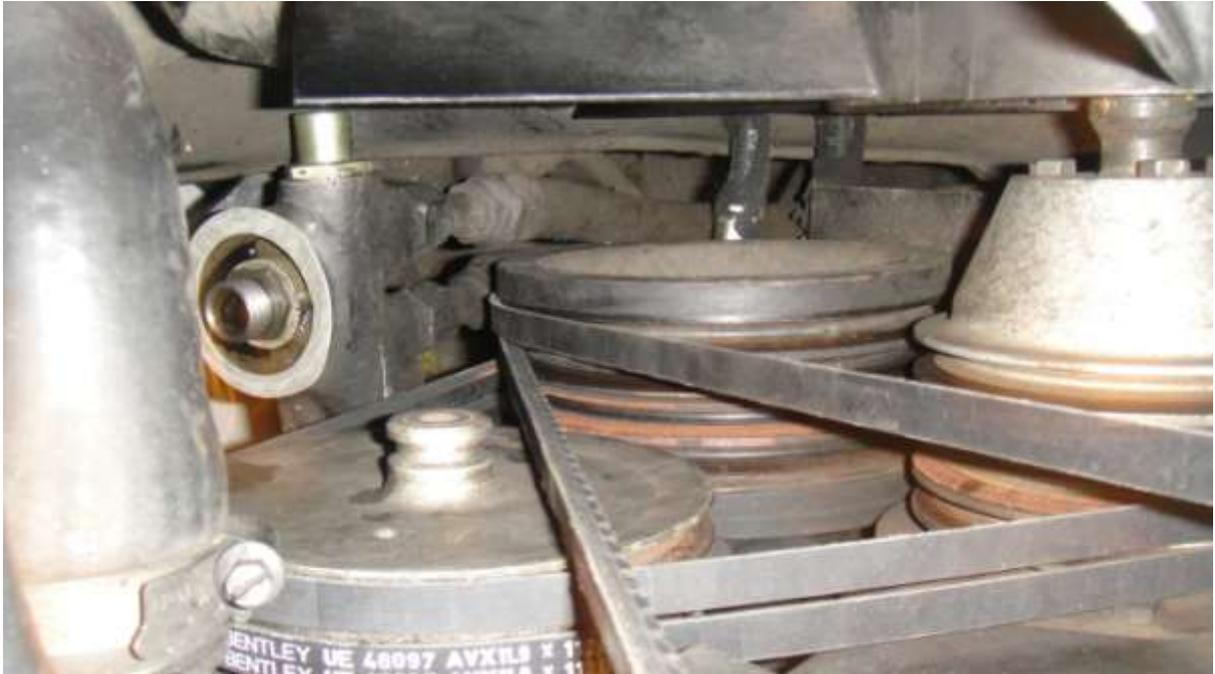
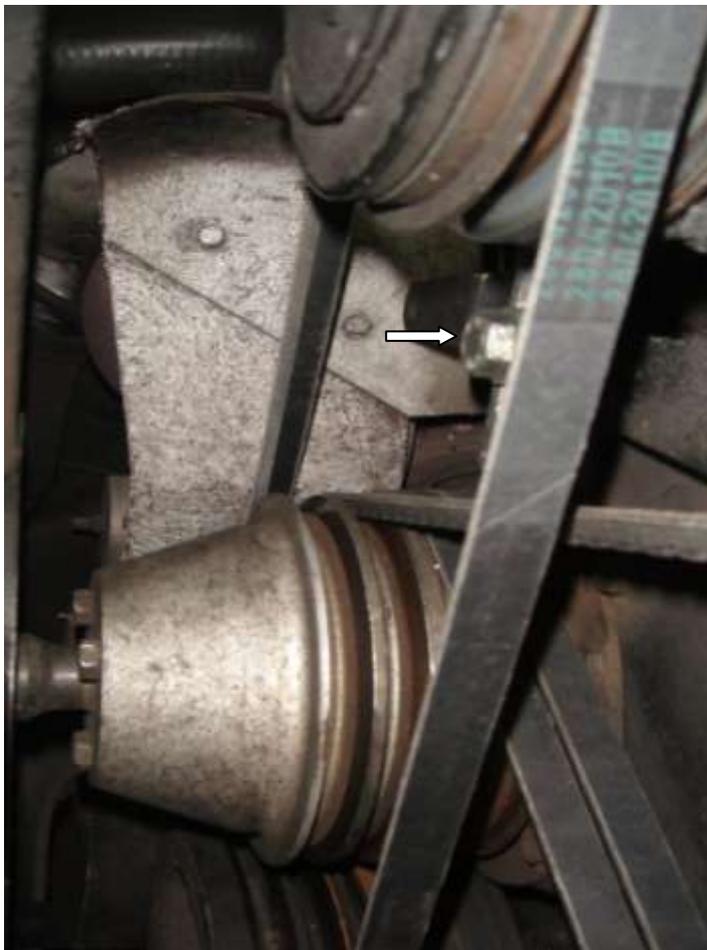
that they enjoy a sump oil cooler which is located behind the main radiator core. This has meant mounting the oil filter on an outrigger and piping the oil to it via massive flexible pressure pipes. In addition there are two pipes to the transmission cooler. All these can be seen in the picture above.

The alternator and power steering pump are mounted on frames which share a common pivot point. The bolt which anchors them can be seen here under the compressor. The shroud at the left rear is covering the turbocharger.

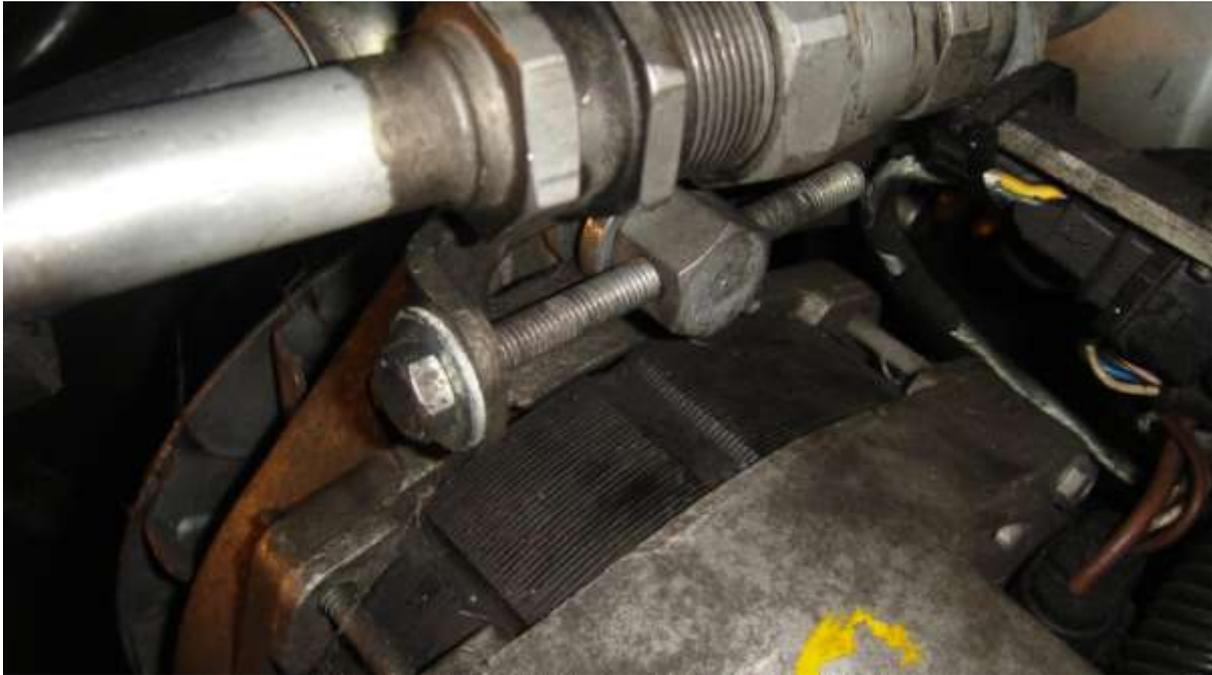
This is one of the tensioning bolts, in this case for the alternator. The bolts need a 7/16" AF spanner and a ratchet ring can be very useful. The special bolt head through which the tensioning bolt is threaded has a threaded shank and nut at the other end to finally lock the adjustment in position. Having threaded the belts the relevant unit can be tensioned manually with a suitable lever. Holding the unit in place with the lever the tensioning bolt can be screwed up with your fingers and the final adjustment made with a spanner. Be sure to use anti-seize grease on all the threads.

Step one is to remove the oil filter carefully preferably after the engine is cold. The belting differs, apart from their routing, from earlier cars in that they have tensioning devices. These consist of a single screw with an anchor point. Some are not particularly accessible so remove the screws clean the threads thoroughly and check that they screw into their fixture with finger pressure. This will allow you to run them up easily before you have to resort to the tedium of spannering in a confined space.

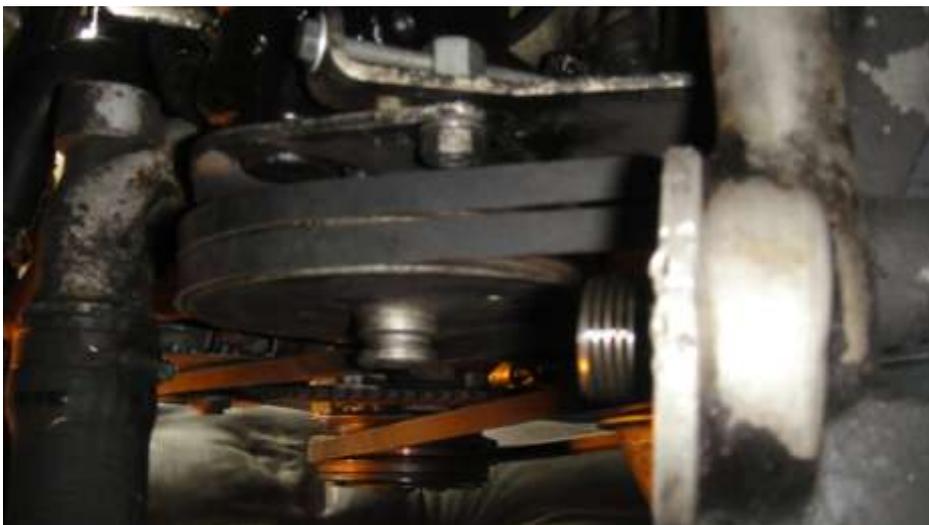
And here is the tensioner for the power steering pump, accessed from below.

Note that the compressor belt is sitting in the wrong pulley groove – it goes in the rear one. The front groove is for the air pump if fitted.

Getting the belts into the correct grooves and keeping them there was the hardest part of the job.

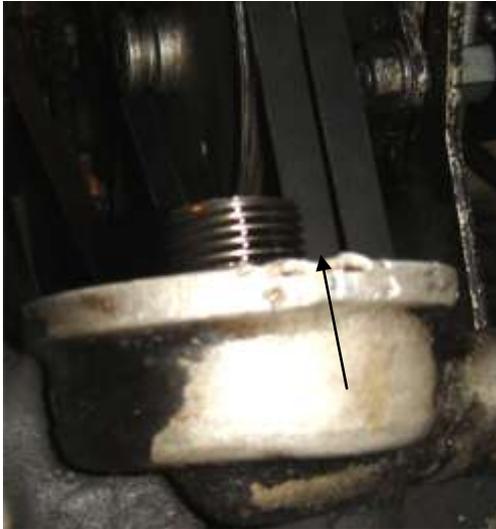
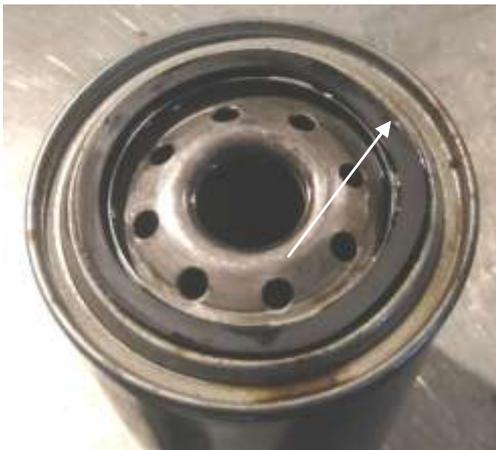
At left is the mounting face of the engine oil filter on a low mileage Turbo Bentley. Some very lazy person who either did not have a filter wrench or couldn't be bothered getting one apparently used a cold chisel! This explained the little dribble of oil at the front and possibly the higher oil consumption.

Below left, the rubber seal has been torn.

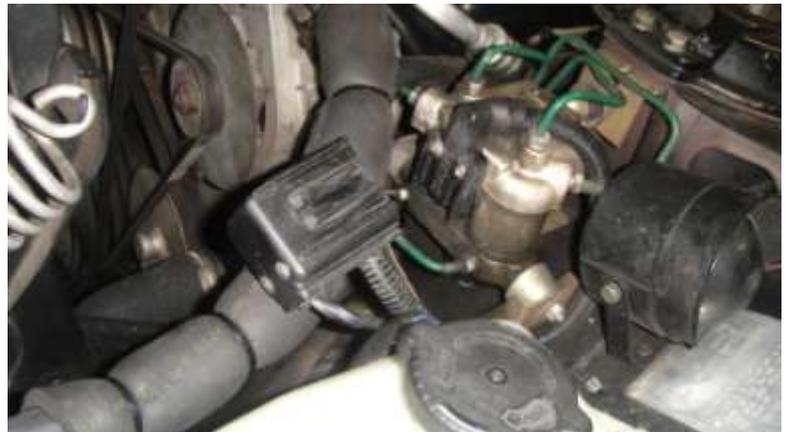
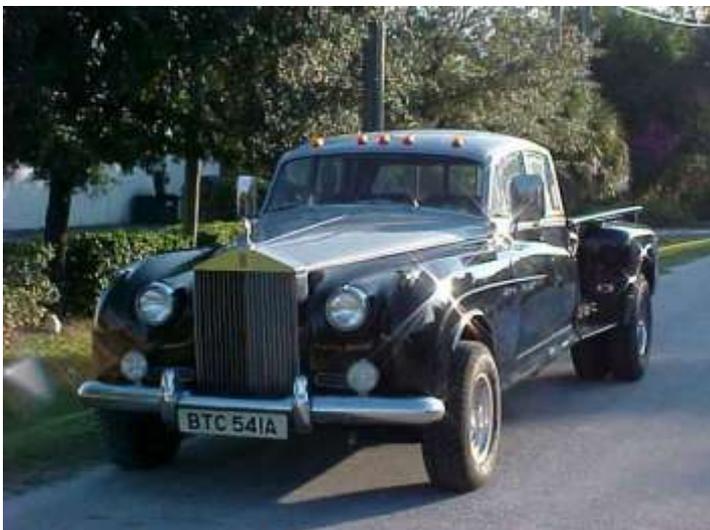
The above is the gubbins for the ABS system (antilock brake system). The small grooved box lying on the insulated air conditioning pipe should be held to the rest of the assembly but it seems that being continually smacked by the pipe

was too much for the grooved moulding and it broke. It can be remounted with a cable tie pending some sort of more effective repair. The obvious prophylaxis is to have the aircon pipe remade a little shorter. Caution here as these cars have a history of breaking the rigid pipes where they are joined if any un-natural strain is placed on them.

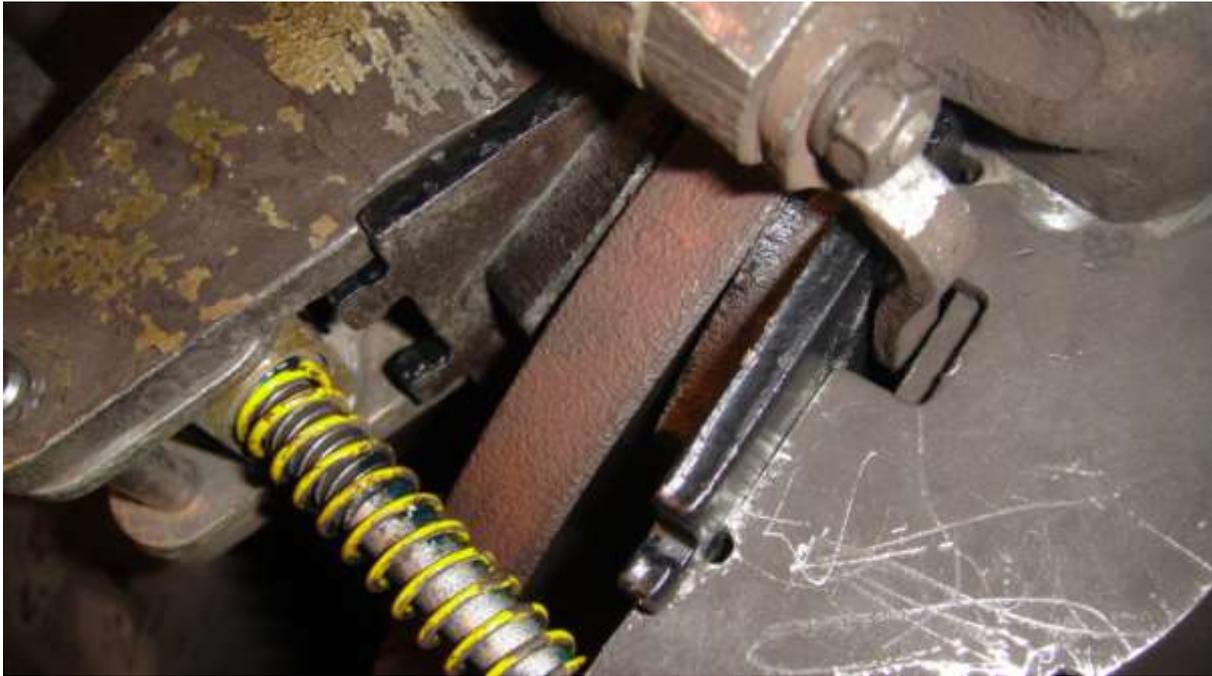
This is a worm's eye view of one of the rear brake rotors with the parking brake caliper. The small pads that clip into the 'jaws' are handed – a fact not often noted by the unfamiliar installer. Note that the curvature of the friction material matches the curvature of the rotor. If they don't they have been incorrectly installed!

The 'jaws' float on their pivot pins and align themselves with the rotor surfaces. The orange coloured spring simply stops rattles and keeps the pads apart. It is important however that the 'jaws' float freely. If as can happen their pivots dry and rust, one jaw can jam against the rotor and burn out the friction material on the brake pad.

To do the job properly undo the adjusting nut completely and also the small bolt and washer holding the retaining fingers and swing the jaws out. Liberal squirting with brake cleaner to clean off the brake dust and road muck follows. The pivots can then be liberally dosed with WD40 and the whole lot reassembled and adjusted.
