CREWED JOTTINGS

Issue 25

JULY 2009 REPORT

1951 SILVER WRAITH H.J. MULLINER TOURING LIMOUSINE (CHASSIS NO. WLE21)

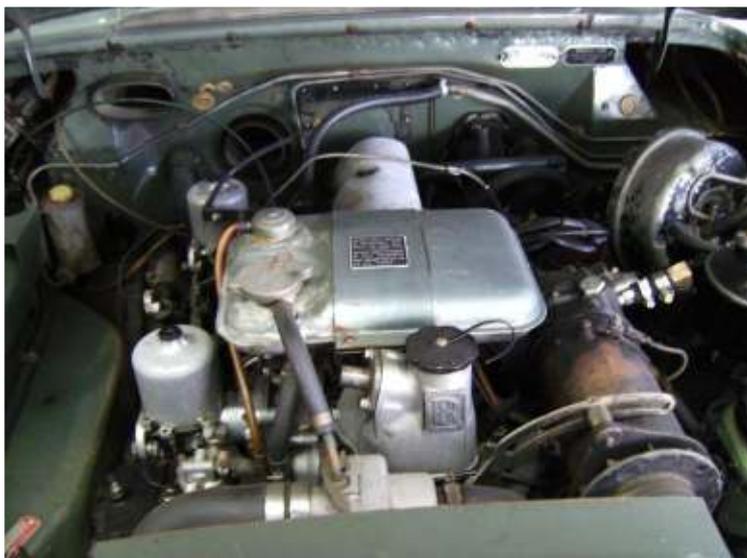
A view of the 4 litre Rolls-Royce B60 engine ordered from the company to power the Vanden Plas sedans.

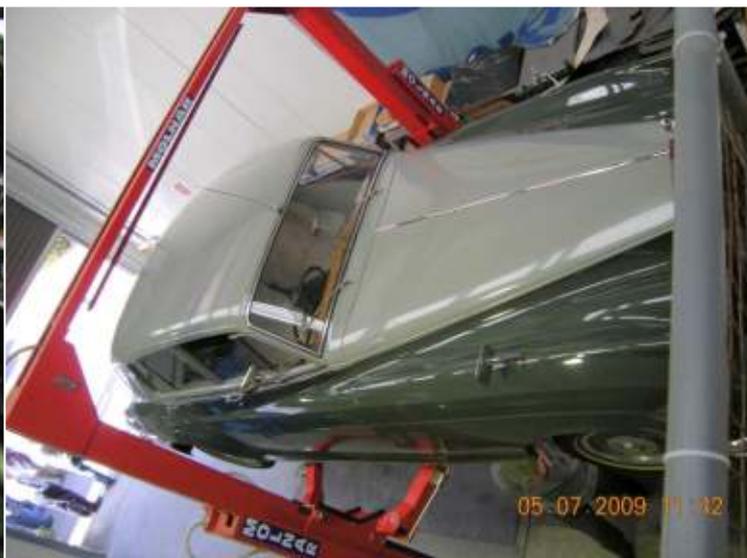
John's Silver Cloud is lifted skyward for a service

John's Silver Cloud was the first car to use the hoist and he took the opportunity to change the oil and filter cartridge, but he also detected a minor coolant leakage which was traced to the drain tap on the side of the engine block. There is a fair amount of corrosion around the tap and the general plumbing around it has also reached its use by date. The leak itself was easily fixed; the tap wasn't fully closed but John will take the car to a radiator and coolant repair shop and replace all the corroded pipes and get the taps attended to (I believe this was done before I got this in print).

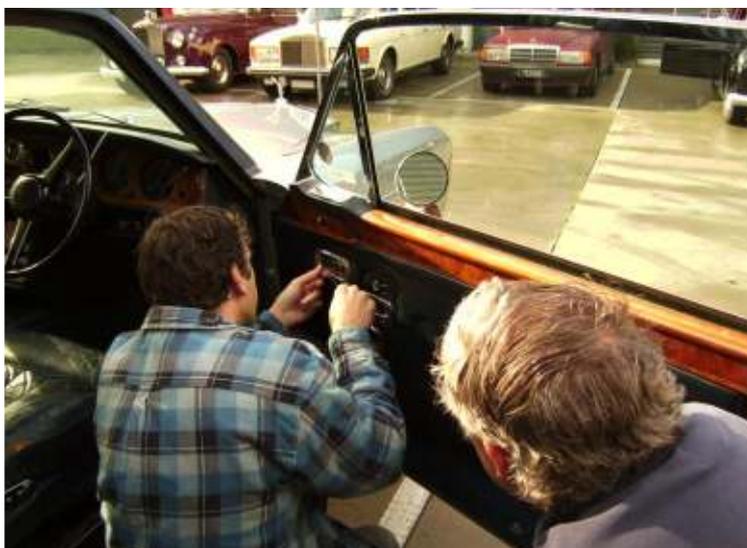
Mark keeps himself busy (as usual) tending to some electrical problems on Ken's driver's door.

The problem was soon identified but unfortunately it was something that couldn't be fixed on the day as the solenoid was cooked. Repairs to the solenoid is not beyond a capable sparky, so Ken will leave the door trim off and get it repaired locally. Ken is now confident that he can reassemble the door trim himself (now he knows where all the screws, nuts and bolts are) and he can service other areas within the door cavity while it's removed.

The problem seems to have arisen from the fact that the cable to the rear view mirror was seizing, due to a lack of lubrication and the overload became too much for the solenoid to overcome. The cable, while not entirely seized was incredibly hard to move. Fortunately, it's not beyond repair and so a good clean and lube should fix it.

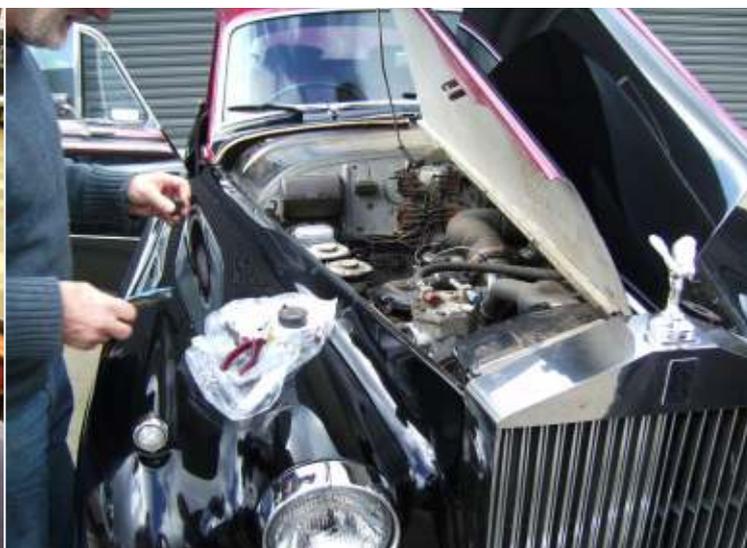
PJH also does some electrical tinkering on his Silver Cloud II

The work agenda started with some investigative work on PJH's Silver Cloud II headlamps, it seemed that he was getting an all or nothing option in regards to his parking lamps and headlamps when he turned on the light switch; turn on the parking lamps and the headlamps also came on. A test using a circuit tester didn't seem to trace the issue with the wiring and as all the earthing points were clean, it was assumed that the problem lies in the switchbox itself – probably something ridiculously simple, but as our electrical whiz kid was attending to another matter elsewhere, PJH will get him to attend to it later.

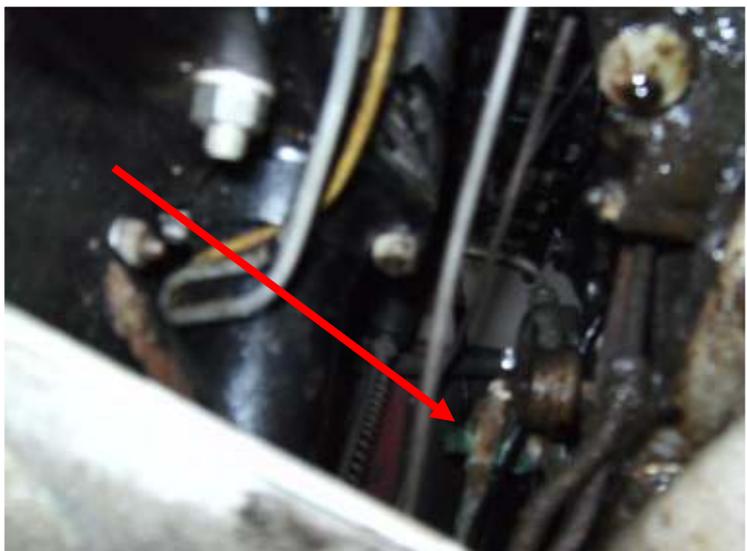
Unfortunately the photo is a little blurred but the 'green monster' of corrosion is easily seen on the Silver Cloud's drain tap.

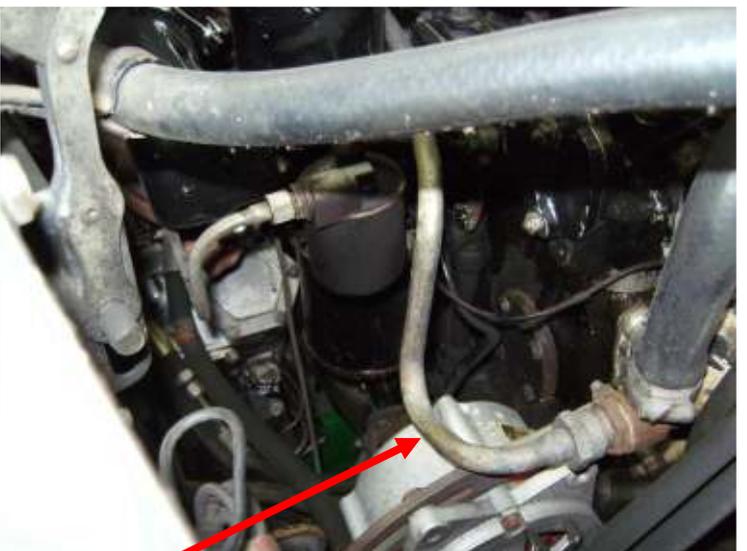
The dark patch on the pipe is an area that is getting very thin and in need of replacement. I understand that this has now been done.

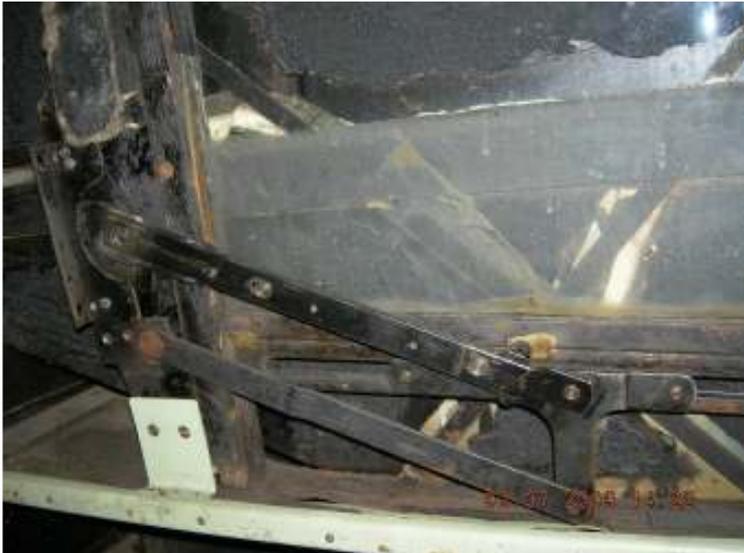
The next day young Scott was tucking the vehicle away for the evening and thought it would be a great idea to wind up the driver side front window. As you are aware the driver's door window is a quick operation mechanism which is controlled by a lever that you push or pull rather than a crank handle. The result was that the handle had become separated from the door and Scott was left standing there with the handle, and part of mechanism still attached, in his hand.

Window fallen to the bottom

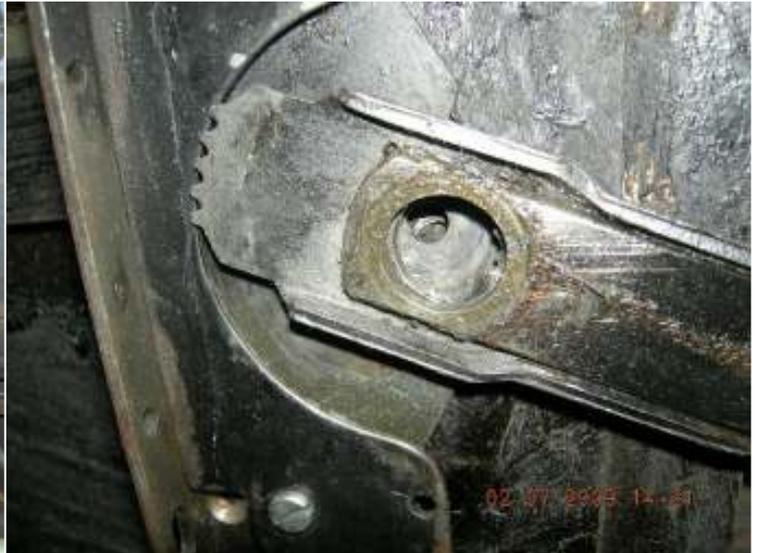
We removed all the fittings, interior trim and inner door skin from the door to expose a very badly worn, and now broken, window regulator.

Worn regulator with missing cam

Back to the broken window: After the examination was complete young Scott removed the mechanism and it was taken down to Roy's workshop for dismantling and measuring. Once dismantled he gave me the badly worn release arm for welding, filing and hardening. In the meantime Roy very carefully measured all the guide pins and the actuator cam. He then went about the slow task of fabricating replacement parts. I might add, this was done to an absolutely amazing standard. He even duplicated the rather odd thread that accommodated the handle retaining screw, in the cam.

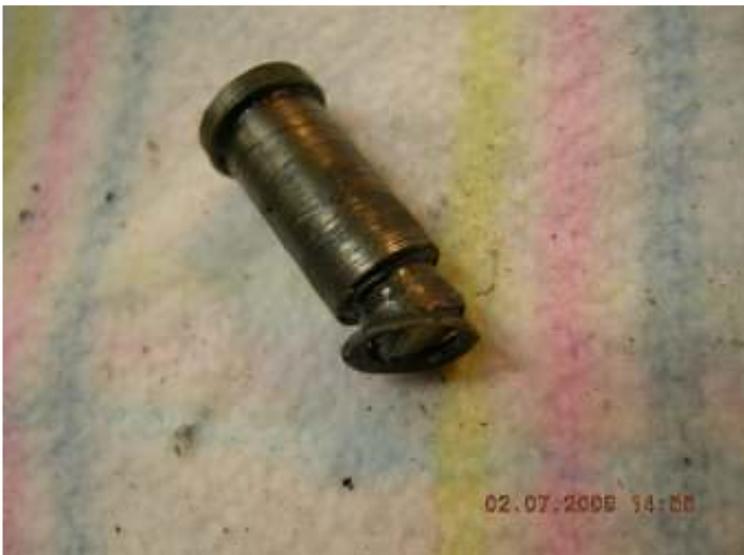
Worn & broken cam retaining pin

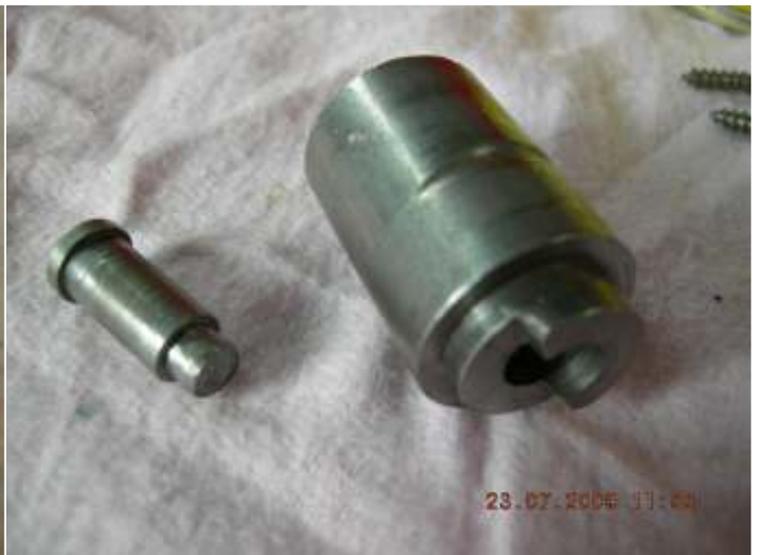
Worn cam & pin ready for the bin

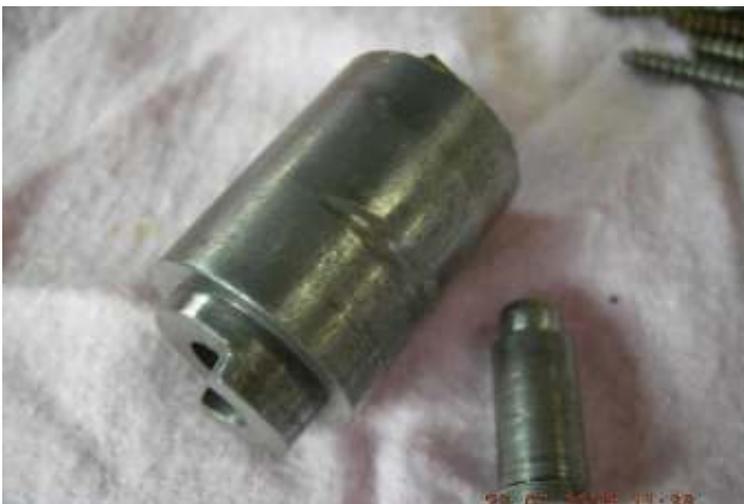
Worn CAM with broken pin

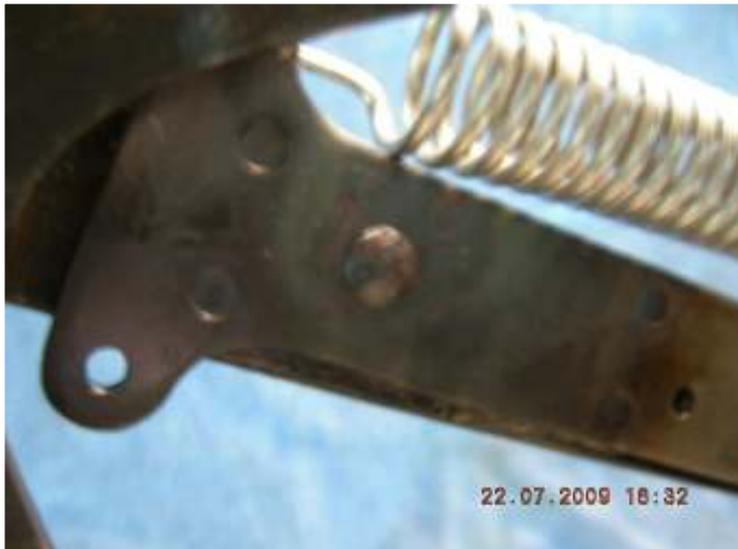
Hot riveted into place

Now that we were satisfied, the two arms were put together and the new guide pins pressed into place. Once this was done the regulator was then turned over and hot riveted for added security. We now installed the new CAM and pressed in its new retaining/pivot pin and also hot riveted it into position. The regulator assembly is now firmly clamped in the vice and the springs are fitted. The next big step is now testing the regulator operation prior to fitting to the vehicle, and it was just perfect, no free play anywhere. An application of rust preventive paint in the appropriate places and we're ready to install.

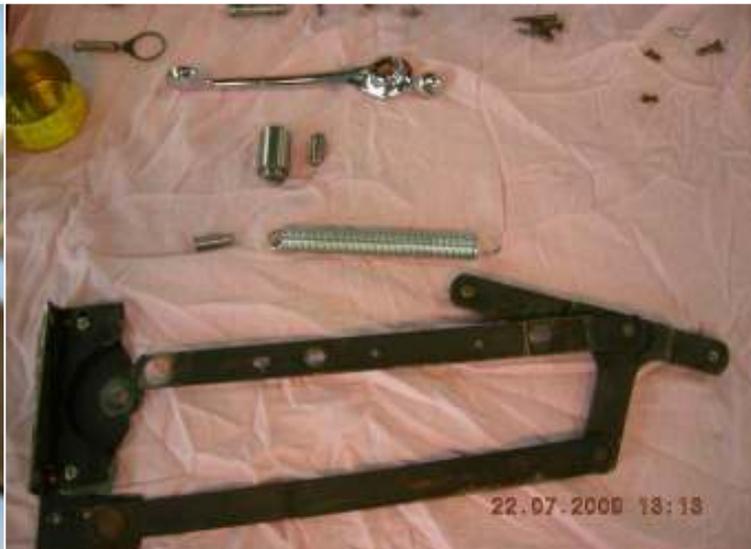
Other parts cleaned & ready for assembly

Once all the machine work was completed and the release arm was repaired, it was then time for assembly. Firstly there was a trial assembly just to make sure that all the tolerances were correct and that the teeth on the release arm was going clear the teeth on the body of the regulator.

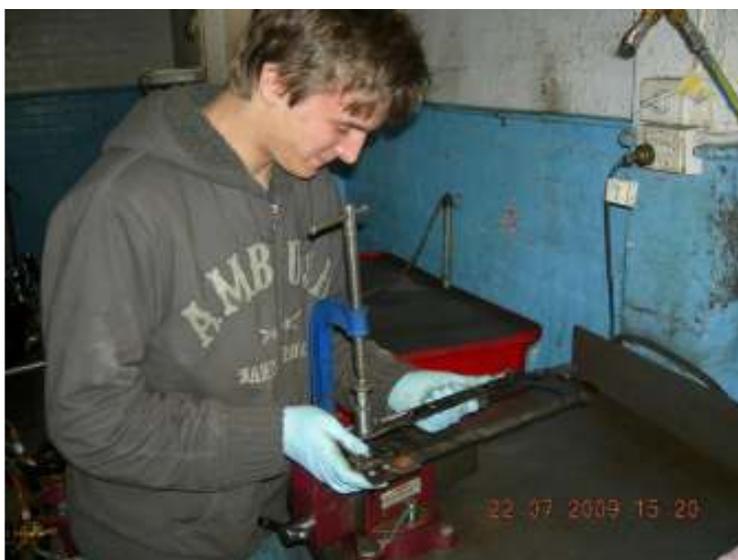
Scott Assembling Regulator for Testing

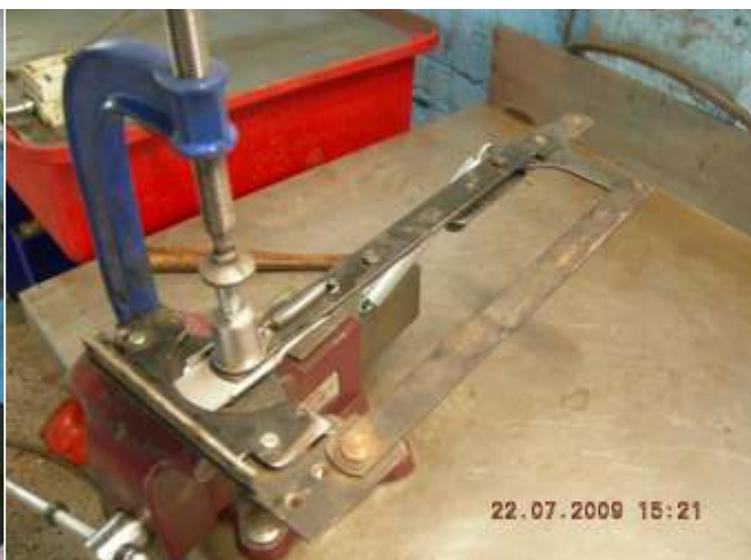
Ready for first test

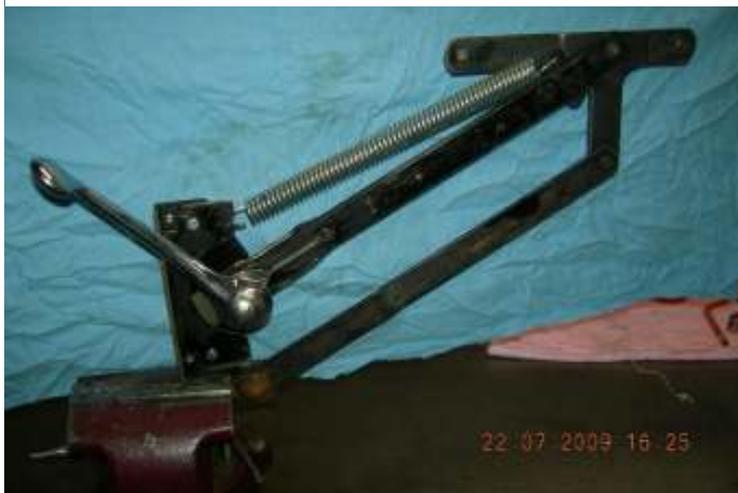
Job done
