CREWE'D JOTTINGS

Issue 9

OCTOBER 9th. -2006 REPORT

Keeping Things Cool

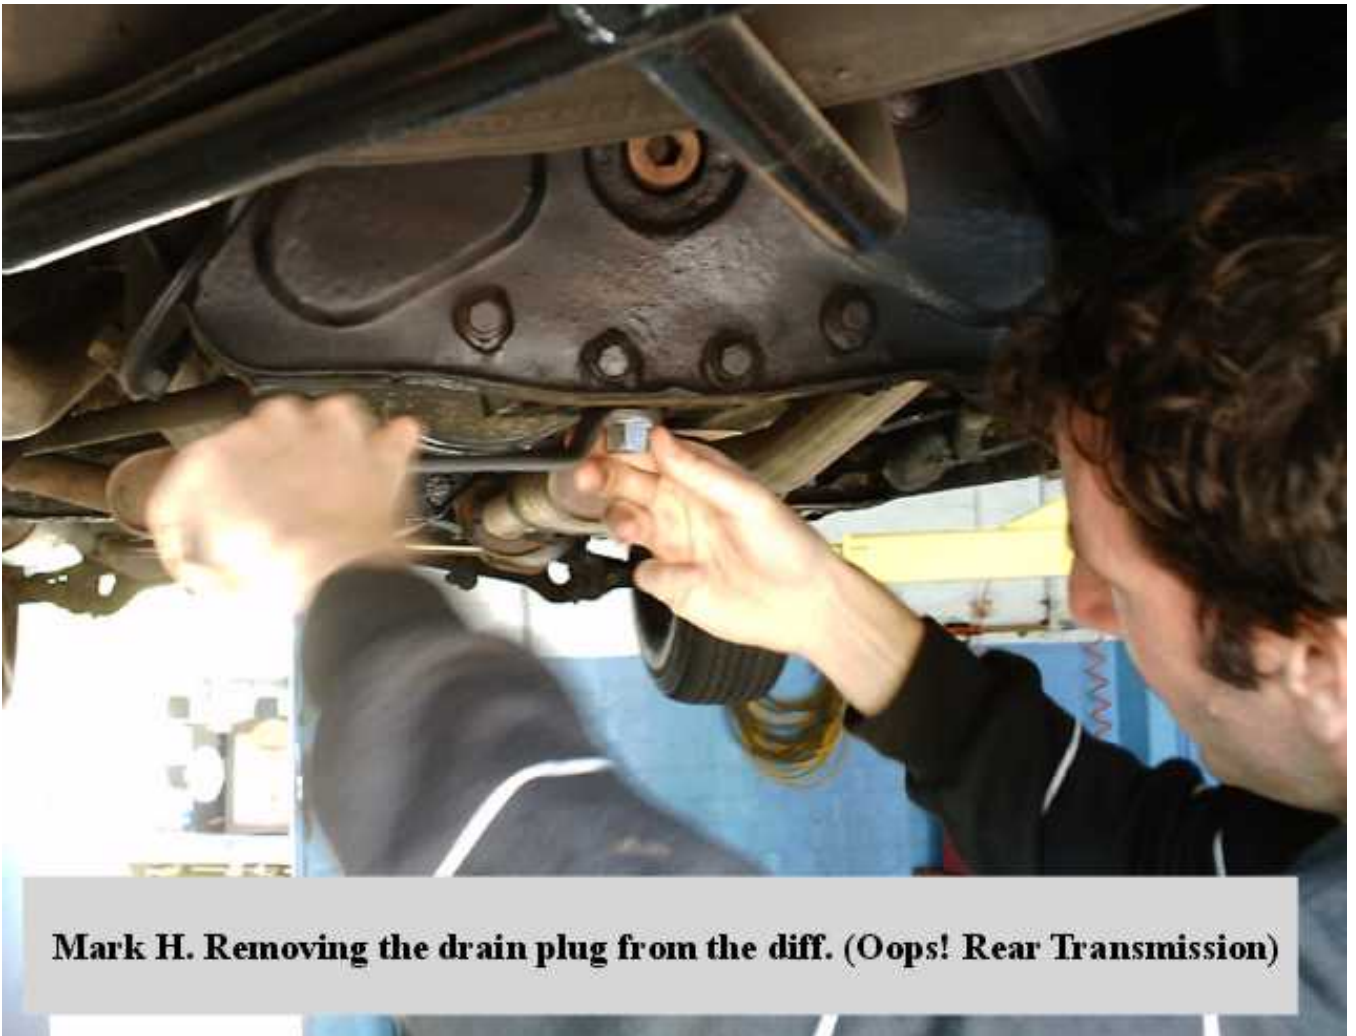
Mark H. Removing the drain plug from the diff. (Oops! Rear Transmission)

It was time to change the oil in the differential (Or as Crewe would have described it, the Final Drive). We were going to check the breather but we found this extremely difficult to get to and we will await the presence of Nick Lang at a future event before we fiddle about with it.

The rest was a simple and uneventful exercise and we were delighted to see sparkling clean oil with no frothing (always a bad sign) and no bits of metal.

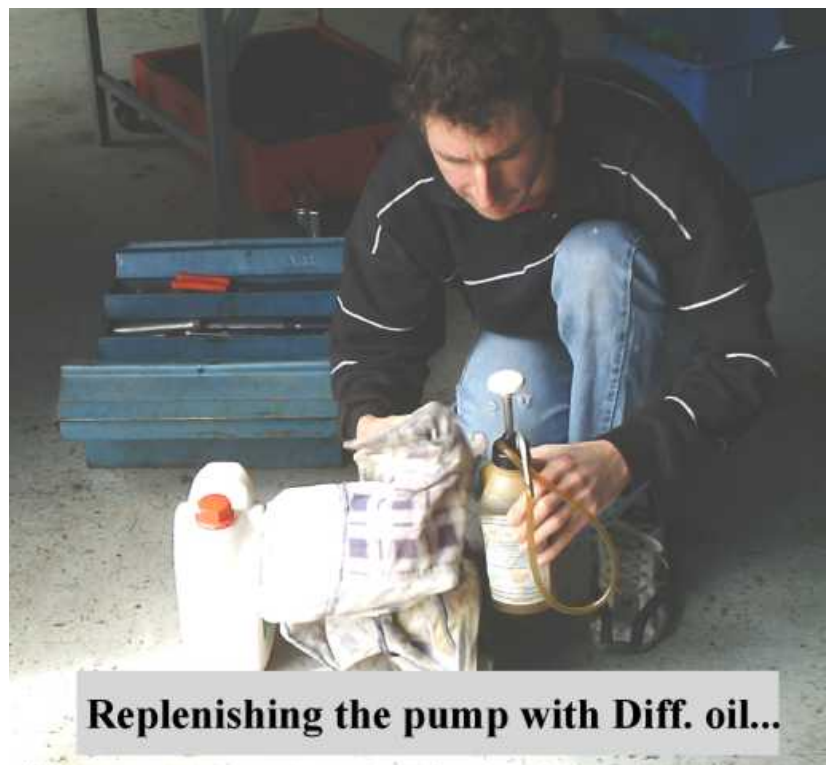
Replenishing the pump with Diff. oil...

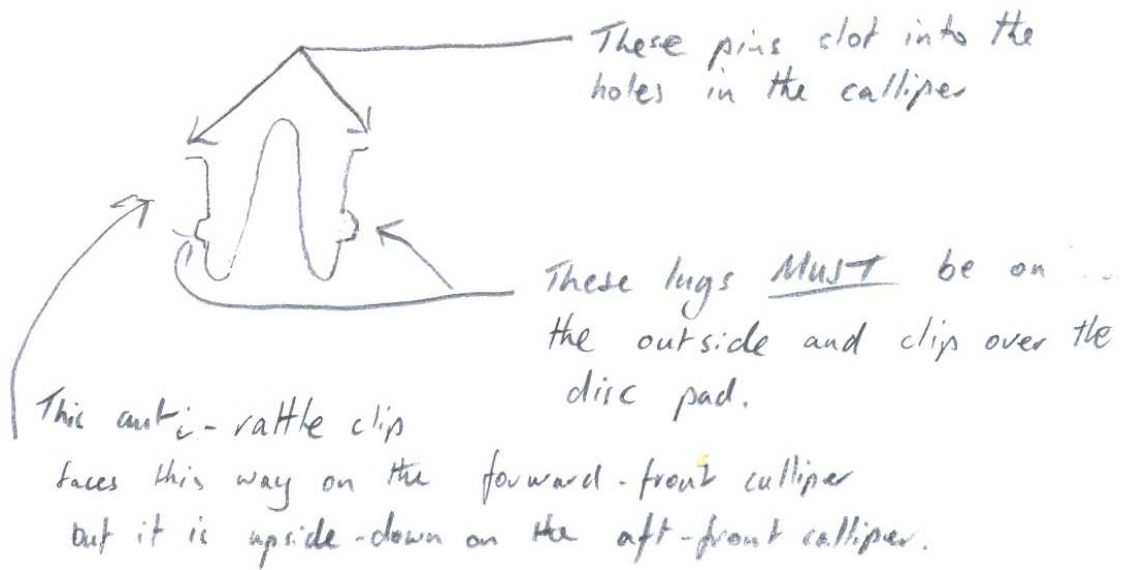
The straight part
of the pin goes
in this hole.

These pins slot into the
holes in the calliper

These lugs MUST be on
the outside and clip over the
disc pad.

This anti-rattle clip
faces this way on the forward-front calliper
but it is upside-down on the aft-front calliper.

This is basically a simple procedure but, **it is very important to put everything back the way it came off.** For instance, the anti-rattle springs that hold the pads in place will break if put back in the wrong way so please ensure that you take special note of how the parts are placed before you remove anything (See diagram on next page).

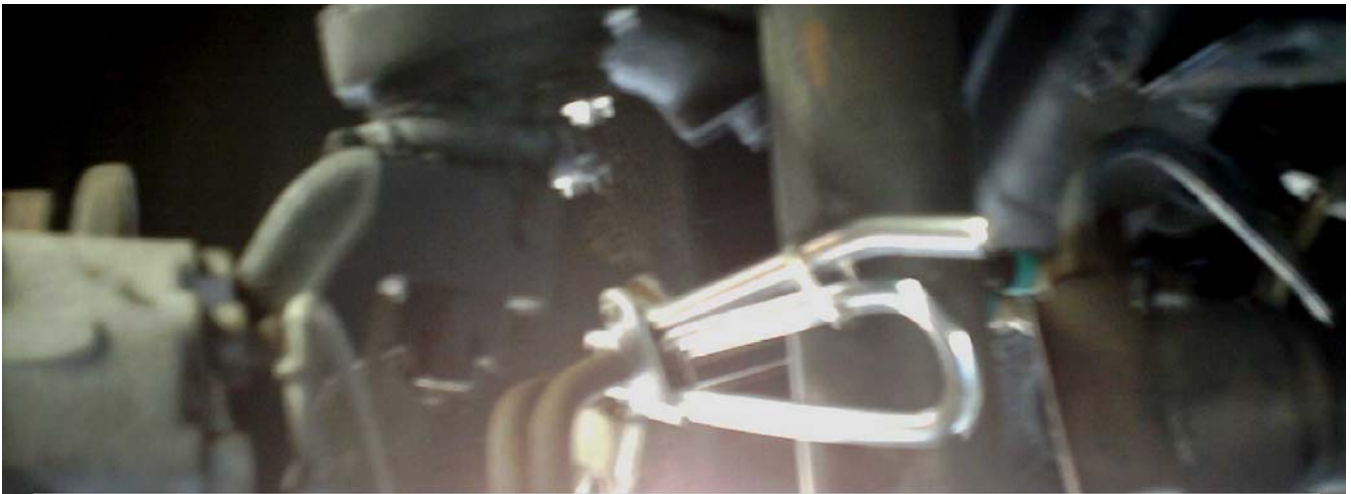
**This tool is a Brake Hose Clamp
It is specially designed to close off the flow of brake/hydraulic fluids
and it has rounded clamp ends to avoid damage to the hoses.**

Terry Farrow brought his brake hose clamps along for the job and these proved to be very handy. These clamps block the flow of hydraulic fluid to the callipers so that you can attach a hose and bottle to the bleed nipple. You are then able to open the nipple to release a minimal amount of oil into a bottle, thus facilitating ease in pushing the pistons back for removal of the old pads and replacement of the new ones. It also gives you an excellent indication of whether any sediment has built up in the pistons. In my case, there was none.

Don't use ordinary clamps however, as these may cause damage to the brake hoses. These ones are rounded and are designed to apply just enough pressure to stop any flow of liquids without crushing the hoses.

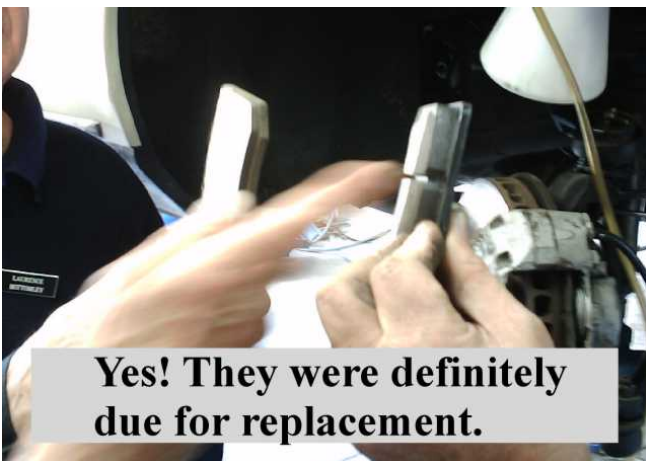
**Yes! They were definitely
due for replacement.**

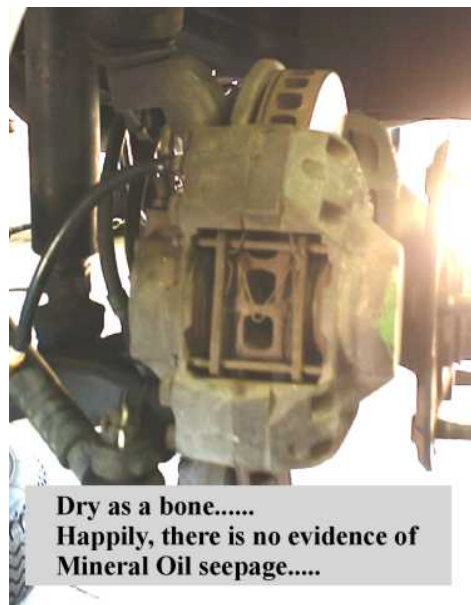
**Dry as a bone.....
Happily, there is no evidence of
Mineral Oil seepage.....**

It is fairly common with systems running on mineral oil to find evidence of seepage around the callipers. This may not be a huge problem but if you do detect it, then it would be prudent to keep a constant check on it. Happily for me, everything was a dry as a bone. Also check the disc rotor for scoring, particularly if the pads were extensively worn. You may need to get them machined or even replaced. Another thing to watch for is rust around the inner part of the rotor. Not a real problem for Australian delivered cars but it can be particularly hazardous to your health if rusting has occurred around the crimped area that joins the two parts of the rotor together. If there is ANY sign of this, ***Get it checked by a specialist immediately.*** I cannot emphasise the importance of this enough as your very life may depend on it. Replacement rotors are expensive but at least they are replaceable, you and your passengers are not.

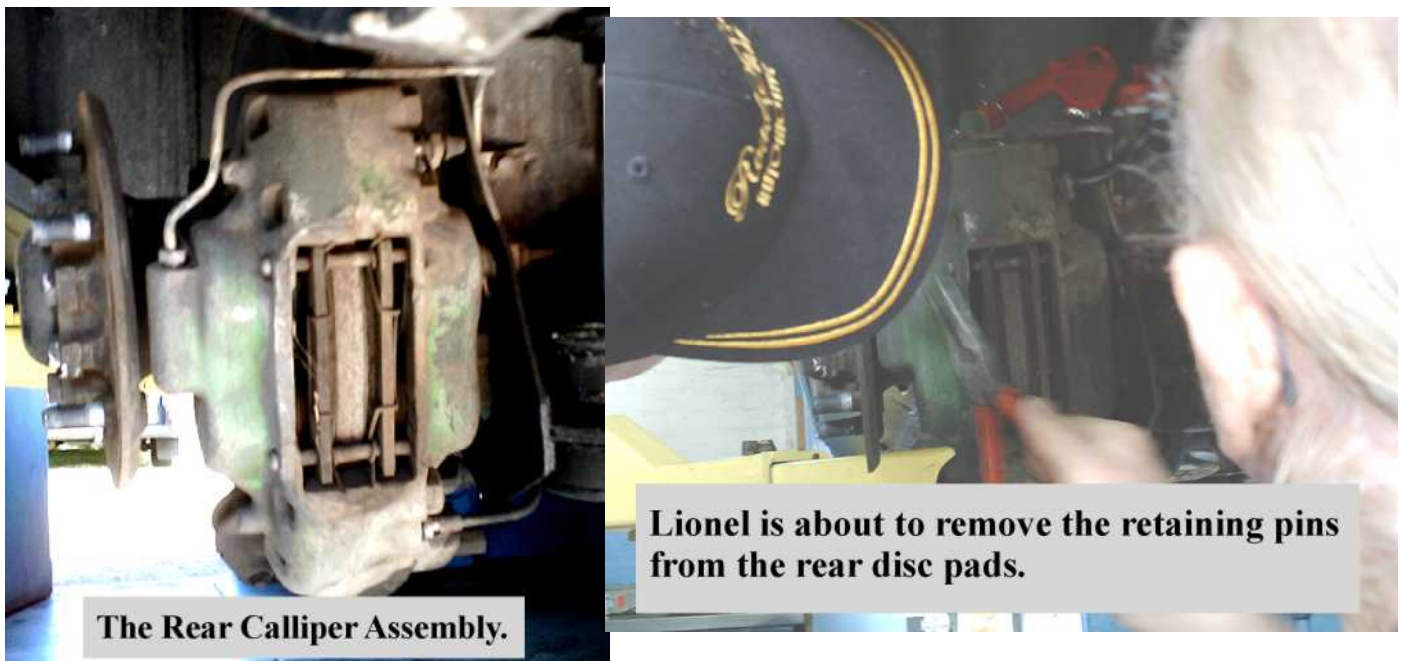
There was something that was a little disconcerting however.

I noticed mineral oil extricating itself out of the bottom of the rear suspension strut. Up until now, there were no discernable leaks from this area.

Make sure that you thoroughly clean the whole area before you put the car back on Terra Firma, otherwise grit can get past the seals and cause damage.

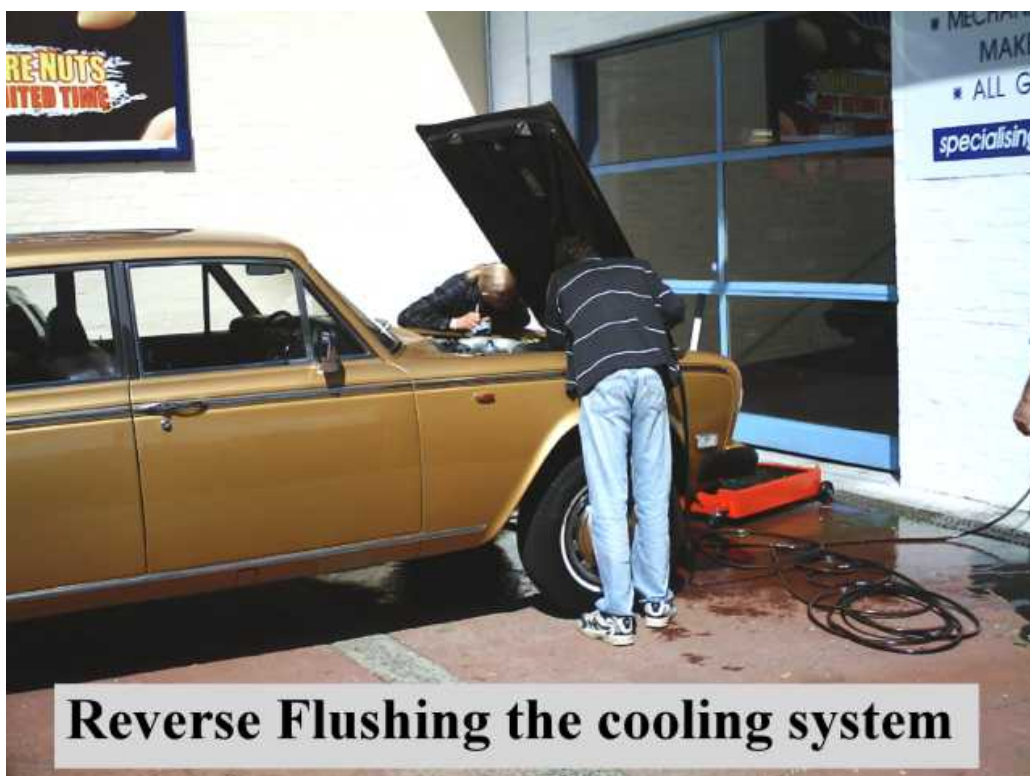
Back to the coolant flushing.

Mark is quite adamant that cooling systems should be flushed every two years. This is especially important with the aluminium V8's as the inhibitor tends to lose its effectiveness shortly after this period. Old coolant, or worse still a concentration of glycol which is too low, can actually be corrosive, so it's vital that this exercise be carried out as a normal service procedure. Use a pure concentrate rather than a pre-mix when purchasing anti-freeze/inhibitor and mix it to a true 50/50 glycol/water concentration (It actually recommended this on the container that Mark purchased as well). Note that most premixed coolants have only a 35% concentration, and many concentrated coolants have only a 70% concentration, so a little calculation is required to reach the desired 50/50 result.

Mark disconnected the hoses to the header tank first and back flushed that unit individually.

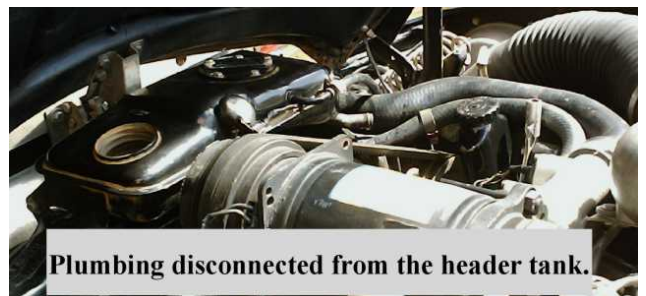
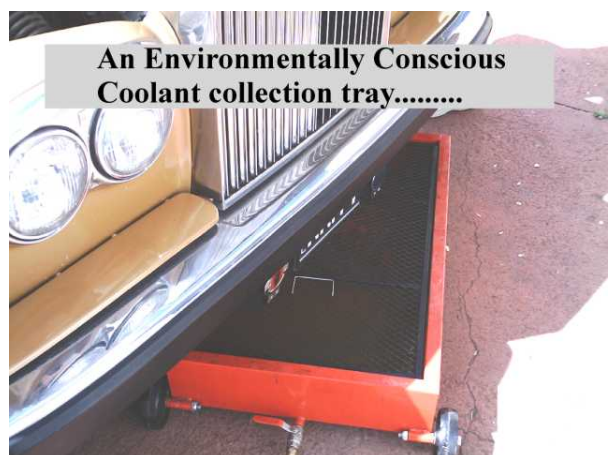
Mark did come up to a minor obstacle. He wanted to remove and replace the thermostat (Which should also be replaced during flushing), but one of the studs looked a little dubious. Now you normally need to remove the thermostat to reverse flush the system anyway and he will be doing this next month at our last gathering for the year when he has a suitable tool to replace the stud if necessary. He managed to bypass it for today's exercise however and was pleased to see that there were no nasties that came out with the old fluids. Mark is taking a sample of the old fluid to the lab where he works to get it analysed. This is just out of curiosity to see how effective the old inhibitor was (and other things-see the last page).

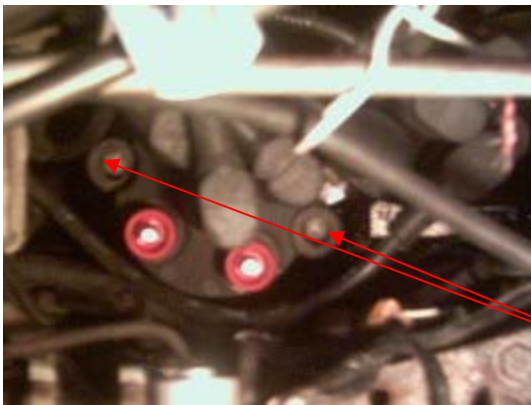
Looking down on the direct driven distributor with two leads removed and the two Phillips screw heads can be seen. The belt driven distributor will also have two Phillips screw holding the distributor cap to the distributor body

Phillips Screws

With the appropriate tool loosen them by pushing down slightly and twisting as they are held by springs then the distributor caps can be removed. Now with a drop of white paint or correction fluid mark the centre line position of the two rotor arms on both the covers and on the body of the distributor. This twin marking will become apparent a bit later (If the belt is broken then only mark the centre line of the rotor on the direct driven distributor as you will have already marked the position for A1 on the belt driven distributor case).

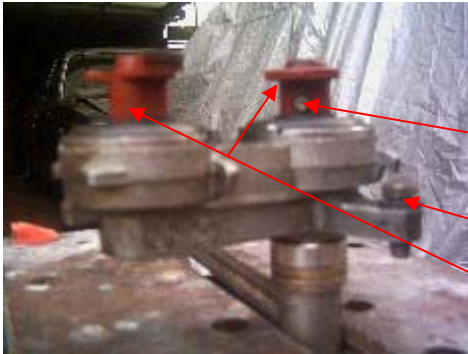
Twin Distributor with rotors still attached

Rotor holding screw

Rotors ½ AF Holding Bolt

For the next step have a socket set easily at hand as you are about to undo the ½ AF bolt that will allow you to release distributor and pull the assembly and shaft from the engine. It is at this point that the 2 hours remaining to complete this job really went of the window for my attempt. The unit did not just pull out! The truth is that after nearly two days I eventually devised a way to release its vice like grip. It is at this stage the knee pads came into use. I placed the curved end of a small crowbar under the distributor and resting the outer edge of the curve on the rear of the engine. Then by gently tapping with a hammer on the other end, the unit gradually lifted up-hooray!! The unit seems to have been held by thick grease that had incredible adhesive properties.

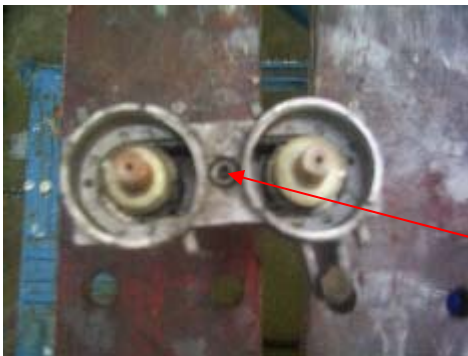
Distributor with Rotors and covers removed

Allen nut holding the two halves of the Distributor together.

Taking the unit to a safe place prepare for the next stage, I took the precaution of holding the unit in a vice. A selection of Allen keys will be needed and in my case a short length of tube to give an extension and additional leverage. I applied considerable pressure and with an audible crack the Allen nuts on the rotor arms came loose and they can be removed along with the covers. Apply the same brute force to the larger Allen nut in the centre and the pieces separate.

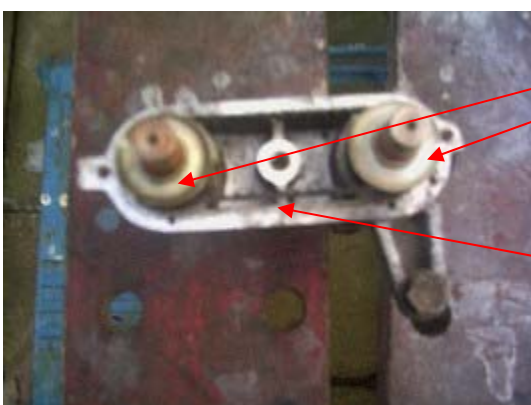
Metal Covers

Belt

I removed one metal cover by tapping gently from beneath using a screwdriver and small hammer. Taking the new belt and placed it over the two shafts, I then replaced the rotors putting in the small screws and aligned the direct driven rotor with the white mark on the outside of the case. At the same time align the belt driven rotor with its white mark and position the new belt. Remove the rotors and put in position the metal cover. Now replace the top cover and tightened the Allen nut followed by the two covers, rotor arms and retaining screws.

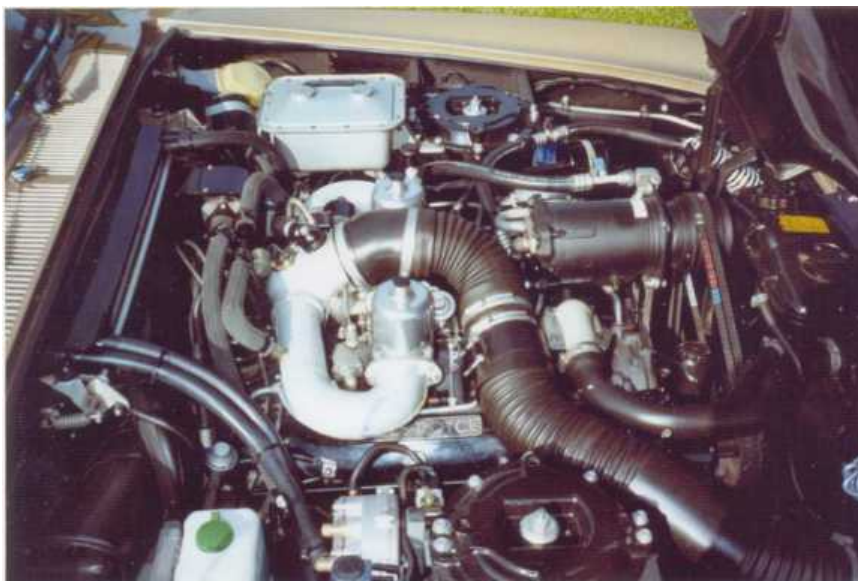
- If installed properly, there is minimal disruption to the engine bay and access for maintenance.

Look Hard. Can you see anything different?

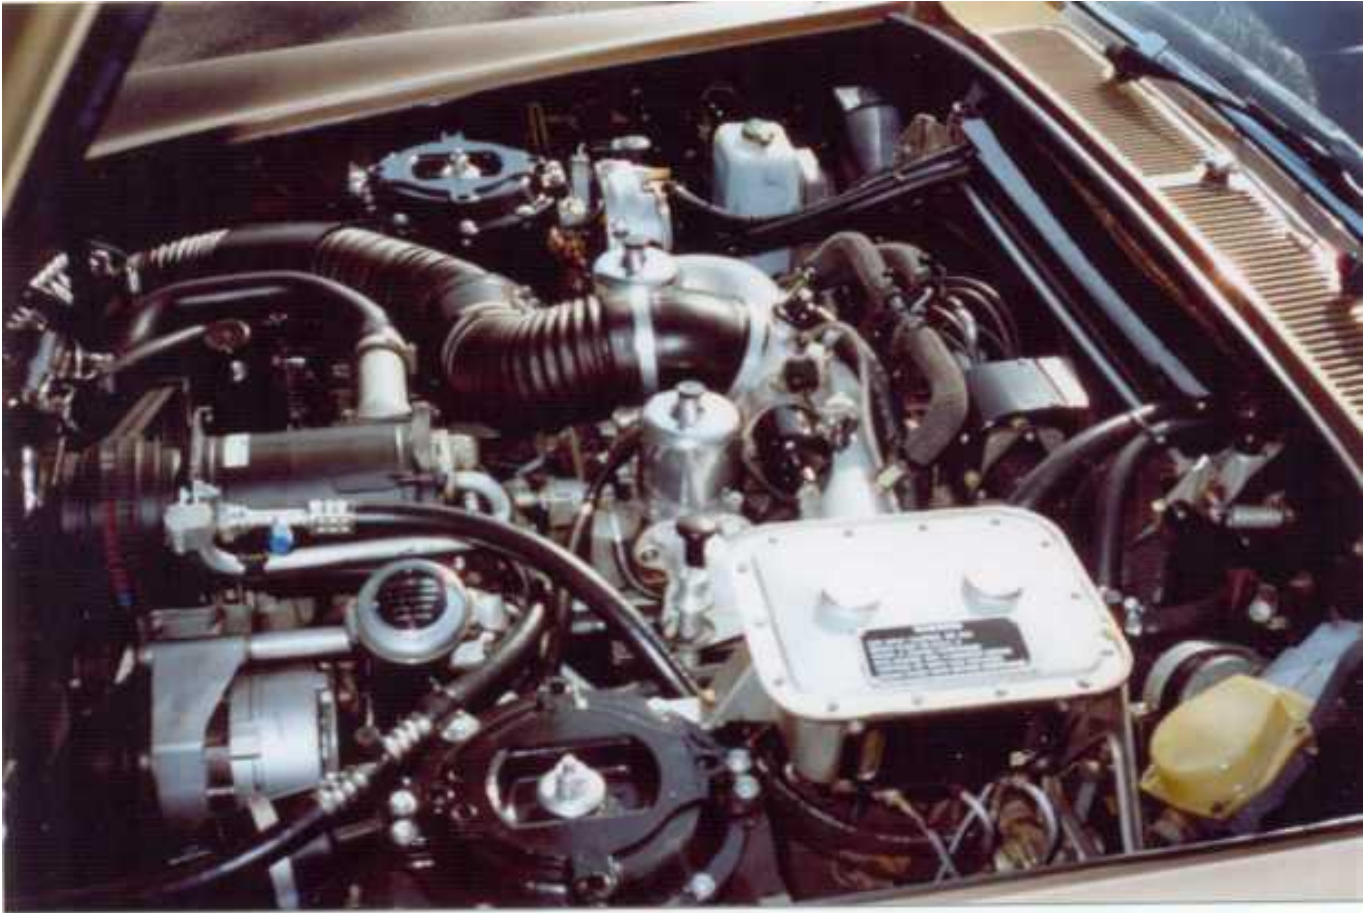
Another view. Snuggled behind the suspension tower is the converter (Driver's side)

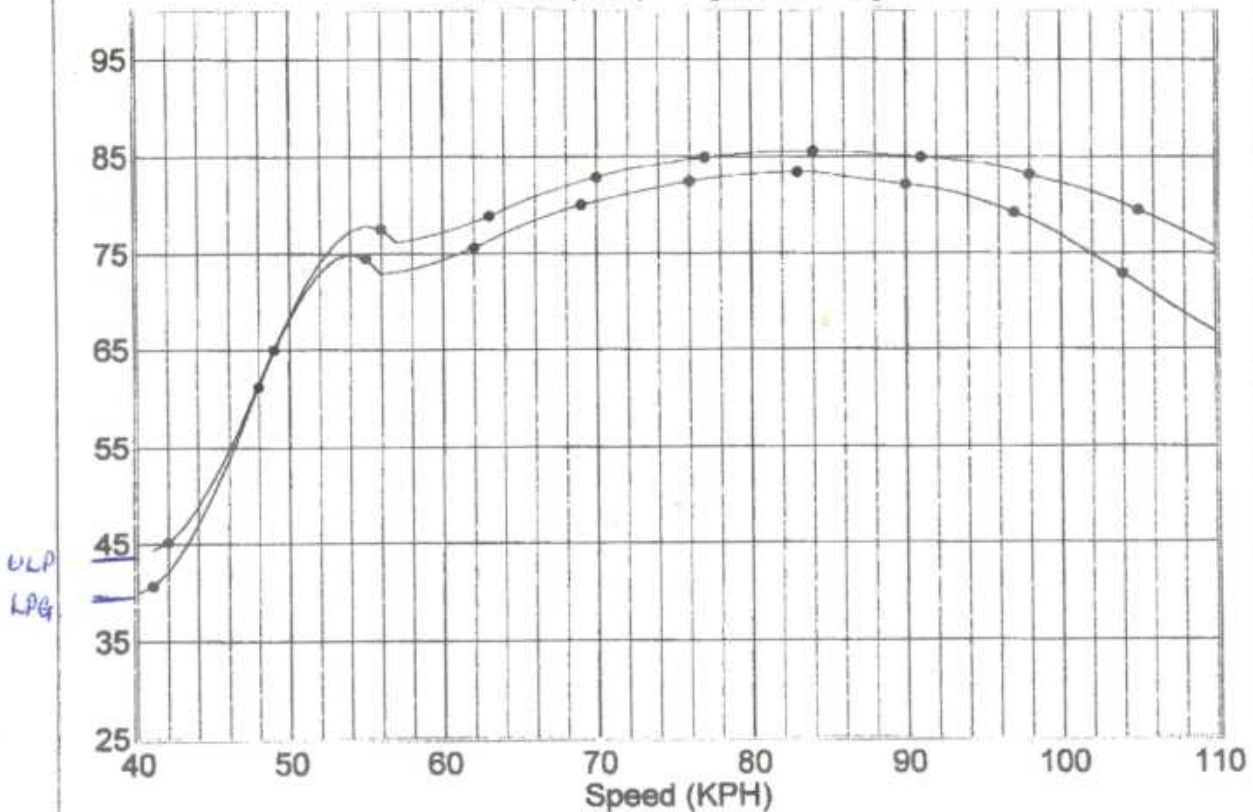
Power(KW) [UnCor'd]

- Optimax (The only fuel you should be using in your Proper Motor Car) is a similar Octane Rating to LPG.
- Refer to the ‘Dyno’ printouts on my car and you shall see there is only a difference of a mere 2.2 Kw at 83 k.p.h.

ULP
LPG
LPG Max: ■ Torque=550.1N.M @82KPH ● Power=83.4KW @83KPH ▲ Motive Force=1137.2Lb @82KPH
LPG Max: ■ Torque=562.2N.M @83KPH ● Power=85.6KW @83KPH ▲ Motive Force=1162.1Lb @83KPH

- Almost identical to petrol (Refer Dyno print-out on my vehicle).
