TEE-ONE TOPICS

Issue 92 – October, 2010

A LIFE SAVING SWITCH

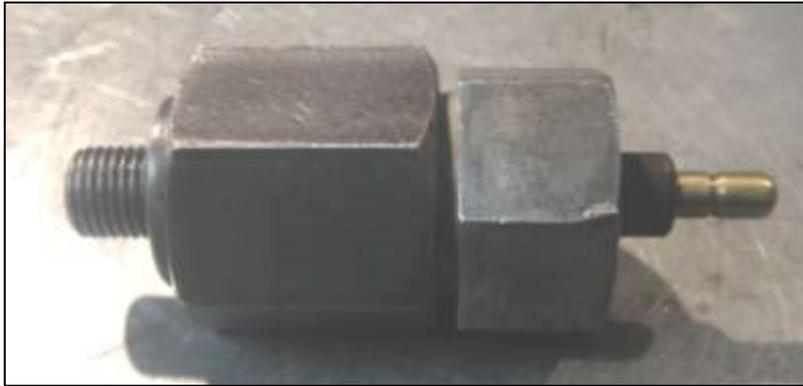
On Silver Shadows these are not very obvious since they are screwed into the accumulators located under the exhaust manifolds. Their function is simply to turn on the lights on your dashboard when the pressure in the

accumulators drops below an acceptable level. The switches were used right up to the end of production but those used on Silver Spirits differed slightly but most importantly, used different oil seals to cope with the change from RR363 brake fluid.

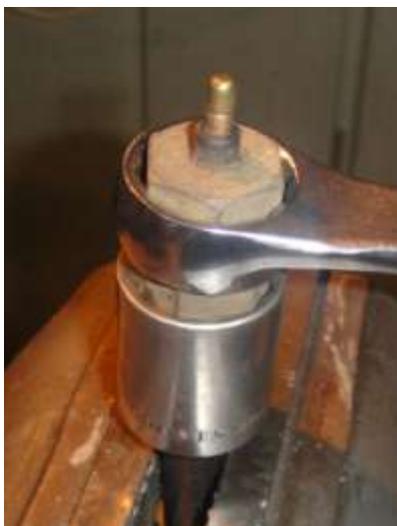
At left is one way of holding the switch while undoing it since the two pieces of the body are usually very tight. The socket is held by a short extension piece which is clamped in a vice.

The brass terminal on top connects to the base of the switch and thus to earth when the switch is not under hydraulic pressure be it either RR363 or LHM. The hydraulic pressure forces its way into the screwed end of the switch, pushes against a diaphragm which in turn lifts a contact disc and breaks the circuit to earth. If the above tests are negative you have a faulty pressure switch. Take it out after you exhaust the pressure.

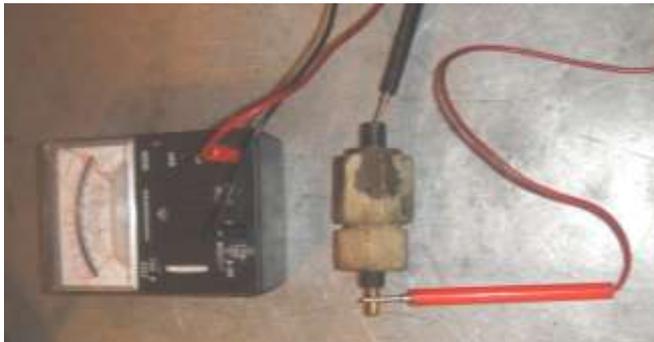
At left, this is the fundamental test you do before pulling the switch to pieces. The ohm meter is connected to the brass terminal and the switch base. The meter should show a clear circuit of negligible resistance. The test at left if you have been plagued with no warning lights will usually show an open circuit.

If you have the facilities to pressurise the switch with nitrogen the same test will show at what pressure the switch opens and breaks the circuit.

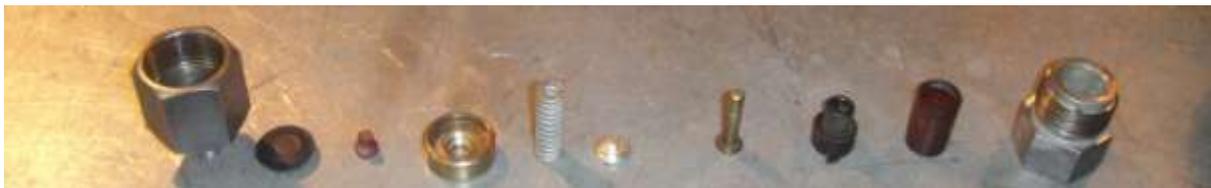
1 2 3 4 5 6 7 8 9 10

Above, here is the guts of the switch nicely cleaned out and lined up for a photograph. From the left:-

1. The switch base which screws into the accumulator and houses the rest of the gubbins.
2. The rubber diaphragm against which the hydraulic fluid pushes.
3. The contact plunger which the diaphragm forces through the hole in the brass holder to the immediate right of it.
4. The diaphragm holder.
5. The spring.
6. The contact disc which is lifted by the plunger.
7. The brass terminal.
8. The stepped fibre ferrule that insulates the terminal from the casing.
9. The fibre sleeve that insulates the spring from the casing.
10. The base of the switch.

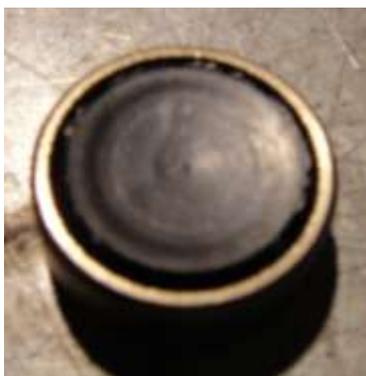
At far left is the diaphragm (2) inserted in the holder (4) with the plunger (3) beneath. This is the end that faces the fluid.

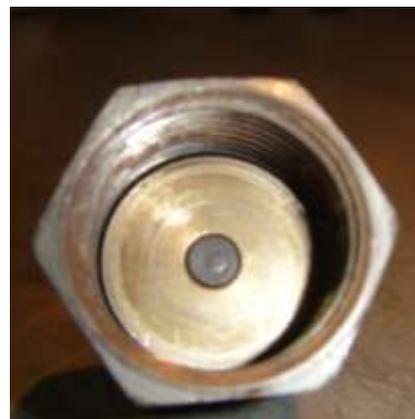
At right, the other side of the holder (4) and inserted in the switch base (1). Note that the plunger (3) seen in the middle of the holder is non-conductive.

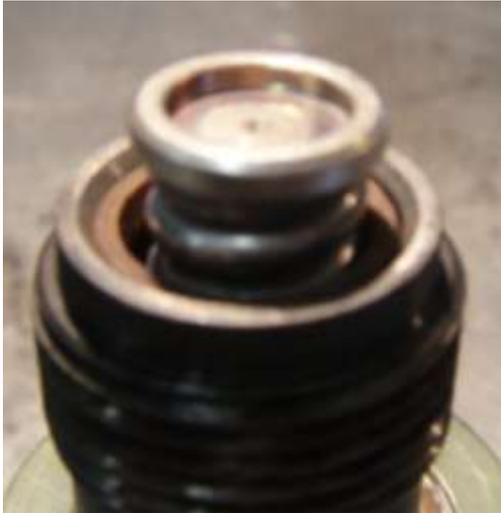
Here we have the other end of the switch with the brass terminal (7), its stepped insulator (8), the spring (5) and the contact disc (6)

When the two halves of the switch are screwed together the recessed contact disc (5) is pressed down hard on the brass seal holder (4) by the spring (5) the other end of which is jammed up hard against the bottom of the brass terminal (7).

The circuit now is through the brass terminal (7) down the spring (5) through the contact disc (6) and the brass seal holder (4) which is jammed onto the switch base that screws into the accumulator. The earth connection is made and the light glows on the dashboard.

When the engine is started the pressure builds in the accumulators and the hydraulic fluid enters the pressure switch through the base (1) and pushes the rubber diaphragm (2).

Eventually it pushes hard enough to move the plunger (3) further

through the hole in the seal holder until it lifts the contact disc off the seal holder. This breaks the circuit and the light goes out! The usual problem with a switch not contacting is corrosion between the recessed contact disc and the brass seal holder. The final test is to ensure that when the switch is not pressurised a clear circuit through it is present.

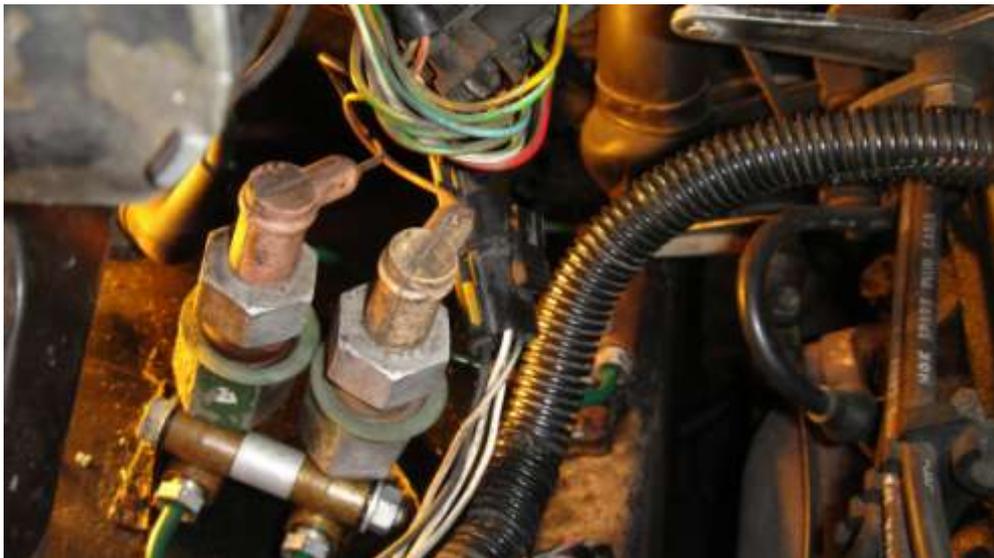
For some reason mineral oil cars tend to demolish their rubber components after a few years. The first victims seem to be the front brake calipers followed by the rear. But lately the pressure switches which also have 'rubber' seals in them are starting to leak. The above picture is of the warning light switches located on this '87 Spirit under the wiper mechanism. The leak however runs over the top of the wheel arch and into the rat trap area, major leaks from which are usually nerve racking. These switches are almost identical and replacement bits as for the RR363 items are readily available. Switches for RR363 and mineral oil are NOT interchangeable.

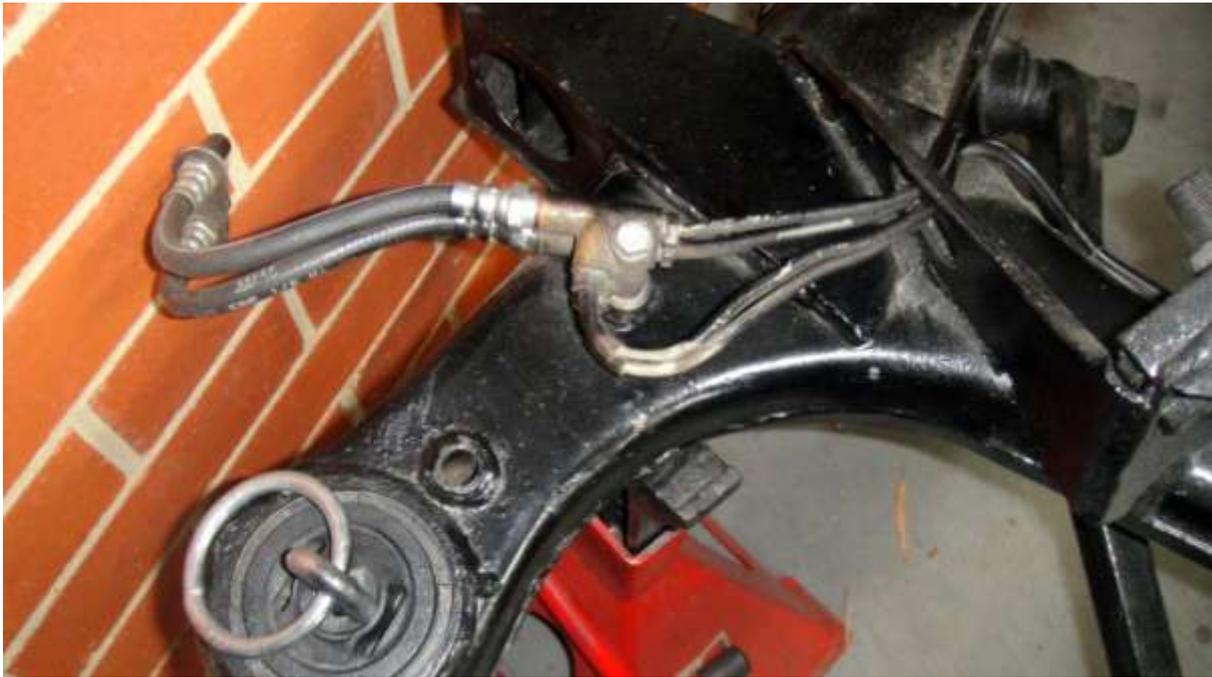
Well yes all hydraulic hoses are vital but these on your Shadow are more vital than any of the others. For those that came in from croquet the larger lump of steel above is the sub frame that bolts under the front of the car and carries your engine, the front suspension and front brakes. The area you are looking at is the right rear corner and the steel pipes connect to the calipers surrounding the brake rotors.

The large circular mount, one of four, one for each corner of the frame, allows the latter to move with the antics of the suspension and the lurching of the motor, thereby insulating the body of the car from vibration and some noise. The four steel pipes, screw into two, three way junction blocks, one for system one and the other for system two. They both need to connect to the two distribution valves in the rattrap under the driver's side floor. Because the frame and junction blocks are moving relative to each other, the designers figured that rigid steel pipes would be candidates for eventual fracture, hence the flexible pipes seen above.

Unlike other 'rubber' pipes around the system, these are under full accumulator pressure all the time. If one blows, one system is off the air, if two blow maybe you will be likewise! Changing them is best done by ET but if he is not around you will find yourself making some interesting spanners to get at the unions.

Spirit owners can rejoice. Although the sub frame is the same the flexible hoses were deleted and replaced with rigid tubes with enough flex to withstand the vibration.

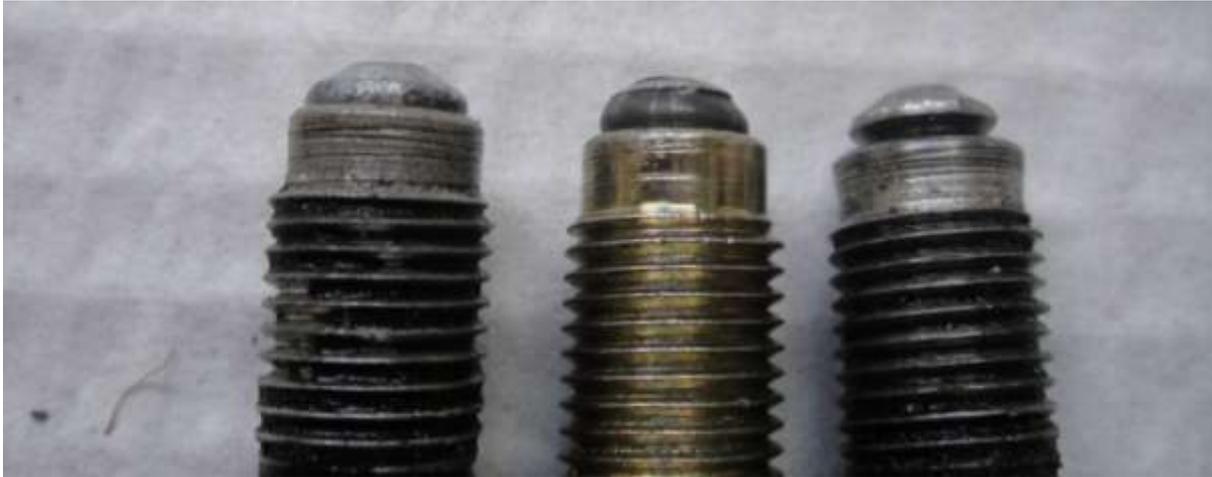
To achieve a seal the end of the brake pipe is flared in the shape of a bell as can be seen in the centre example. The nipple in this case is brand new. Tightening the nipple involves forcing the bell shape into a matching seat in the receiving unit be it a wheel cylinder, caliper or whatever. The tightening is firm, sufficient to stop leakage and no more.

The nipple on the left has been tightened excessively and the 'mouth of the nipple is just starting to spread. The nipple on the right has been grossly over tightened, spreading the mouth to the extent that it is often difficult to get the nipple past the thread of the receiving unit.

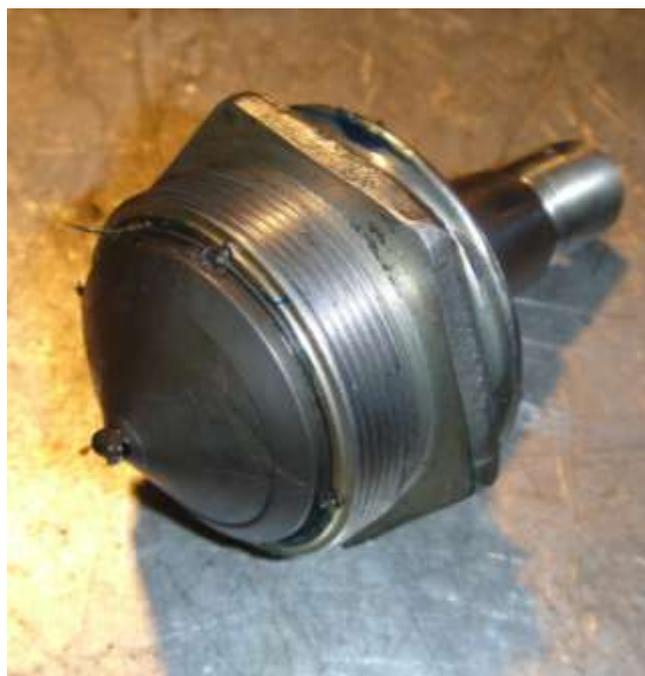
So the only solution to the bocking was to pull the whole suspension out and examine each bit. It also allowed me to look at items pre-packed with Crewe grease during production and which can wear seriously. One of these is pictured on the previous page. This is the lower ball joint on which the whole car sits and allows the front wheels to swivel.

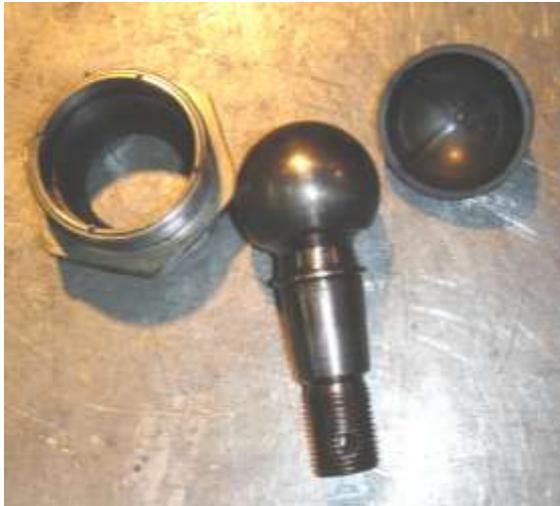
And this is the joint in pieces. The Shadow and Spirit used 'plastic' very slippery cones and cups seen here for the ball of the joint to turn in. With liberal greasing there is little friction and little wear.

Both the cup and the upper seat (it's fitted in the top cover) have four axial grooves cut in them to help distribute the grease. They also give some idea of the extent of wear.

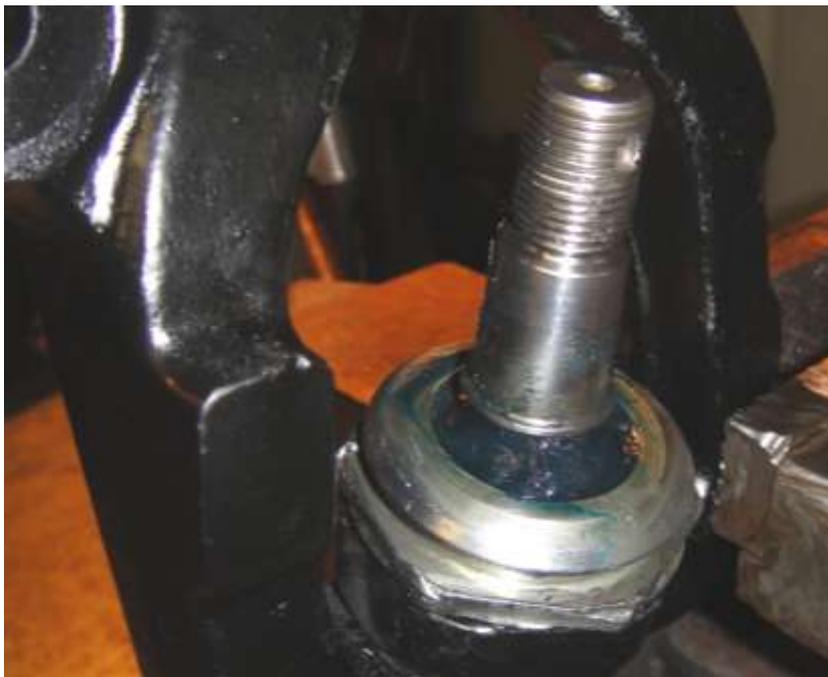
Below is the cleaned up and greased lower ball joint installed. The bright shiny cap which holds the whole lot together has shims between it and the main housing. These are removed selectively to tighten the grip on the ball. The tension should be such that you can

just knock the ball pin sideways with the ball of your hand without screaming in agony.

My 'cups and balls were in great condition albeit a little loose. Dropping a shim out brought them back to spec! One casualty however was the rubber boot which was nicely sliced radially and would have let road muck in if not replaced.

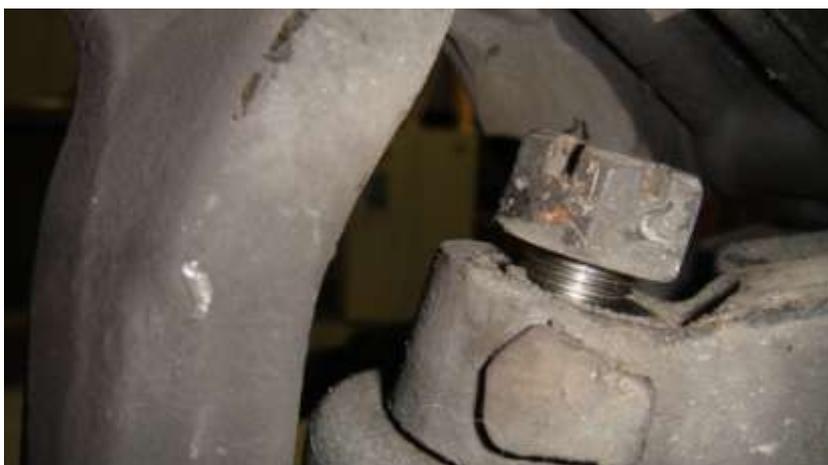
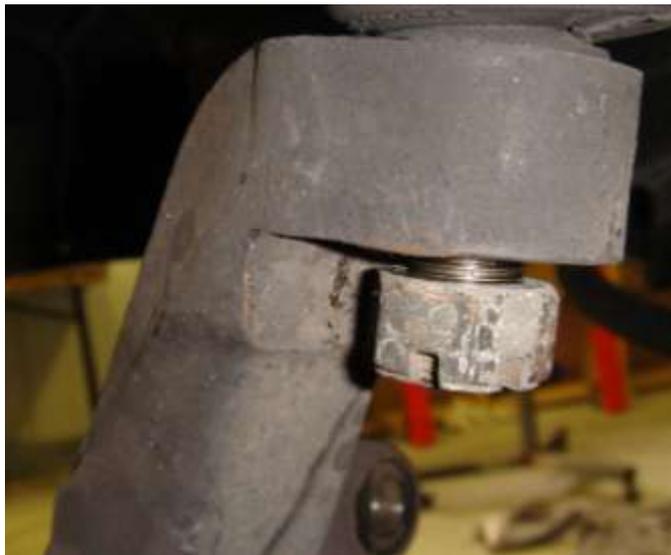
These are difficult to position and awkward to tighten. The solution is fairly simple. Undo

the retaining nuts about 3/16" obviously with the car on stands and the wheel unsupported. The pictures show the bottom yoke bearing above and the upper yoke bearing below. All that remains is to use a large brass drift and a brickies hammer to belt the yoke. If you find a serious attack of bursitis coming on, stop hammering and apply a little heat then a couple of bangs.

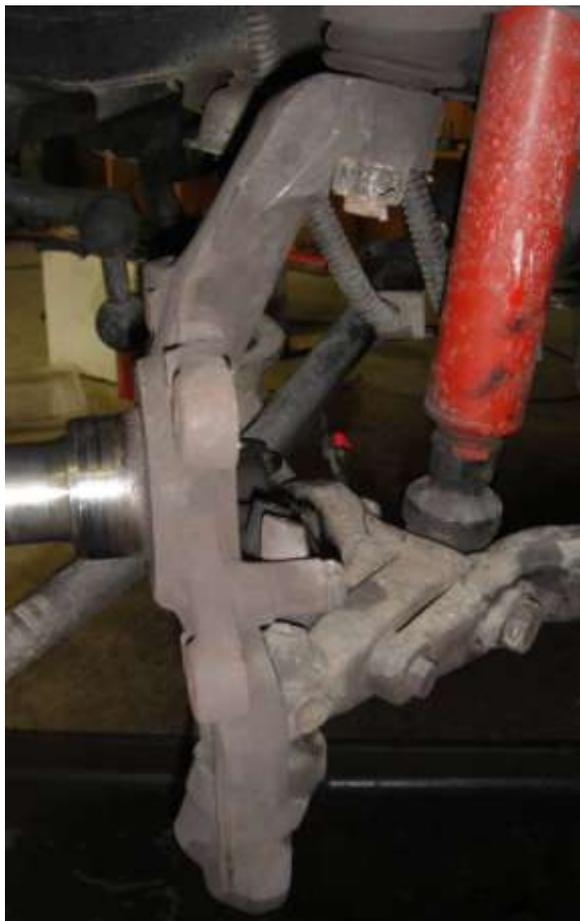
The first wheel I tackled (the right one) I simply (?) disconnected the steering arm and the brake lines. Having undone the ball joints I lifted the whole assembly and carried it to the bench, then retired to my cot to get over the strain. The assembly of rotor, two calipers and yoke is very heavy. Sense prevailed for the left side and I dismantled all the detachables before lifting!

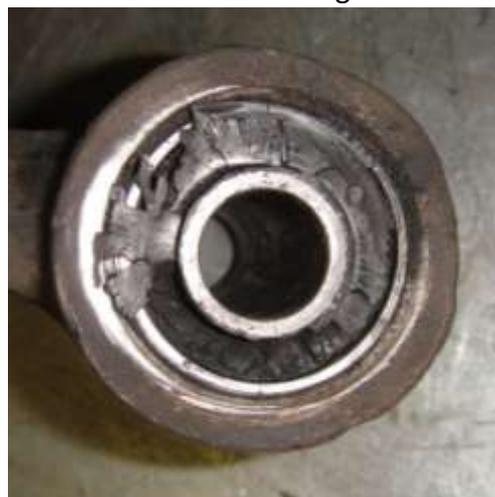
Finally I dragged out the upper suspension arm and found the source of the bocking – the silentbloc camber bush. The bright metal on the arm is where the arm has been able to move back and rub on the mount.

The camber bush had to be pressed out and the new one pressed in. This time I had George my machinist mentor to make me an arbor and support sleeve to handle the very considerable force needed to do the job.

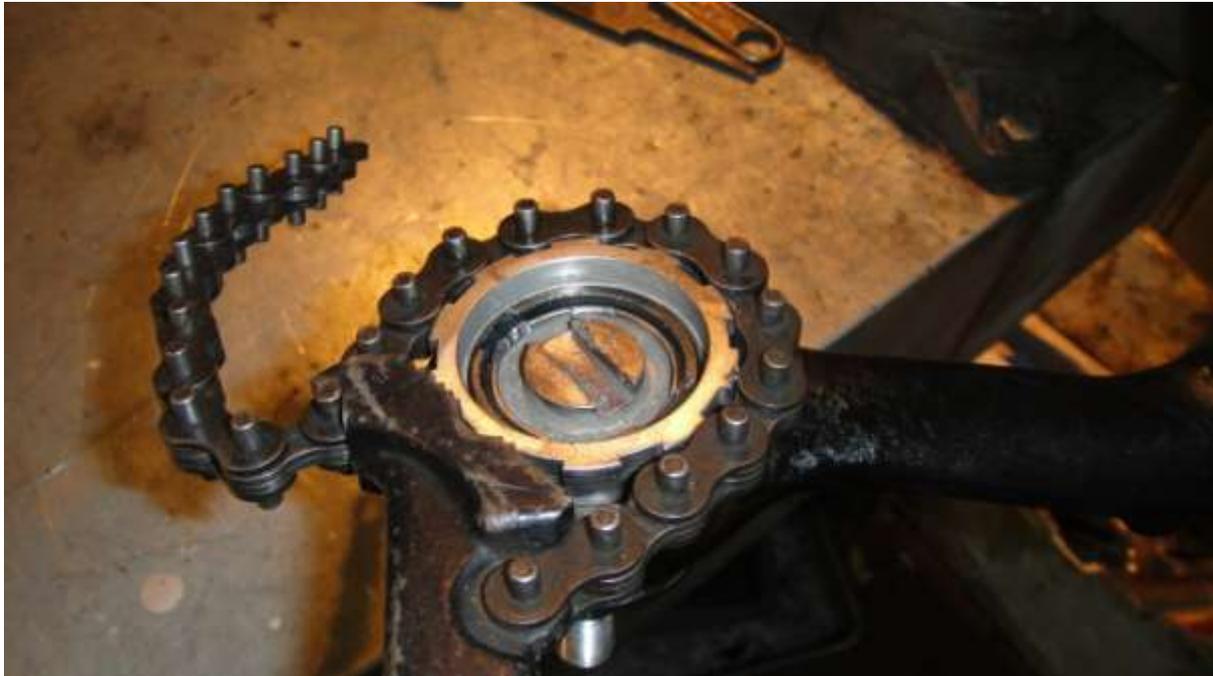
And here we have Madam Lash, as I like to call my chain wrench, entwined about the retaining collar securing the top ball joint bearing. Having removed the retaining ring above I realised that it was not really necessary unless you need to replace the bearing housing itself. Anyway it made cleaning the whole thing easier to clean and allowed fitting of a thick bastard in the slot of the adjusting cap.

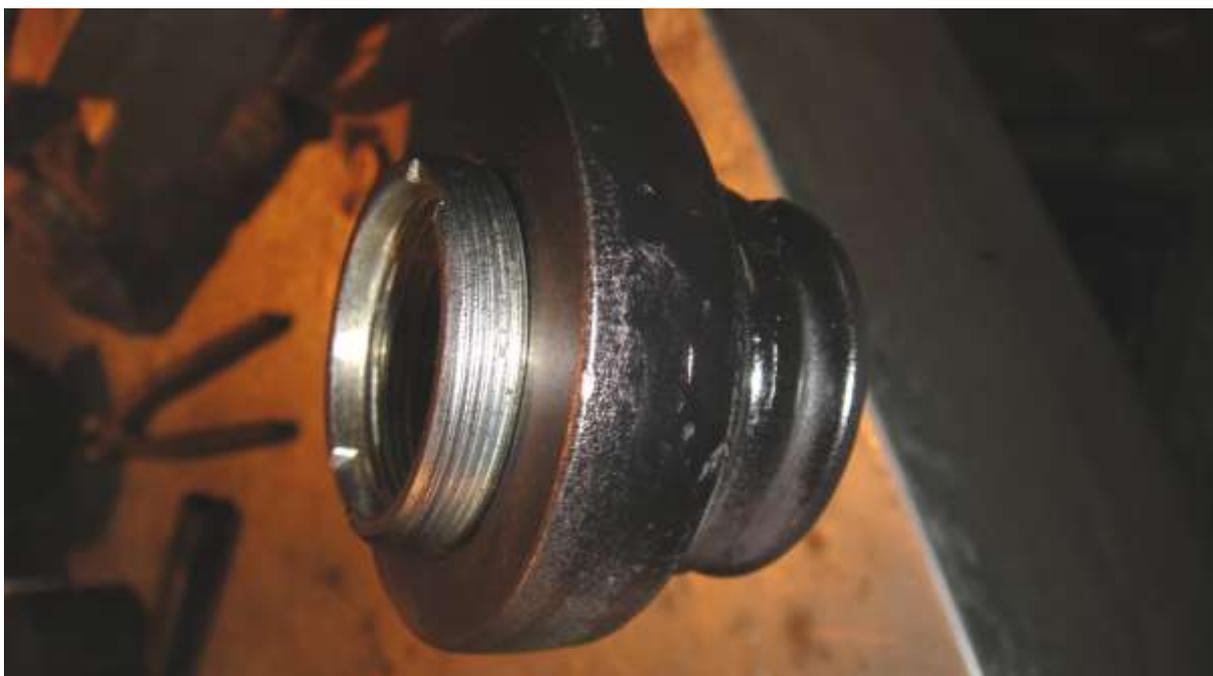
Retaining ring off, the rubber boot can be left in place if it's in good condition. Note the slots machined in the top of the bearing casing. The slots in the housing are provided to allow the adjusting cap lip to be peened at these points to lock it in place.

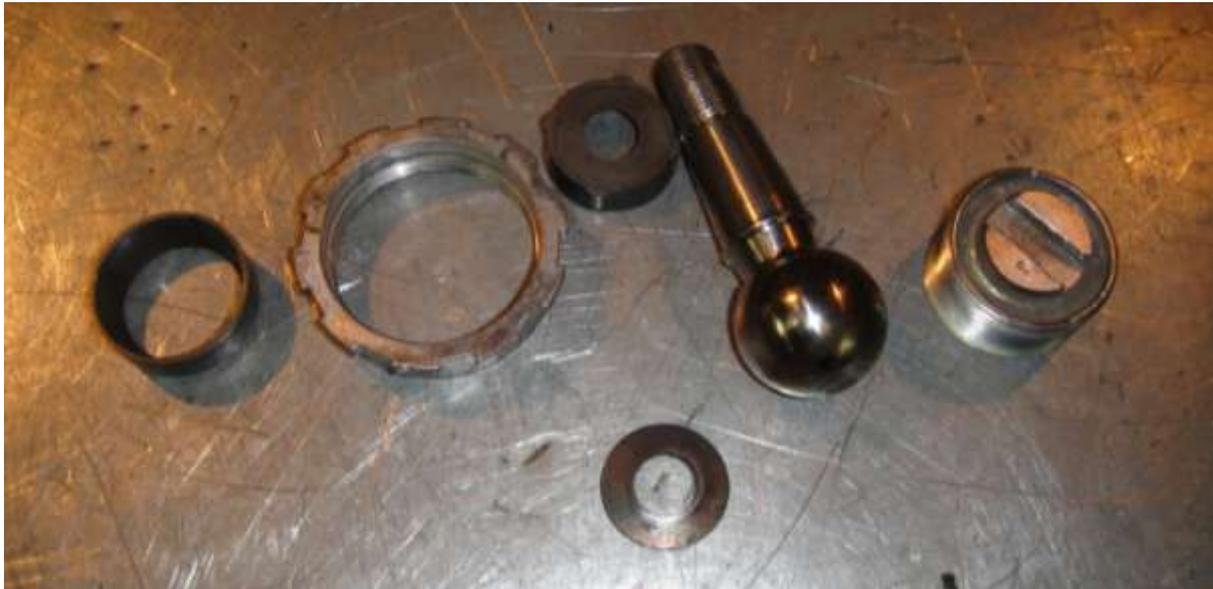
Here is the whole gubbins laid out. The adjusting cap is on the right, the friction cones are much slimmer than the lower ball joint items and the small Belleville washer sits on the top cone to help keep its shape. The slot in the adjusting cone is clearer here. My earlier reference to the product of an illicit liaison by name, applied to a bastard file. The end of a large thick example of one of these and a stout adjusting spanner are ideal for tightening down that cap.

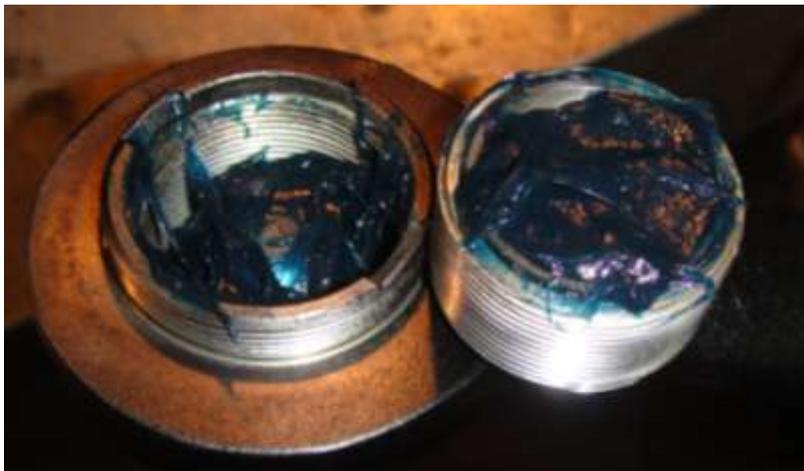
Here the bits have been refitted with lots of wheel bearing grease and the cap is ready to be screwed down and adjusted.

The bits for these bearings are not available from the Factory – one buys the whole assembly. All the bits however are available after market.

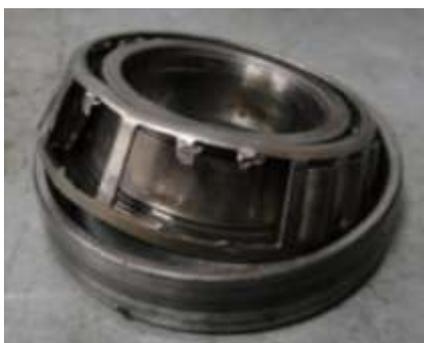
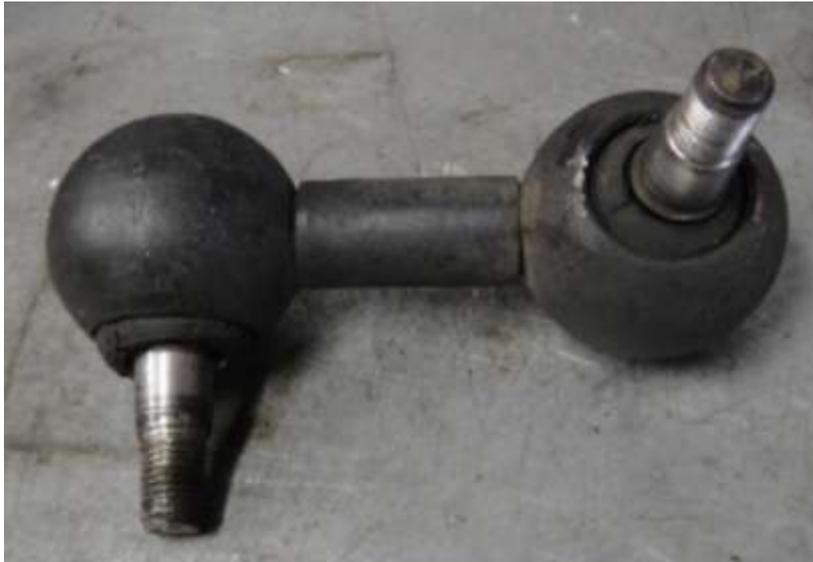
This was a nasty surprise. When I bought the car the supplier remarked that they had to fiddle with one of the front wheel bearings but it was 'all OK'!!!!!!!!!!!!!! Like the trusting idiot that I am I had not bothered to check the result of their 'fiddling'. When I pulled the front hub off this was what greeted me. Had a bit of that cage got jammed in the rollers, I may well have departed

prematurely for that great garage in the sky! The outer race on the front wheels is relatively small compared with its predecessors in the Clouds so it is worthwhile keeping a watchful eye on their condition.

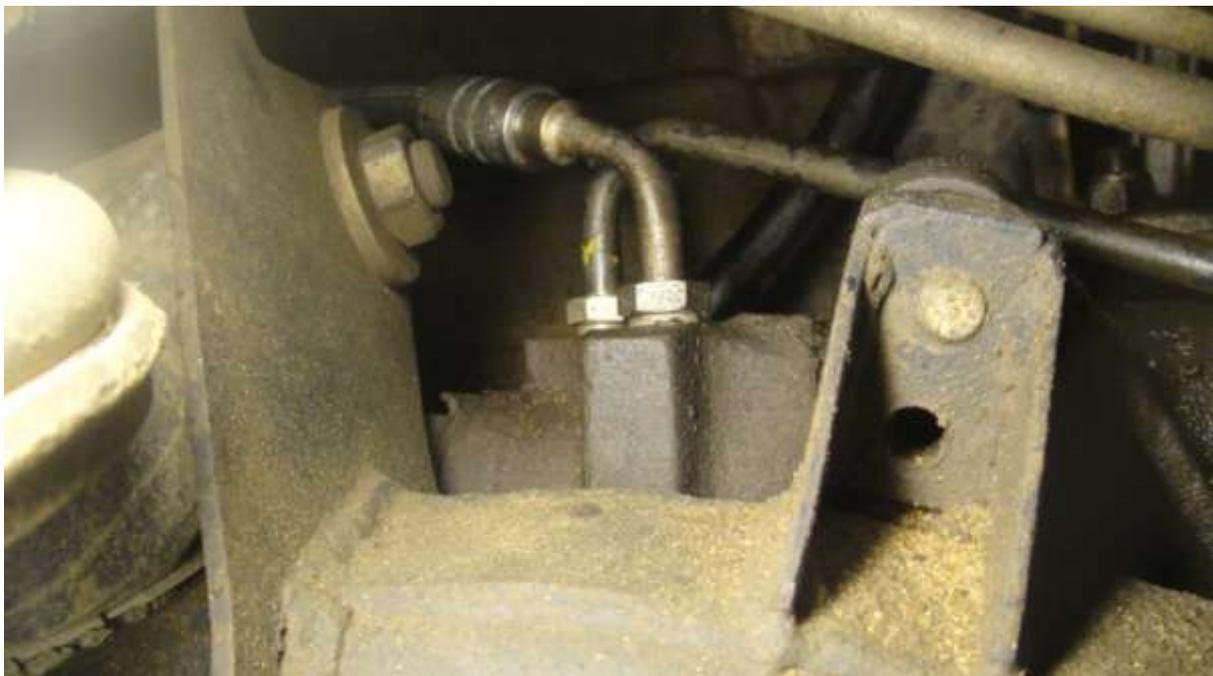
All Shadow I's (sic) still functioning will have had their high pressure hose from the back of the power steering pump to the top of the steering box replaced at some time. Some

owners find that the second hose which they had made at their local hose shop, didn't last as long as the first one. The reason for this is pictured above.

If you follow the route this hose takes and note the relative angles between the inlet and outlet fixed pipes, you will appreciate that the latter is quite critical. The above pipe's maker made a fair guess at the angle and assumed that any error could be overcome by just twisting the hose a bit. Hoses like these do not like twisting.

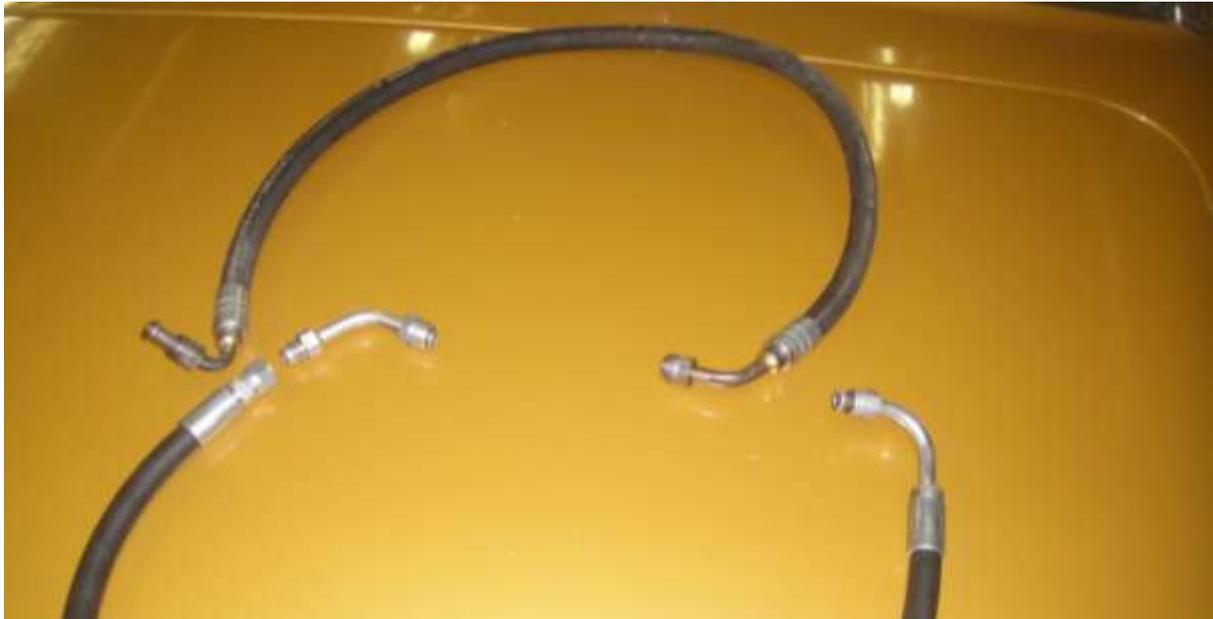
So here is the solution, the lower hose has been made up but the end into the box has been modified as an attachment. The latter is made up loose and the hose installed. The end nipples are nipped up, the hose support bracket fitted and last of all after assuring yourself that the hose is perfectly relaxed, the modified connection to the hose at the box end is tightened!
