Front Seats and Door Mirrors - Memory Battery Pack Replacement

Introduction

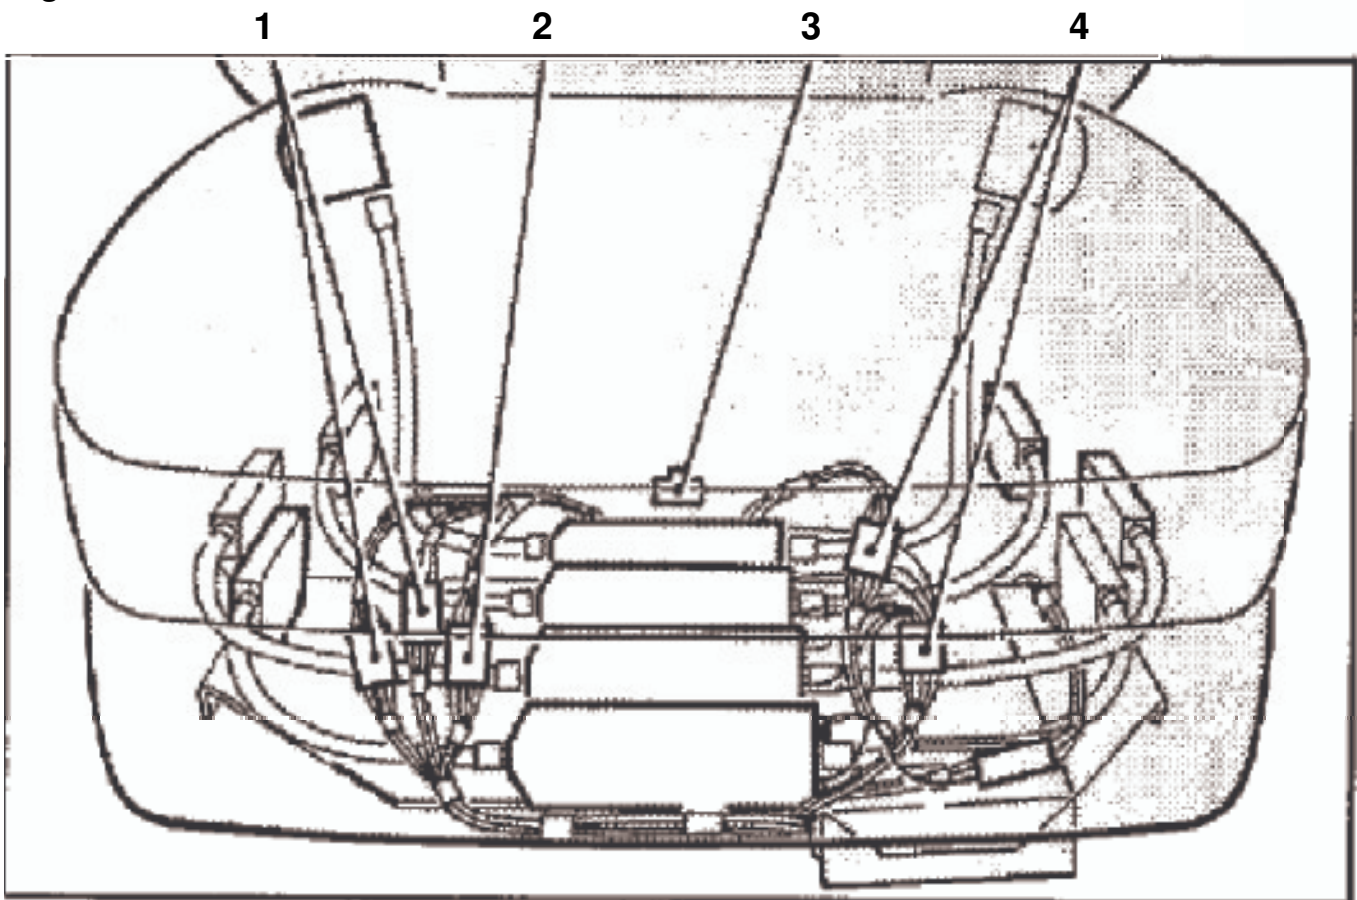
Figure M13-1

- 1.) Disconnect the two five-way connectors (see fig. M13-1 on Page 2, item 1)
 - M13-1 Seat connections**
 - 1 Five-way connectors
 - 2 Twelve-way connector

- 3 Relay socket
 - 4 Nine-way connectors
- 2.) Disconnect the twelve-way connector (item 2)
- 3.) Disconnect the two nine-way connectors (item 4)
- 4.) Unscrew the module and withdraw it
